# **Assessment of Riparian and Aquatic Habitat Associated with the upper Gunnison River, Gunnison County, Colorado.**

December, 2010

# Upper Gunnison River Riparian Assessment, 2010

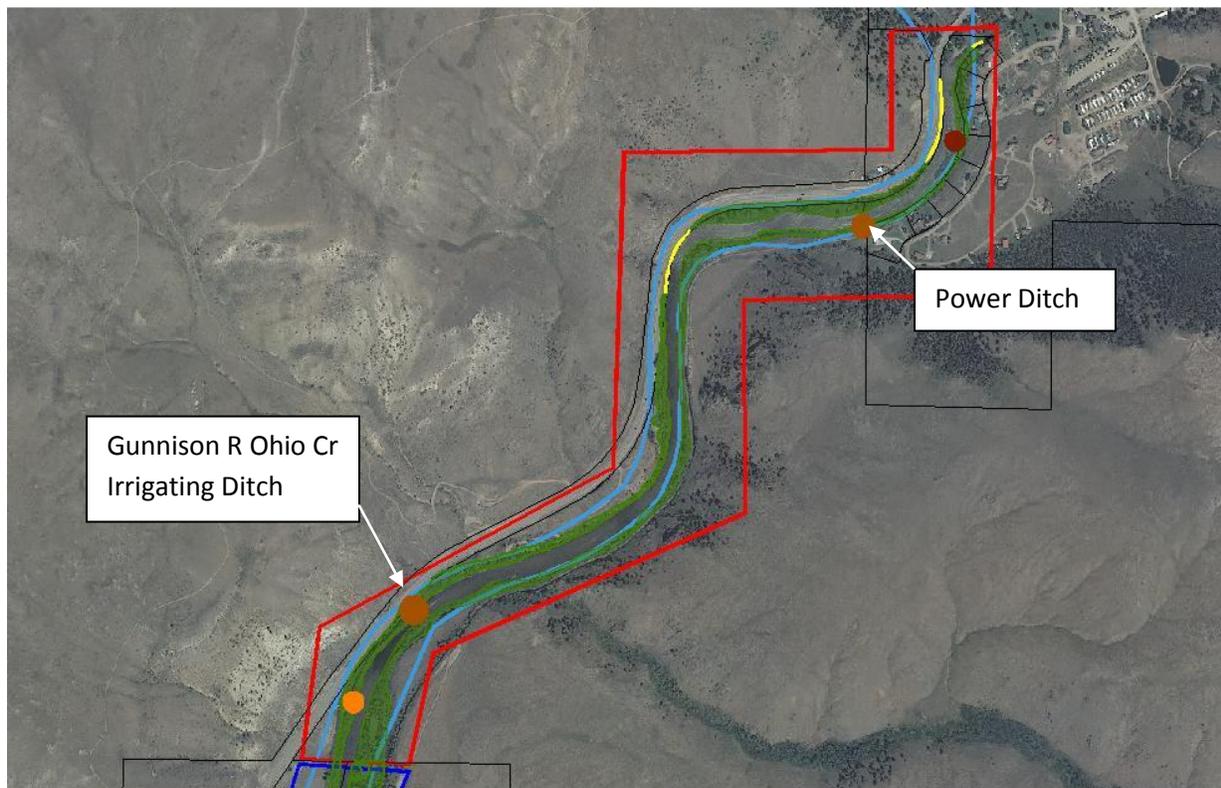
Assessment Segment 1 (7690 Linear Feet (LF), 1.45 mi.): Confluence of the East and Taylor Rivers in the Town of Almont to the southern boundary of the Almont Campground area. (Scores: 184/200.) Overall Proper Functioning Condition with two sections of Nonfunctional riparian areas.

**Photograph 1.** Aerial overview of Segment 1 (2009 NAPP imagery of Gunnison County).

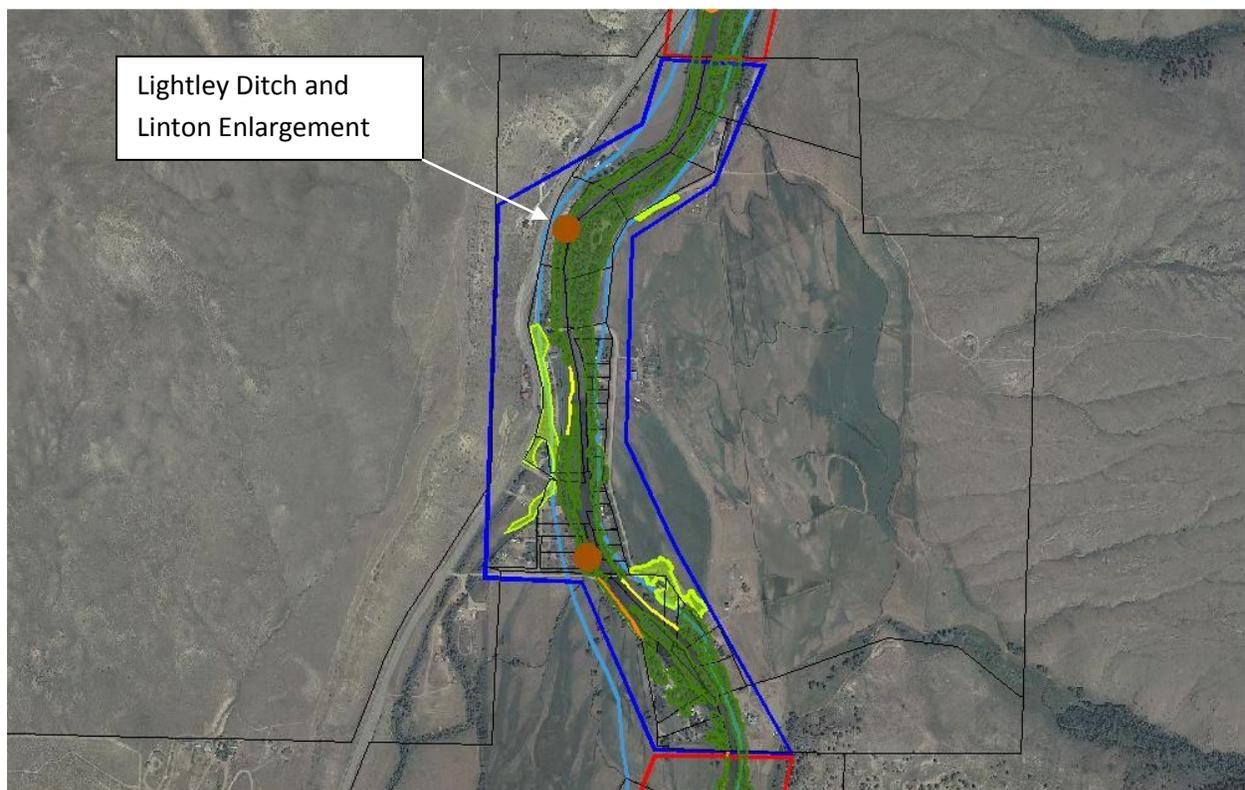
Assessment Segment 2 (5995 LF, 1.14 mi.): Lost Canyon Area and adjacent subdivisions (Scores: 182/200.) Overall Proper Functioning Condition with two stretches of Non-functional and one stretch of Functioning at Risk riparian area.

**Photograph 2.** Aerial overview of Segment 2 (2009 NAPP imagery of Gunnison County).

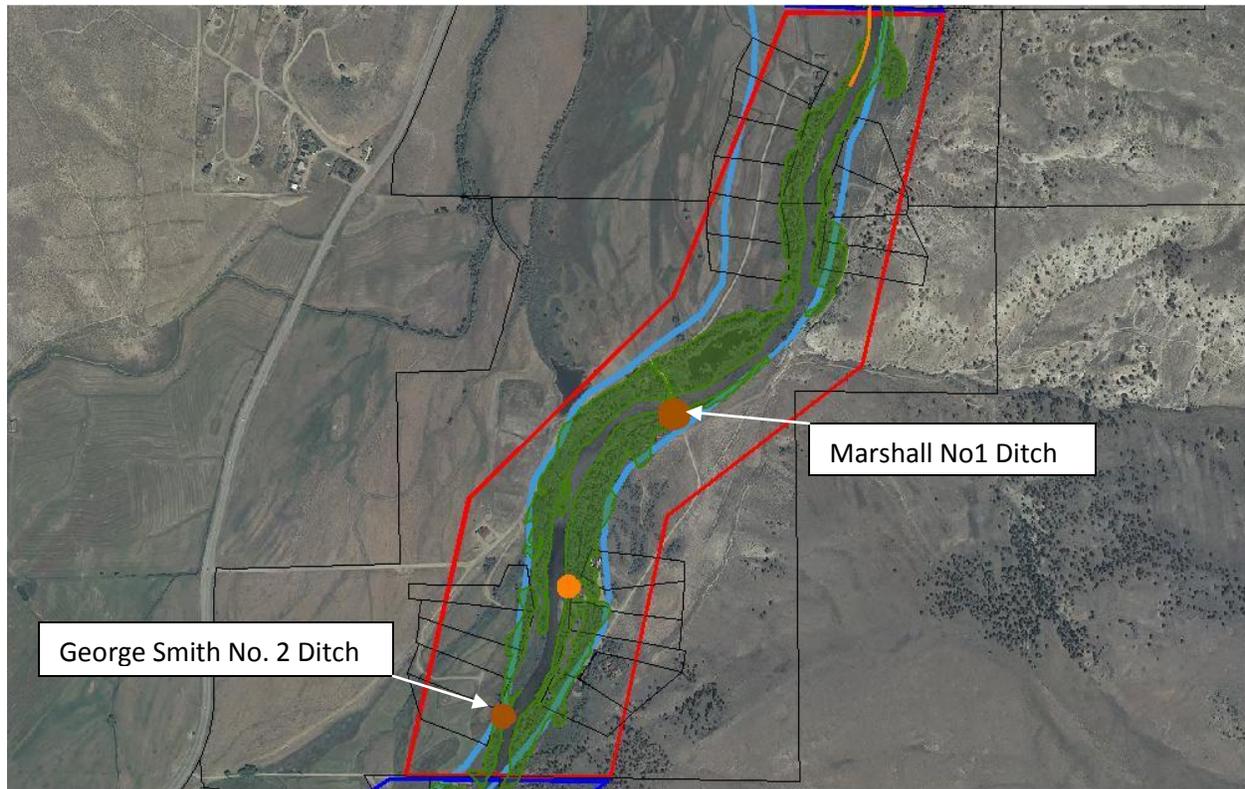
Assessment Segment 3 (6045 LF, 1.14 mi.): Gunnison River Banks Development (Scores: 184/200.) Overall Proper Functioning Condition with one stretch of Functioning at Risk.

**Photograph 3.** Aerial overview of Segment 3 (2009 NAPP imagery of Gunnison County).

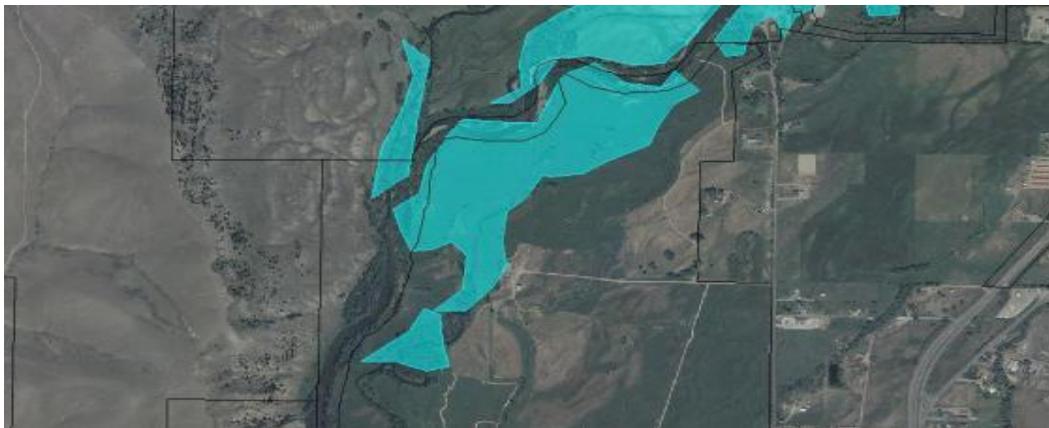
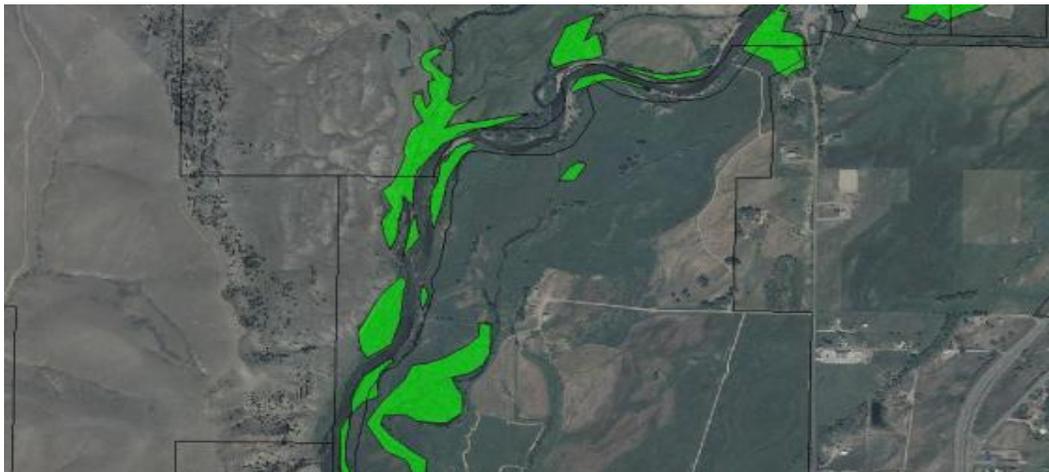
There are approximately 16 river miles of Gunnison River from Almont to McCabe's Lane that are contained in this assessment. Of this, approximately 83% of the Gunnison River riparian corridor is in Proper Functioning Condition which is a measure of having a riparian community that continues to function yet also allows for human land use. However, 24,408 linear feet of bank (about 17%) were rated as nonfunctional or Functional At Risk. Even though the study zone was predominantly functioning, based on a GIS analysis of aerial photographs riparian forests aerial coverage has declined by approximately 50% since 1950 (Photographs 13 and 14). In addition to riparian community loss, some riparian community has been degraded through perforation (Photograph 15).

**Photograph 13 and 14.** Aerial photograph of Van Tuyl Ranch and vicinity (Gunnison County, CO) with shading indicating extent of riparian forest in 1950 (top photograph, blue) and 2006 (bottom photograph, green).

- The Van Tuyl Ranch was listed above as an area for conservation but it is also in need of restoration. Based on aerial photographs from 1950 to the present, this area has lost much of its riparian forest and thus some of the functions of a riparian area. To maximize this publicly owned land for these benefits, we recommend the restoration of the riparian community, restoration of active side channels and overland high water flow in this area to maximize the benefits of water storage, aquifer recharge, water quality protection, a productive riverine/fisheries ecology and additional flood protection for the City of Gunnison and downstream.

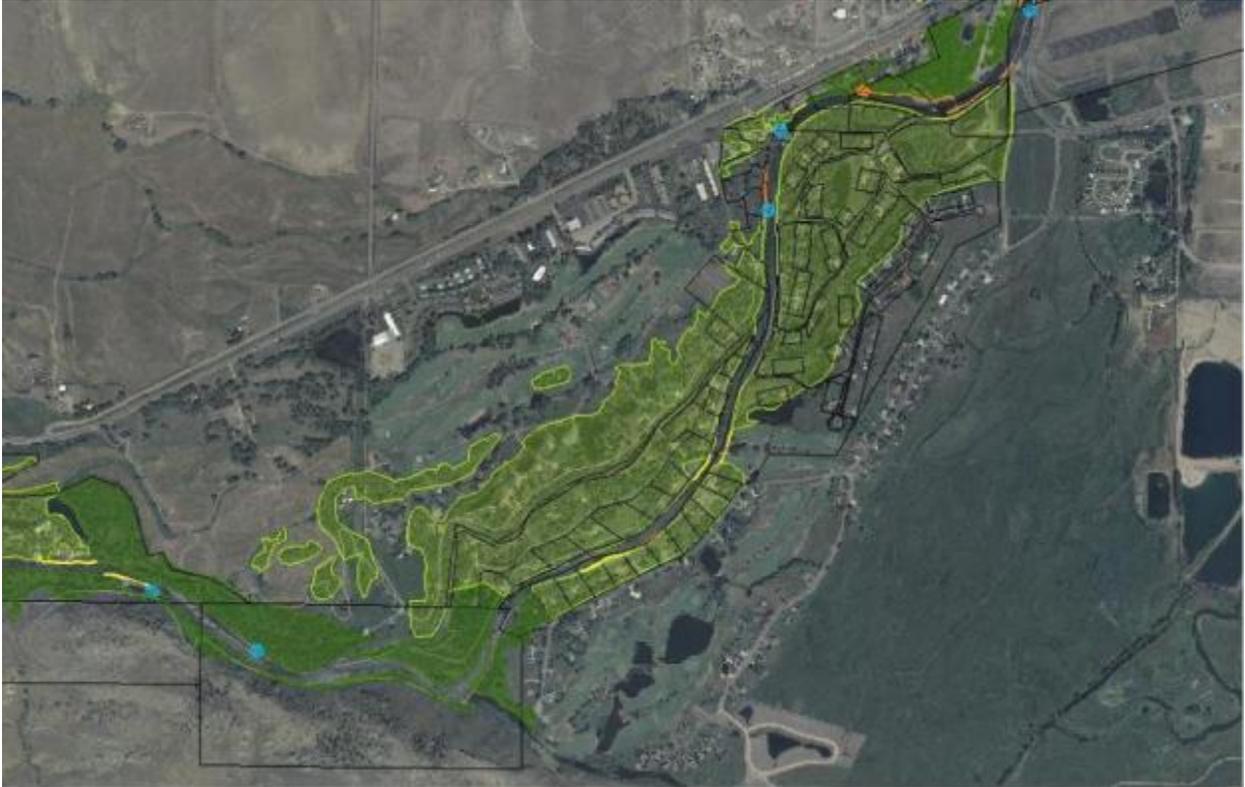
**Photograph 15.** Aerial photograph of Dos Rios subdivision (Gunnison, CO) in 2009 illustrating perforation of riparian forest (light green).

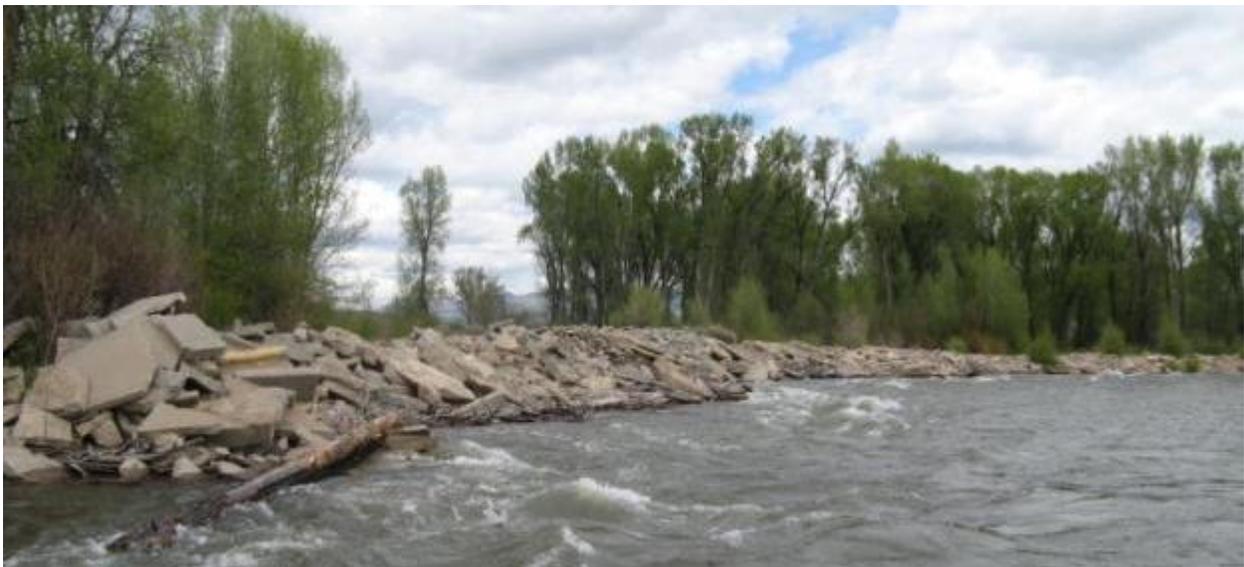
- The riparian vegetation near the confluence of Ohio Creek and the Gunnison River has been historically altered and the change required the use of concrete and rubble to prevent streambank erosion and property loss. In doing so, this removed much of the function and benefits that a healthy riparian community provides. We recommend working with willing landowners to reach an acceptable means to restore this riparian area and to diversify the in-stream habitat that has also been historically homogenized.

**Photograph 16.** Photograph taken during peak runoff, 2010, of bank armoring of the Gunnison River (Gunnison County, CO) upstream of the confluence with Ohio Creek near Van Tuyl Ranch.

- Van Tuyl Ranch, Ohio Creek confluence and areas immediately upstream (Assessment Segment 7) needs the restoration of overbank, side channel high water flow, plus the restoration of riparian forests and instream habitat. This assessment segment has lost approximately 80 acres of riparian forest (about 60%) between 1950 and 1979 plus saw catastrophic flooding in 1984. The stream has been channelized, the banks armored (Photograph 16) and the stream habitat has been homogenized. Riparian and instream restoration is recommended since this area includes a large node of riparian habitat and is publicly owned. This region provides substantial groundwater recharge that is used by domestic water wells for the City of Gunnison. Additionally, this is an area immediately upstream from a human populated area in the City of Gunnison and this may be used an area to reduce some of the impacts from floods. Improved overbank and side channel flow during normal spring floods (Photograph 17) and instream channel restoration will also benefit the fishery in the Gunnison River. This wetland enhancement could also function as a wetland bank for other public works projects in the Gunnison River basin.

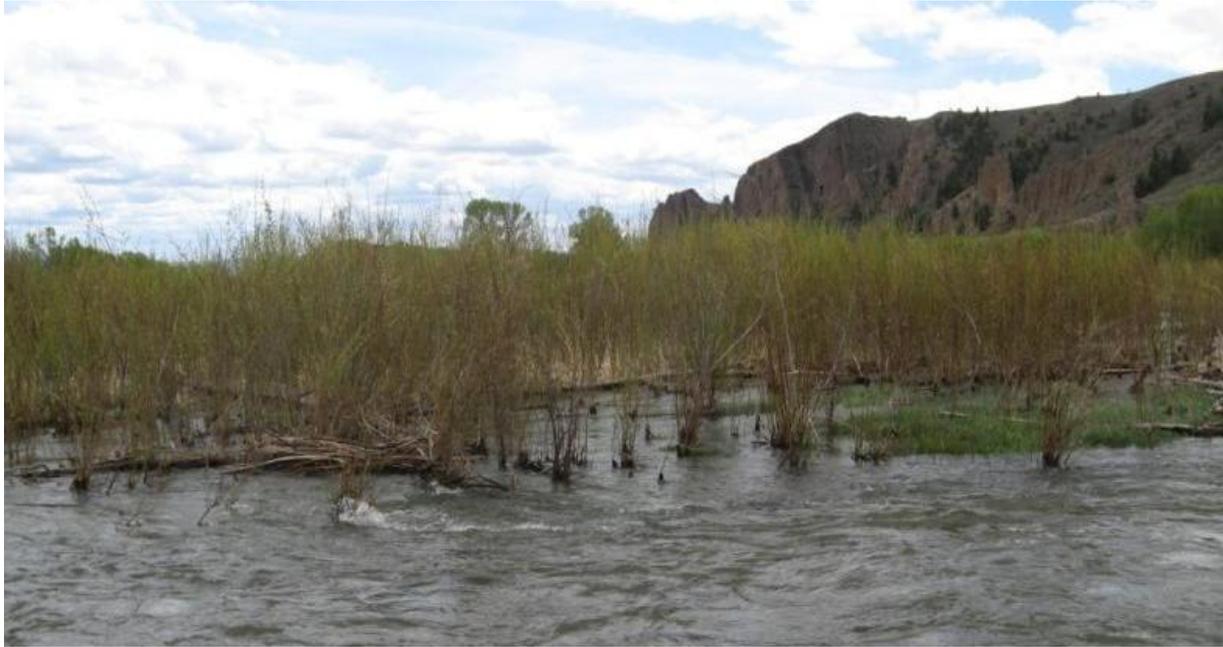
**Photograph 17.** Photograph taken during peak runoff, 2010, of overbank flow of the Gunnison River (Gunnison County, CO) upstream of the confluence with Ohio Creek near Van Tuyl Ranch.

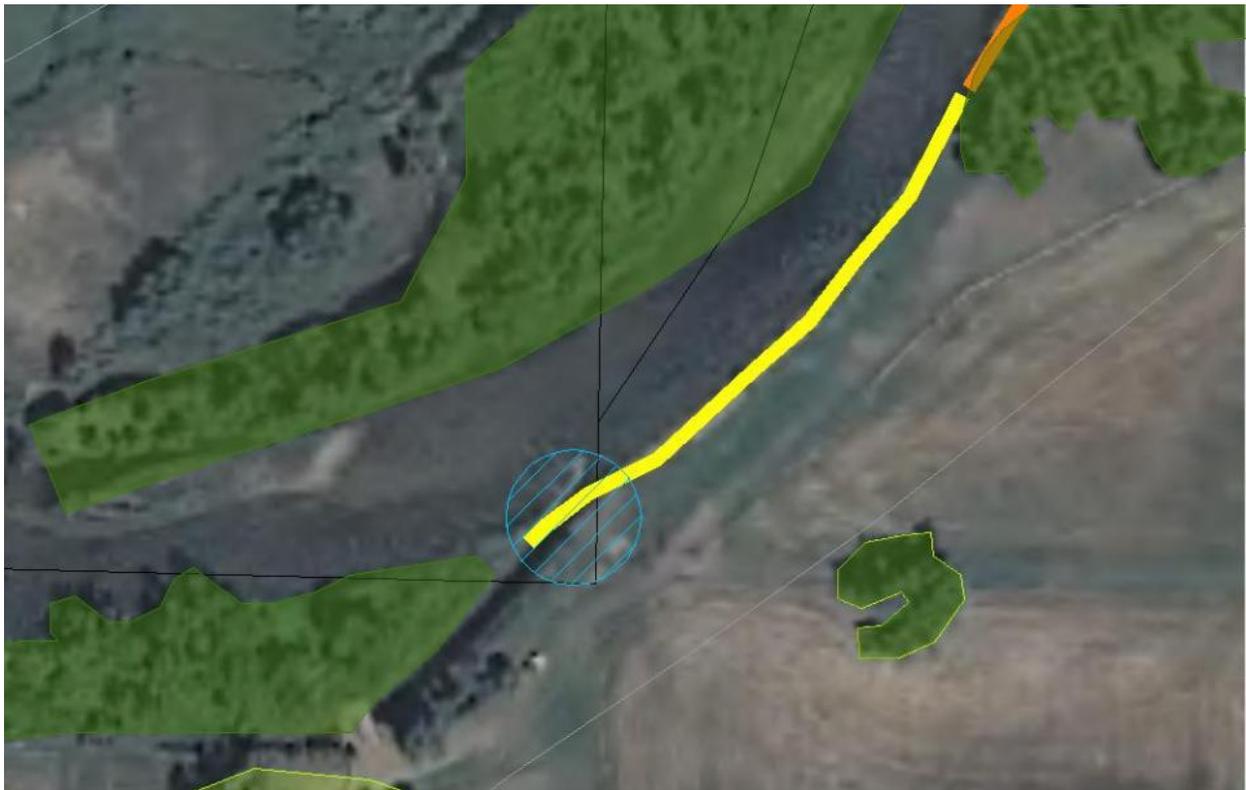
- Diversion structures and their associated headgates areas are found consistently throughout the study area and have impaired riparian zones and often caused downstream impacts due to diverting and concentrating stream energy. We recommend designing and engineering diversion structures for willing landowners that minimize impact to the riparian zone and reduce maintenance costs while also ensuring water supply to the diversion users.

**Photograph 18.** Aerial photograph of diversion structure and impaired riparian zone along the Gunnison River (Gunnison County, CO).

restoration of these areas, where practical. This restoration project could increase reliable irrigation supply, reduce impact to riparian zones and decrease maintenance costs for owners of the diversion structures. Funding for these projects or other water supply projects could come from the Colorado Water Control Board's (CWCB) Water Supply Reserve Accounts Grant program, the Upper Gunnison River Water Conservancy District's grant program, or a variety of other CWCB grants or possibly the new Colorado River District Water Resources Grant Program.

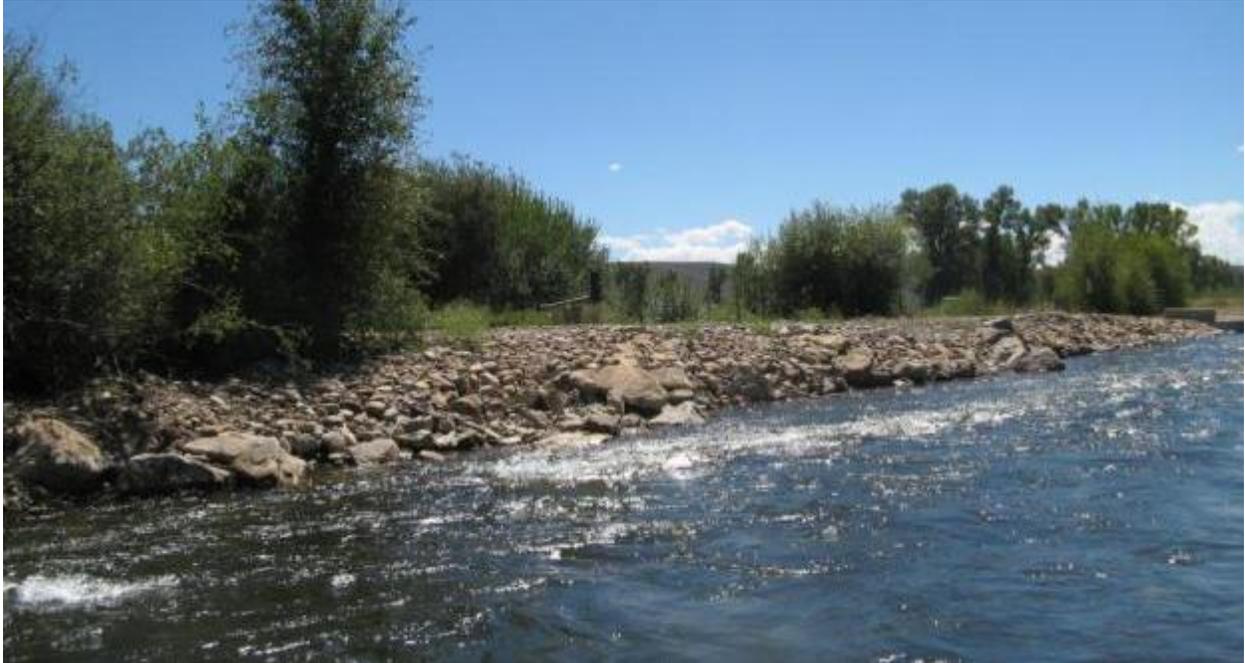
**Photograph 19.** Photograph of impaired riparian zone near the diversion structure on the Gunnison River (Gunnison County, CO) documented in Photograph 18.

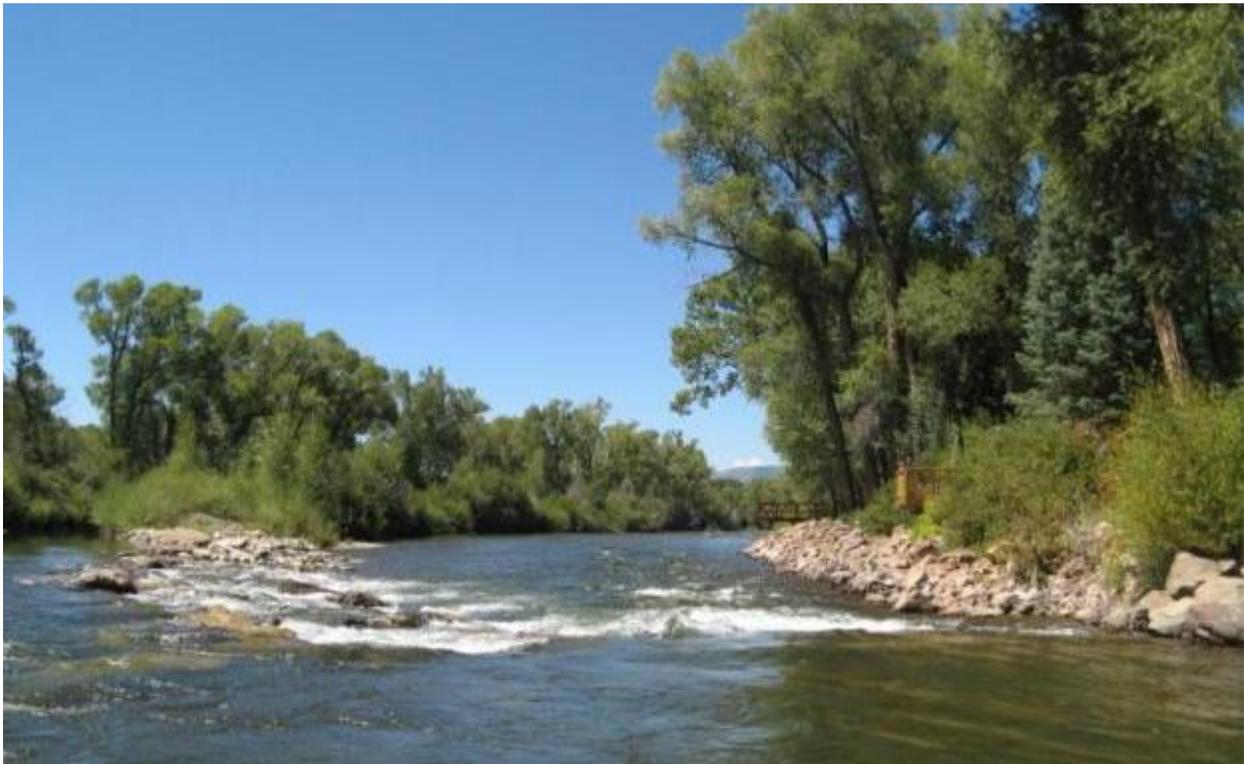
**Photograph 21.** Photograph taken in 2010, documenting armoring on the streambank of the Gunnison River to reduce erosion by displaced stream energy from the diversion on river left (left side of photo) and the removal of riparian vegetation on river right (right side of photo).

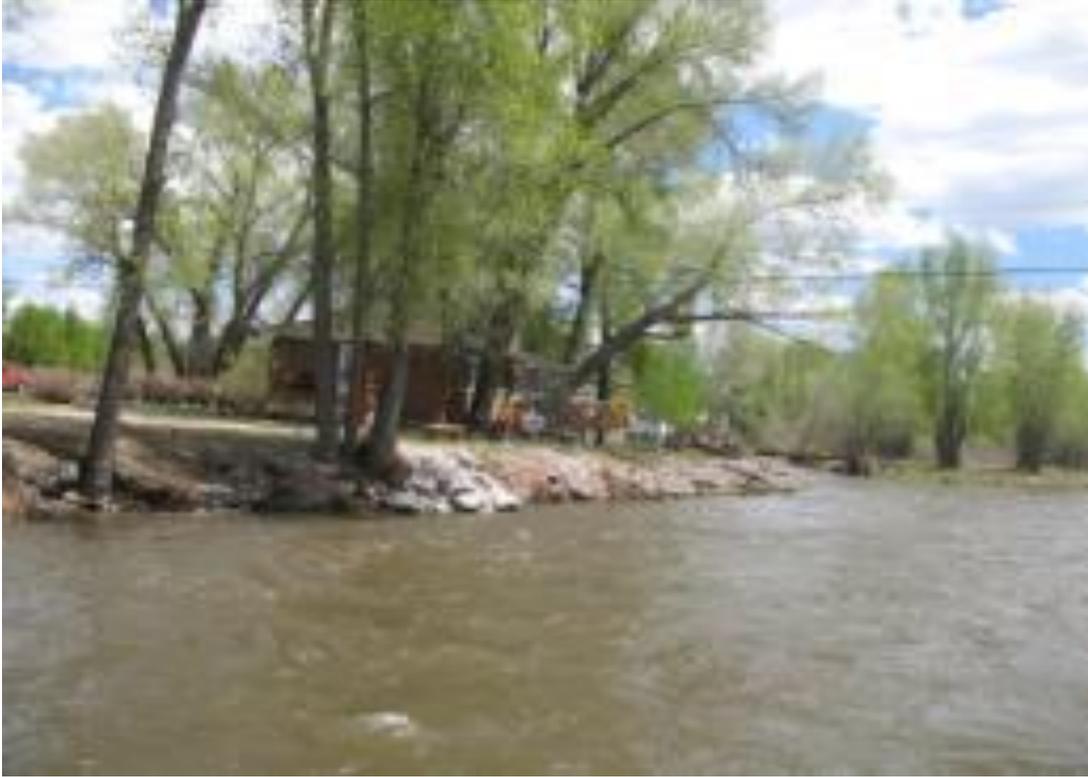
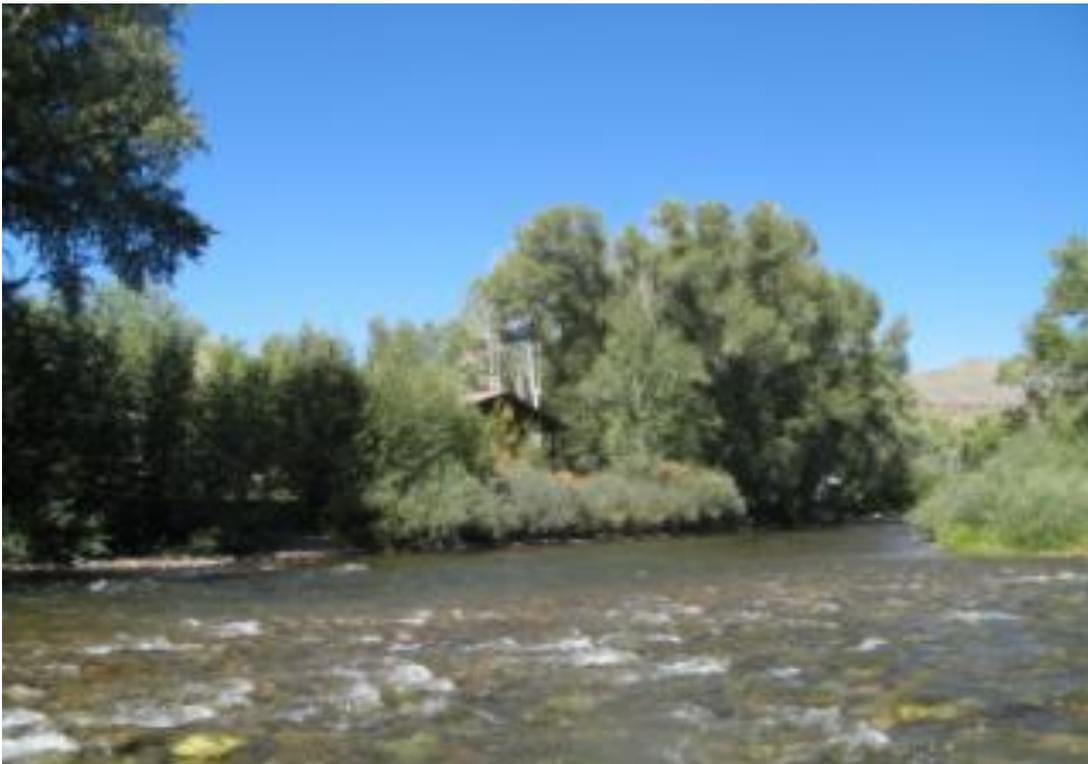
- Often housing owners remove the riparian vegetation along the Gunnison River (various Assessment Segments). This vegetation removal (Photographs 21, 22) decreases the ability of the riparian zone to absorb pollutants, reduces the riparian zones ability to absorb flood waters, reduces the ability to prevent erosion and leads to increased stream sedimentation. Additionally, there are declines in the ability of the riparian zone to maintain microclimatic conditions or support wildlife and fisheries. Often after homeowners remove riparian vegetation, the banks are armored with rocks or concrete to prevent the resulting erosion and loss of stream bank. This activity often displaces stream energy downstream and may be causing erosion on nearby downstream properties. This displaced stream energy eroding downstream banks often results in additional streambank armoring at properties downstream continuing to exacerbate the impacts to the Gunnison River riparian zone.

**Photographs 22 and 23.** Photographs of housing on the Gunnison River with riparian vegetation removed (Photograph 22) and riparian vegetation relatively intact (Photograph 23).

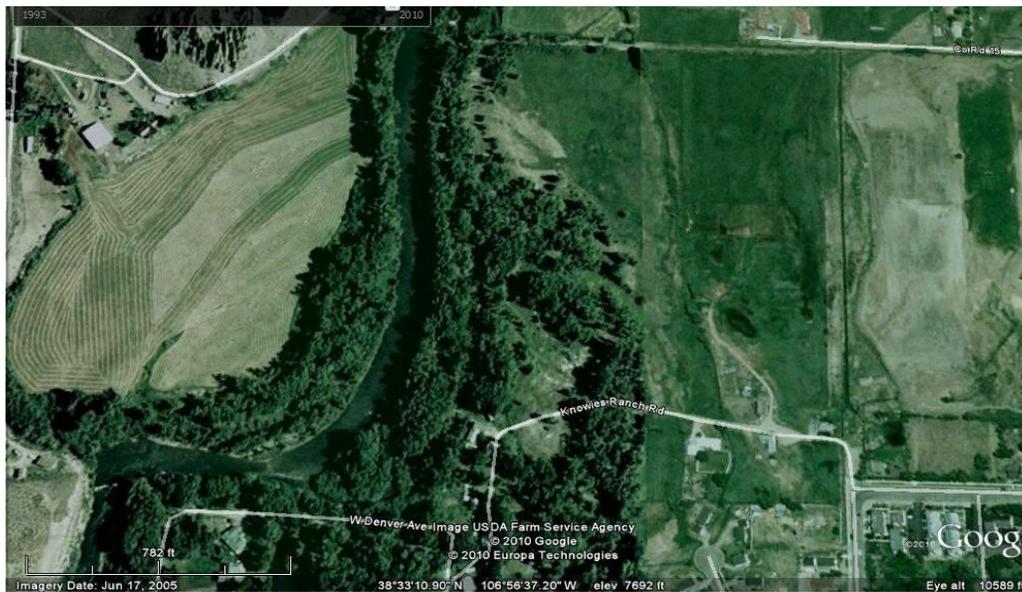
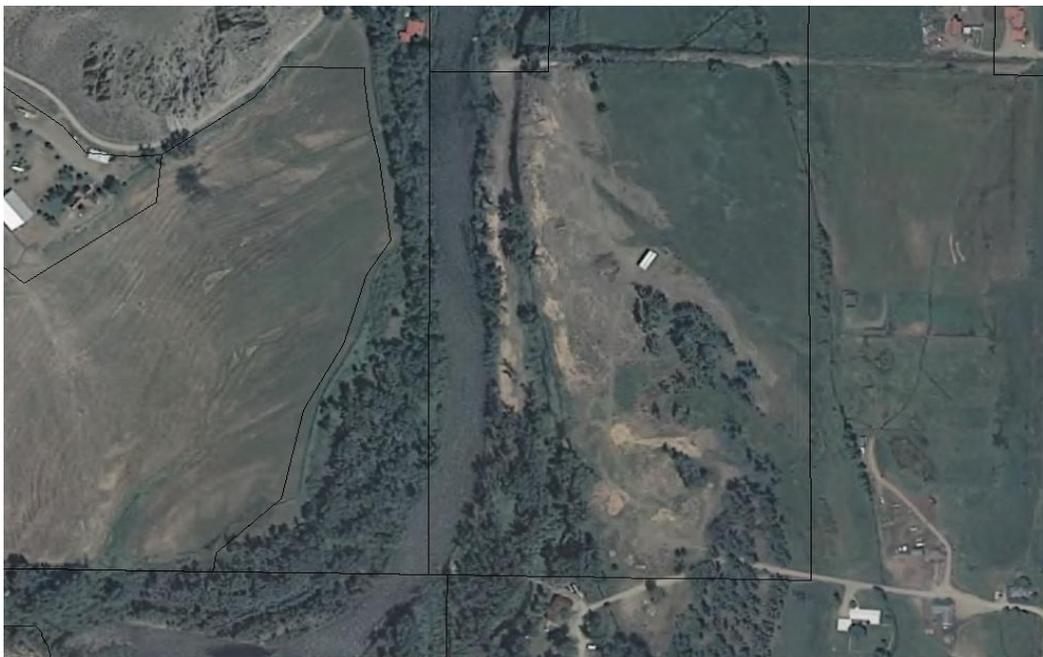
**Photographs 24 and 25.** Aerial photographs of riparian cottonwood gallery forest from 2005 (Photograph 24, upper) and 2009 (Photograph 25, lower).

- The narrowleaf cottonwood gallery forest removal immediately downstream from Van Tuyl ranch (Assessment Segment 7) may need restoration or mitigation on Van Tuyl Ranch. During 2009 and 2010, a large tract of riparian forest was removed downstream from Van Tuyl Ranch. Additionally, planning for riparian protection within the City of Gunnison should be considered. Urban riparian forests such as these protect water quality and may help reduce the impacts from floods (Photographs 24 and 25).
