**UPPER GUNNISON RIVER
WATER CONSERVANCY DISTRICT**

**UPPER GUNNISON RIVER BASIN
WATERSHED ASSESSMENT AND MANAGEMENT PLANNING – PHASE I**

**Ohio Creek, East River, and the
Lake Fork of the Gunnison River Basins**

Final Report

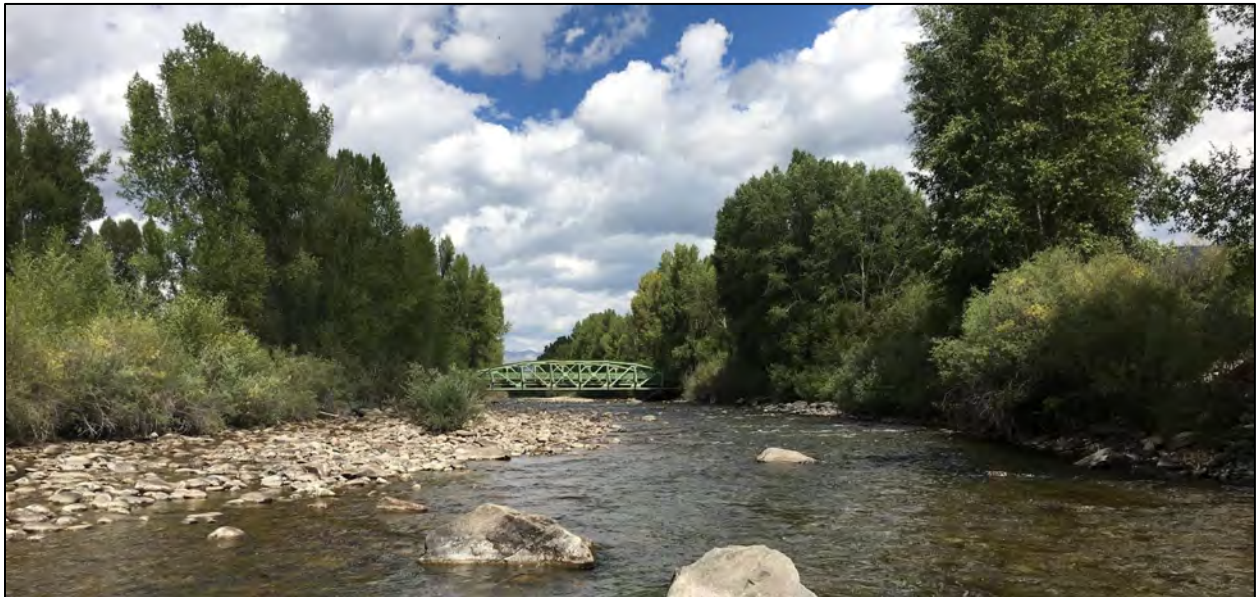
Photo 19-1. The East River downstream of Roaring Judy Road Bridge on August 27, 2018. The flow measured during the assessment was 65 cfs. The average daily flow for the East River at Almont is 158 cfs. The 2018 flow was just 41 percent of average.
