Chapter 7

The Lake Fork Basin

Section 1. Basin Characteristics

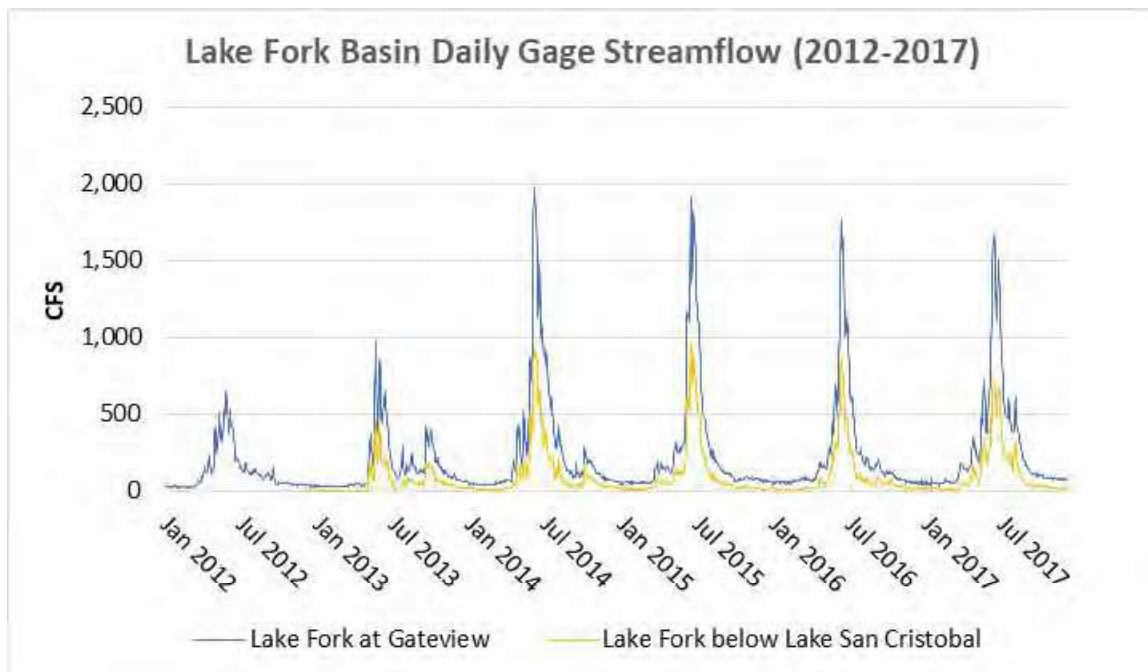
The streamflow in the Lake Fork Basin is highly variable depending on snowpack. Figure 2-2 shows daily flow for the period 2013 through 2017 for the two active gauges on the Lake Fork. The following observations can be made based on the figure:

- The runoff pattern and peak flow months are similar for these two locations.
- This period includes wet years of 2014 and 2015 and one of the driest years of record, 2012.
- The difference in annual stream flow between 2012 and 2014 is more than 114,000 acre-feet at the Lake Fork at Gateview gage.

Figure 2-2: Lake Fork Basin Streamflow (2005-2017)

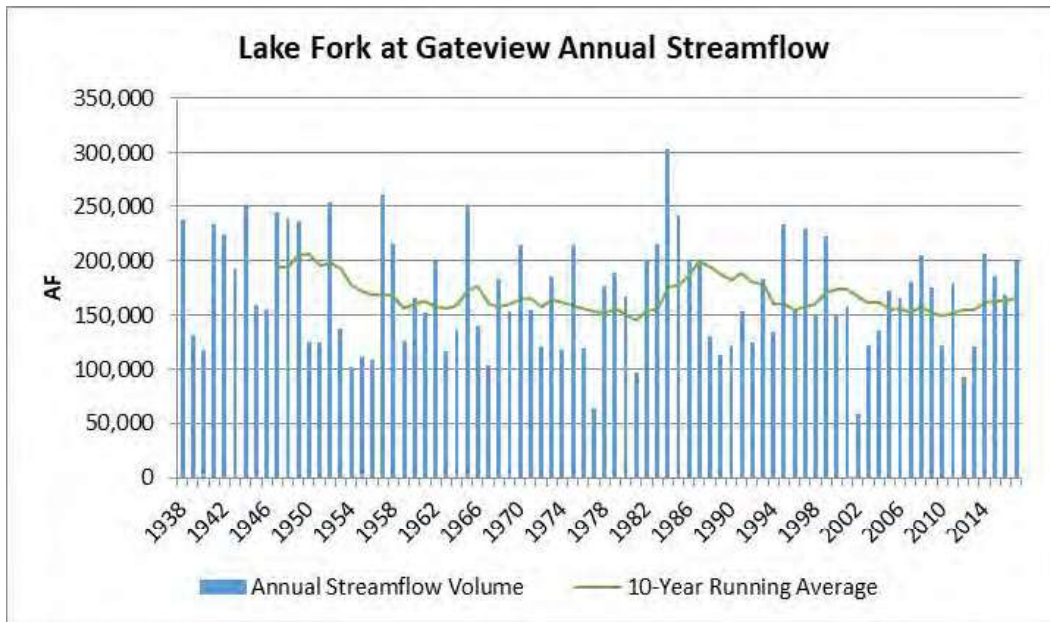
Figure 2-3 shows the historical annual streamflow volume for the period 1938 through 2017, along with the 10-year running average for the Lake Fork at Gateview gage. As shown, streamflow varies widely from year to year. Although the 10-year running average is highly variable, it does not indicate a long-term trend in terms of total flow volumes. The peak runoff is variable depending on snowpack. In average years, the peak generally occurs in early June and shifts to mid or even late June in extremely high runoff years. In about 25 percent of the gaged record corresponding to the driest 25 years, the peak runoff occurred in May. Several of the years with earlier runoff correspond to low flow years seen since 2000. The 1960s decade also showed a significant number of years with earlier runoff, and there does not appear to be a permanent shift in the peak.

Figure 2-3: Lake Fork at Gateview Annual Streamflow (1938-2017) in acre-feet

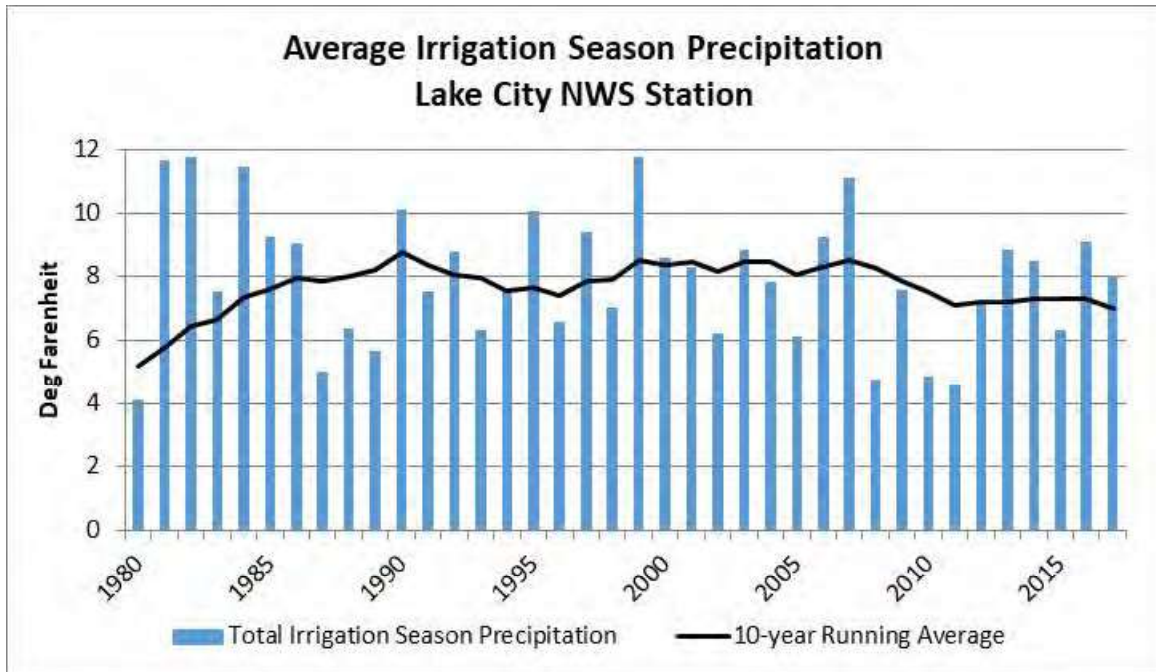
Precipitation during the irrigation season reduces the amount of water required from irrigation to meet crop demands. Figure 2-6 highlights the variability of total precipitation during irrigation season (May through September) also recorded at the long-term NWS Coop station. As shown, the total precipitation during irrigation season varies from 11.8 inches in 1982 to only 4.1 inches in 1980. Even though precipitation has been relatively high from 2012 through 2017, the 10-year average has yet to recover from the drier summers between 2008 and 2011. Note that although higher irrigation season precipitation reduces the amount of water crops need from an irrigation source, water available from runoff is the primary factor in river diversion variability.

Figure 2-6: Total Irrigation Season Precipitation at Lake City (1980-2017)

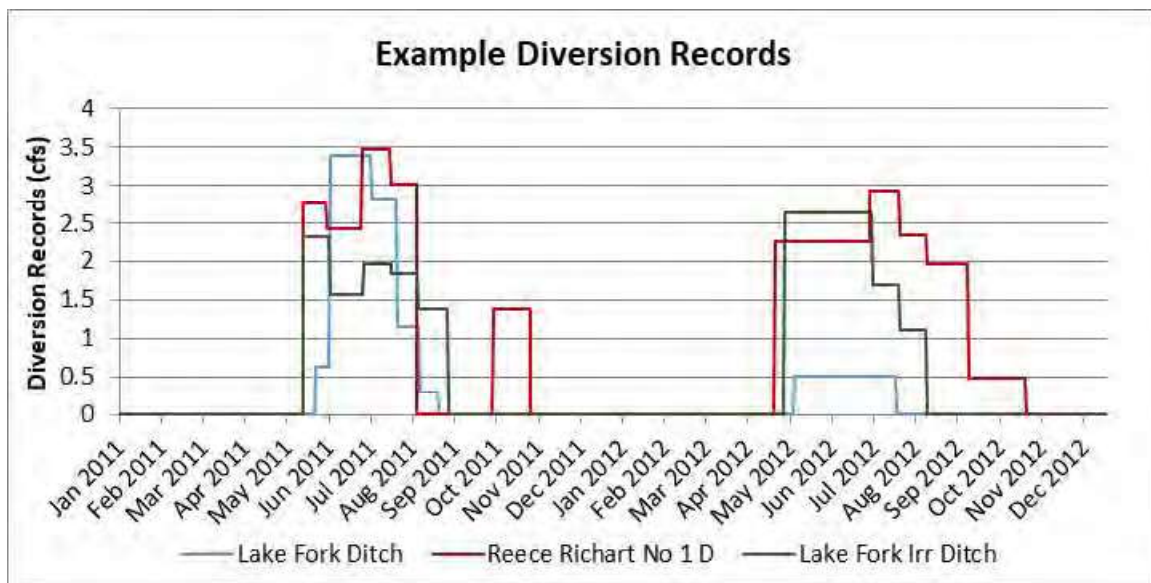
Based on the review of diversion records and discussions with the water commissioner, it is common for him to visit each headgate only once per month during the irrigation season. Note, that although this is typical of most water districts in western Colorado, diversion records do not mimic changes in daily stream or ditch flow. In addition, daily variation in flows, most notably during runoff or following large precipitation events, can cause diversion rates to change throughout the day, which cannot be captured even if the water commissioner visited each diversion once per day. Figure 2-10 provides example diversions in the Lake Fork Basin for 2011 and 2012 where the standard fill-forward approach was used by DWR. In many cases, the irrigation start and stop dates are estimated by the water commissioner rather than reported by the water users. The diversion records do not include information about operational practices; for example, reducing diversions to allow fields to dry before haying.

Figure 2-10: Example of the Fill-Forward Approach for Reporting Diversions

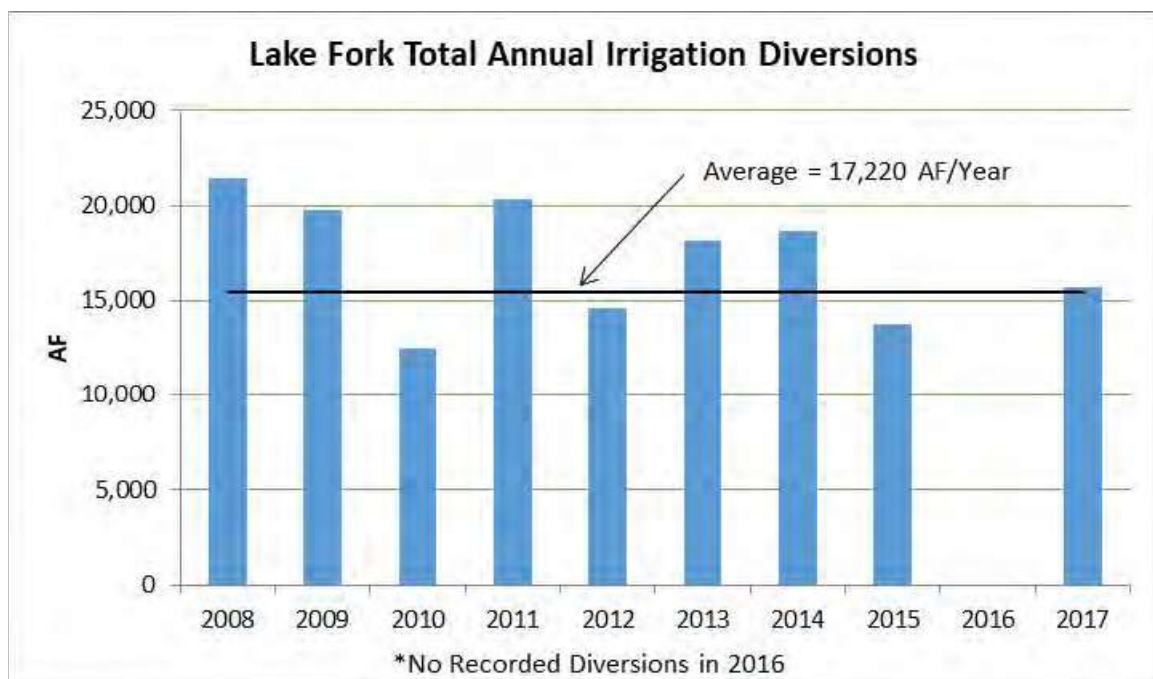
The diversion records maintained by DWR are still the best source of data available. There are 47 active irrigation ditches in the Lake Fork Basin. For the recent period from 2008 to 2017 (excluding 2016), diversions averaged 17,220 acre-feet per year. Note that Water District 62 had an open water commissioner position in 2016, and no diversions were reported for the year. Similar to streamflow, annual diversions are variable, as shown in Figure 2-11. On average, irrigation diversions in the Lake Fork Basin are around 10 percent of streamflow measured at the Lake Fork at Gateview gage.

Figure 2-11: Annual Lake Fork Basin Diversions

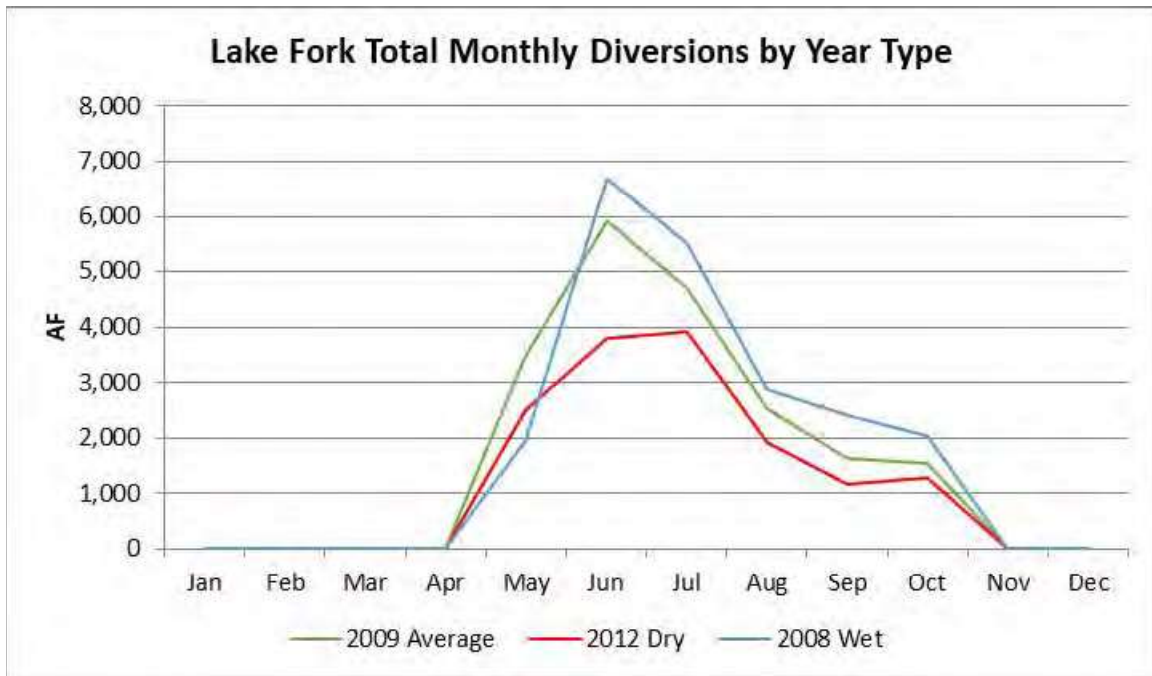
Figure 2-12 shows total monthly irrigation diversions for a representative average (2009), wet (2008), and dry (2012) hydrologic year in the Lake Fork Basin. As shown, the annual amount diverted is similar for the representative wet and average years. In the 2012 representative dry year, reduced runoff resulted in lower diversions throughout the irrigation season. Water supply dropped off significantly in July 2012.

Figure 2-12: Monthly Lake Fork Basin Irrigation Diversions for Representative Years

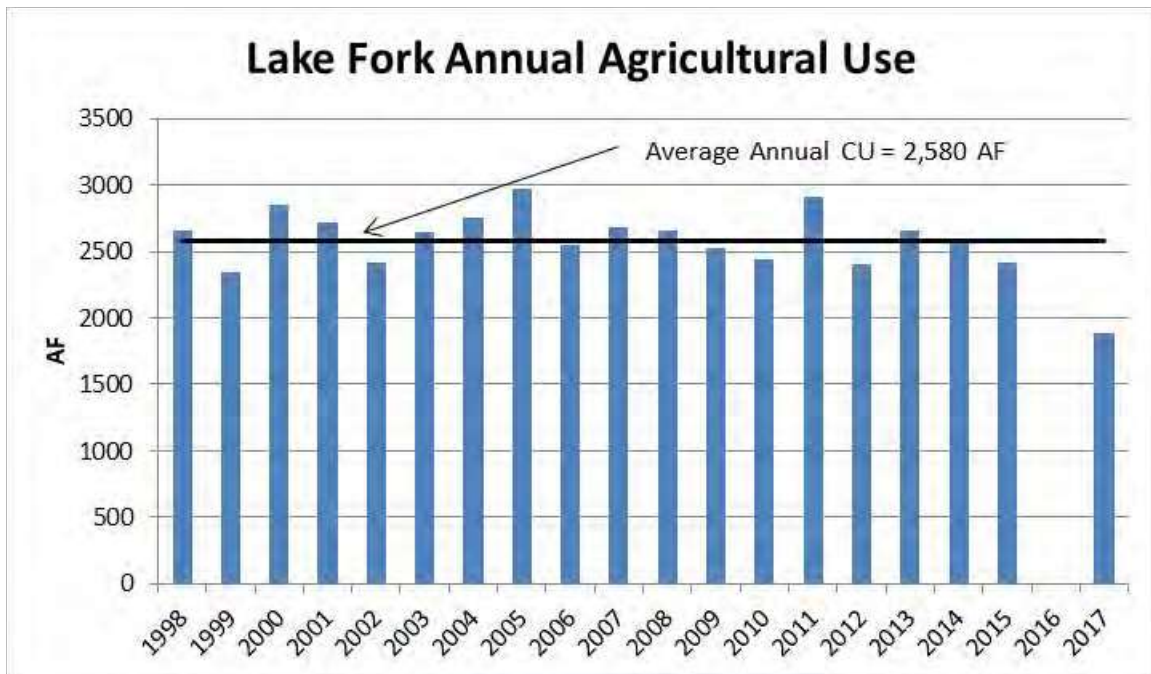
Figure 4-15 shows the annual variability of agricultural water use for the period 1998 through 2017. The results are for the Lake Fork Basin; but each ditch was represented individually in the consumptive use analysis. Average annual consumptive use from irrigation for 1998 through 2017 was 2,580 acre-feet, varying from a low of 1,890 in the extremely wet summer of 2017 to over 2,900 acre-feet in the hot, high-runoff year of 2011. No diversions were recorded in 2016 and there were also no diversions recorded until May of 2017, which may account for the lower than average consumptive use that year.

Figure 4-15: Annual Lake Fork Basin Agricultural Use, 1998 through 2017 (acre-feet)

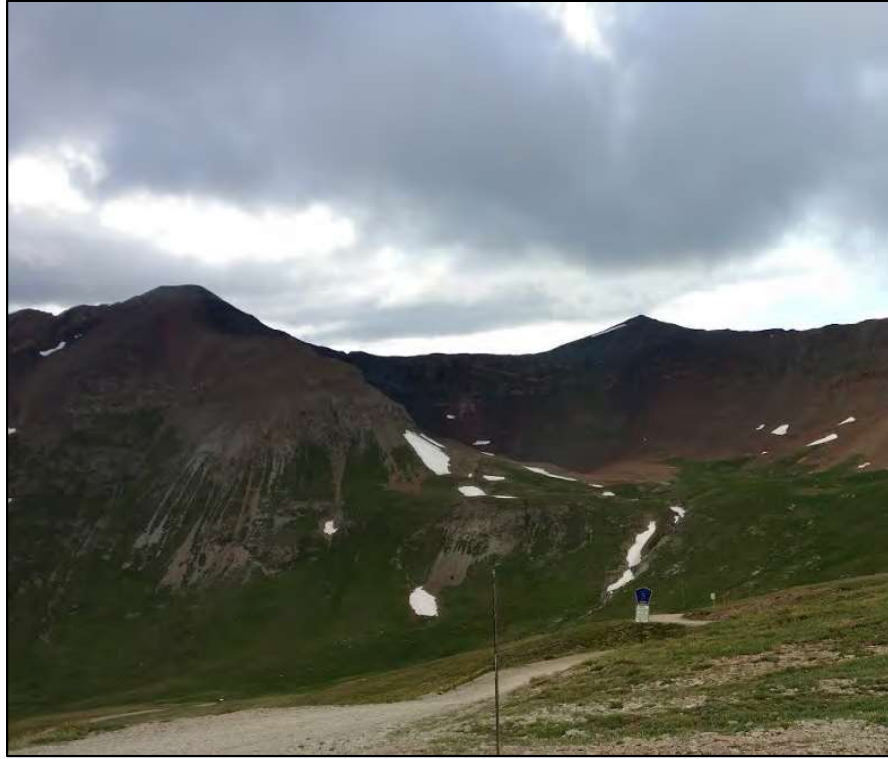
Due to the steep slopes and the materials found on the slopes, hillslopes in the headwaters are naturally susceptible to mass erosion which includes landslides, earth flows, debris avalanches, debris flows, torrents, and snow avalanches. These sporadic events provide massive natural sediment sources as shown in Photo 5-1. Evidence of recent mass erosion is very common throughout the headwaters area. Natural mass erosion events are probable throughout the headwaters area. These natural hillslope processes are an enormous source of sediment to the Lake Fork River. Natural mass erosion dominates sediment supply in the headwaters. These events form the background that human impacts must be evaluated against.

*Photo 5-1: View from the Summit of Cinnamon Pass.
Steep hillslopes covered with evidence of mass erosion.*

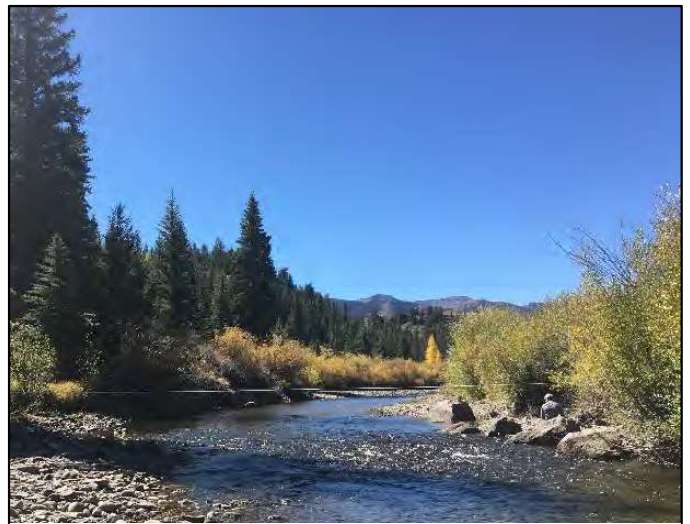
Photo 5-2. The Lake Fork River approximately 1 mile upstream of Lake San Cristobal during 2018 R2Cross and pebble count.

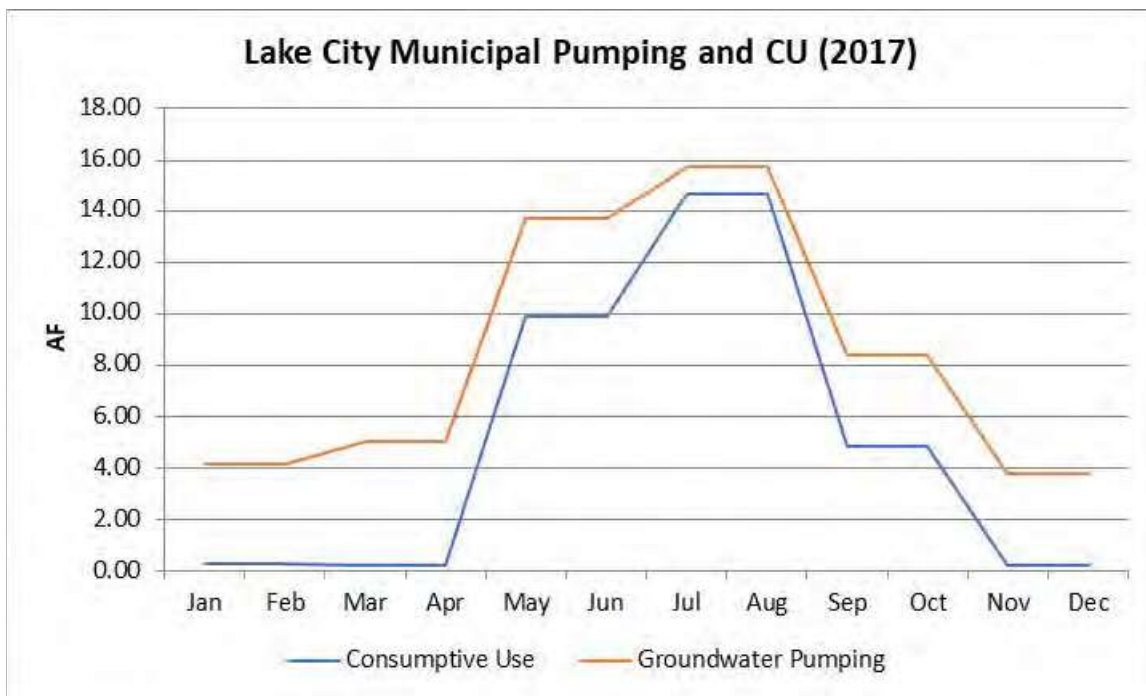
Figure 7-3: Lake City Municipal Pumping and CU (2017)

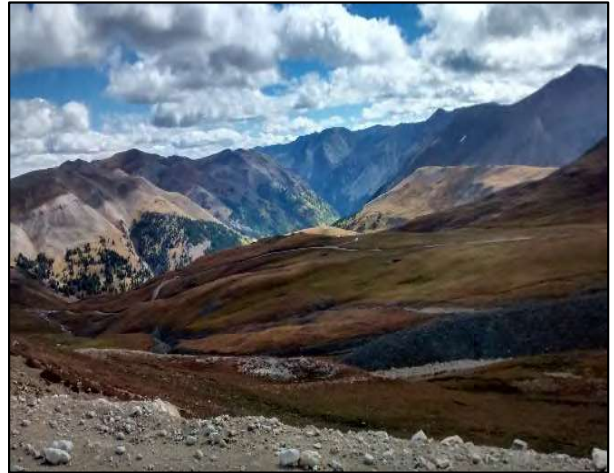
Photo 8-1. View from the summit of Engineer Pass. The drainage in the foreground is Palmetto Gulch near the Hough Mine reclamation site. The background slopes are characteristic of steep tributaries to Henson Creek.

Due to the geology and steep slopes, hillslopes in the headwaters are naturally susceptible to mass erosion which includes landslides, earth flows, debris avalanches, debris flows, torrents, and snow avalanches. Natural mass erosion events are probable throughout the headwaters area. These sporadic events provide massive natural sediment sources, as shown in Photo 8-1. Evidence of recent mass erosion is very common throughout the headwaters area. These natural hillslope processes are an enormous source of sediment to the Lake Fork River. Natural mass erosion dominates sediment supply in the headwaters.

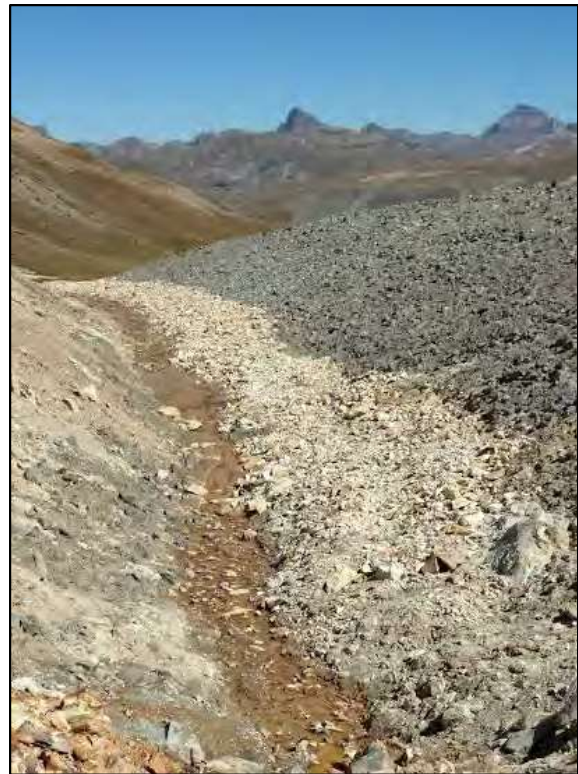
The Hough Mine, located just below the summit of Engineer Pass at nearly 13,000 feet, was the largest mine in Palmetto Gulch. Prior to reclamation the site had an open draining adit, a partially collapsed shaft, and two large waste dumps with a footprint of approximately seven acres. Major reclamation activities included consolidating contaminated mine wastes into a repository, lining and capping the repository to prevent surface water infiltration, constructing three run-on channels to divert water around the repository, and revegetation of disturbed areas. A grate is installed over the adit and drainage flows into a constructed channel. Reclamation at the Hough Mine took two field seasons and was completed in late fall of 2014. Revegetation was completed in early summer 2015.

Photo 8-3: Drainage from the Hough Mine en route to North Palmetto Gulch in September 2016, one year following reclamation. The right side of the photo includes edge of the mine waste repository.

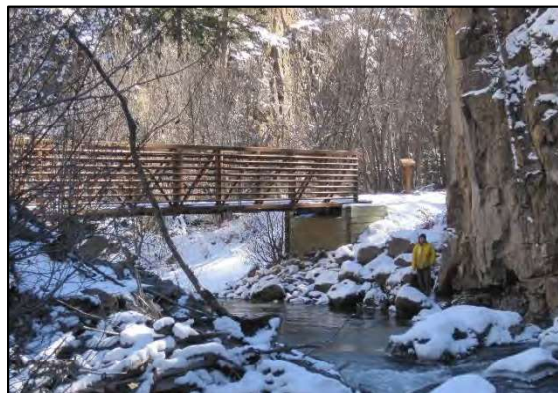
Photo 8-4: BLM employees remove the temperature sensor from Henson Creek near Alpine Gulch in October 2017.

BLM staff installed two continuous temperature sensors in the Henson Creek Basin in recent years. One sensor was installed in the North Fork of Henson Creek at the County Road 20 bridge, upstream of the confluence with Henson Creek. The other sensor was installed in Henson Creek near Alpine Gulch, shown in Photo 8-4. Water temperatures at both locations attained the aquatic life standards during all three summers that the sensors were deployed, shown in Table 8-2.

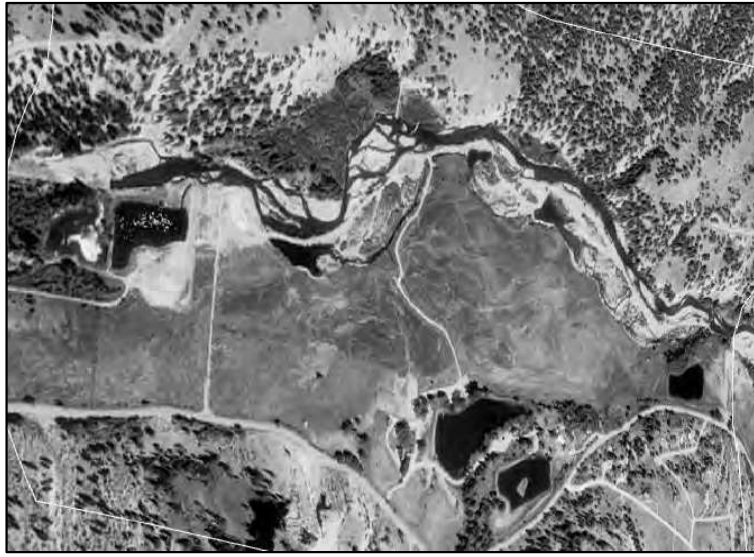
Photo 9-1: Lake Fork River in September 1998 (image by USGS via Google Earth). In the center of the image multi-thread channels navigate large, wide sediment deposits. A low-water ford allowed vehicles to cross the river. Prior stream stability and channels configurations are unknown.

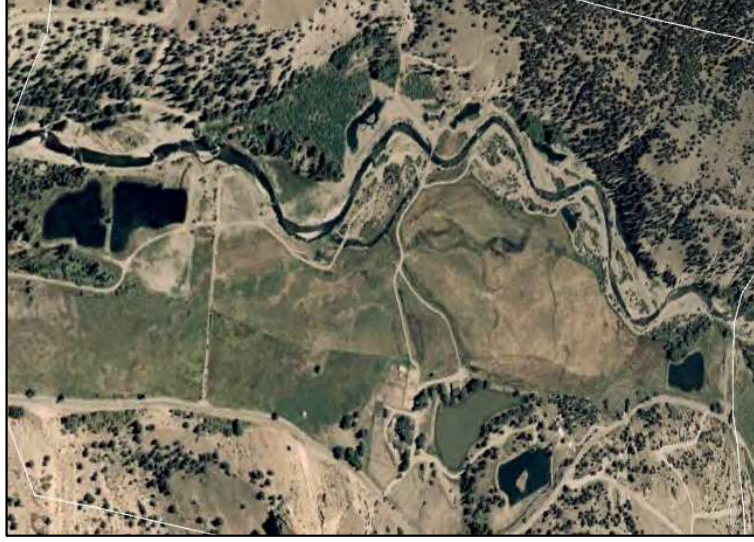
Photo 9-2: Lake Fork River in October 2005 (image by USDA Farm Service Agency via Google Earth). A large channel stabilization project was completed some time between 1998 to 2005. The project increased the channel sinuosity, narrowed the channel width, and installed many cross vanes and J-hooks throughout the reach. The project objectives were to improve fisheries. A bridge was installed across the river and a picnic pavilion was later built immediately downriver from the bridge.

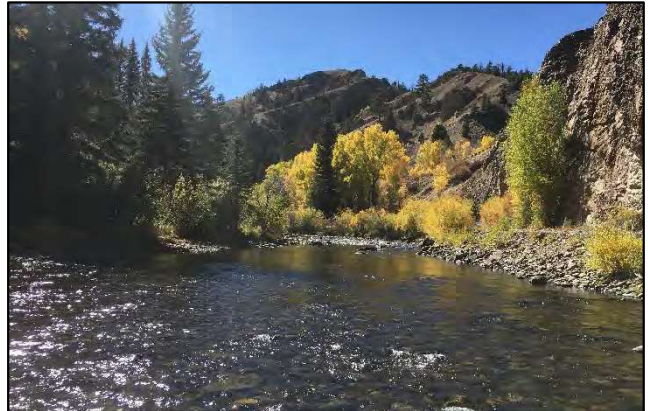
Photo 9-4: Lake Fork River near the confluence with Devil's Creek. This area is a popular fishing area.

BLM staff installed two continuous temperature sensors in the Lake Fork River in recent years. One sensor was installed in the Lake Fork River at Devil's Creek (Photo 9-4) and the other was installed in the Lake Fork River at Gateview Campground. Water temperatures at both locations attained the aquatic life standards during each of the summers that the sensors were deployed, shown in Table 9-3 and Figure 9-5.
