# **Assessment of Riparian and Aquatic Habitat Associated with the upper Gunnison River, Gunnison County, Colorado.**

December, 2010

# Upper Gunnison River Riparian Assessment, 2010

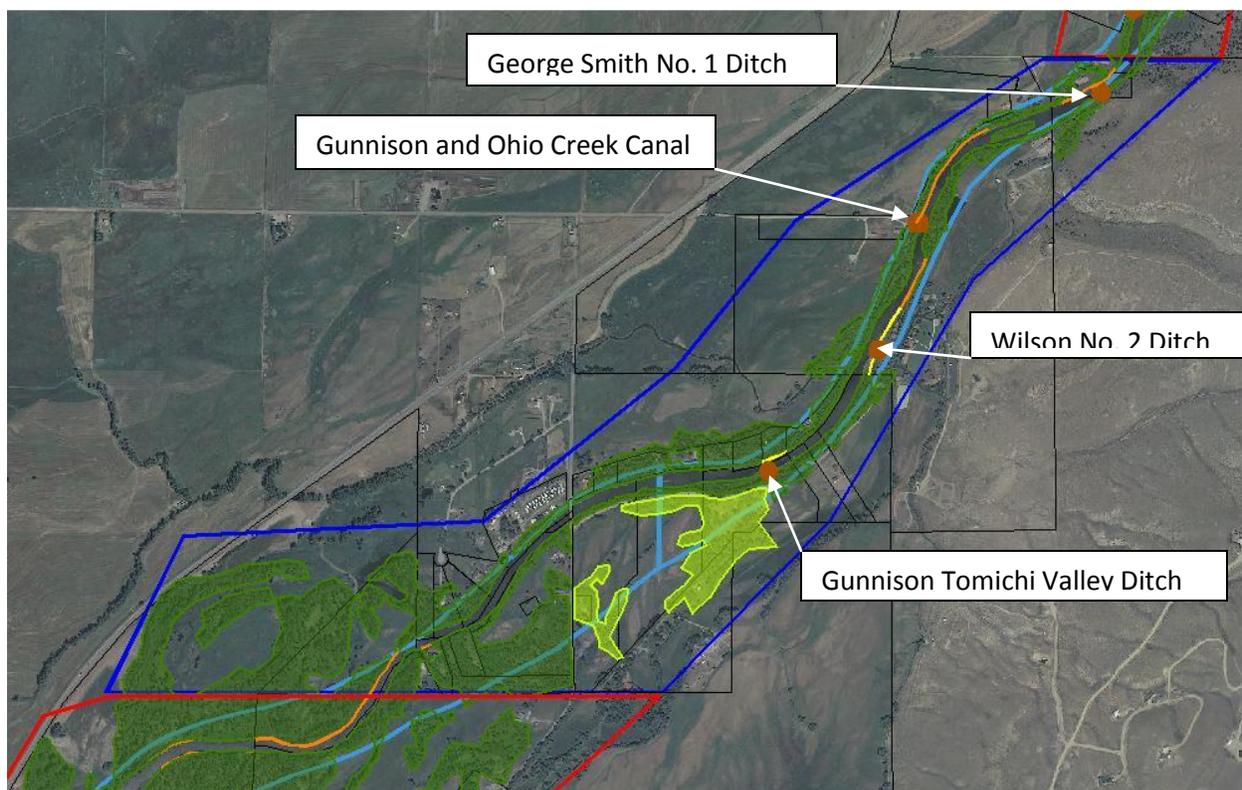
**Photograph 4.** Aerial overview of Segment 4 (2009 NAPP imagery of Gunnison County).

*Assessment Segment 4 (8630 LF, 1.63 mi.):* North of County Road 10 to the Gunnison River Banks boundary-South of County Road 10 approximately 0.5 miles (Scores: 186/200.) Proper Functioning Condition with six areas identified as Non-functioning or Functioning at Risk.

This segment includes approximately 8630 linear feet of ranchlands, communities, resorts and housing along the streambanks. The segment includes four irrigation diversion structures located in the northern 2/3 of the segment along with the County 10 Bridge in the southern 1/3 of the segment (Photograph 4).

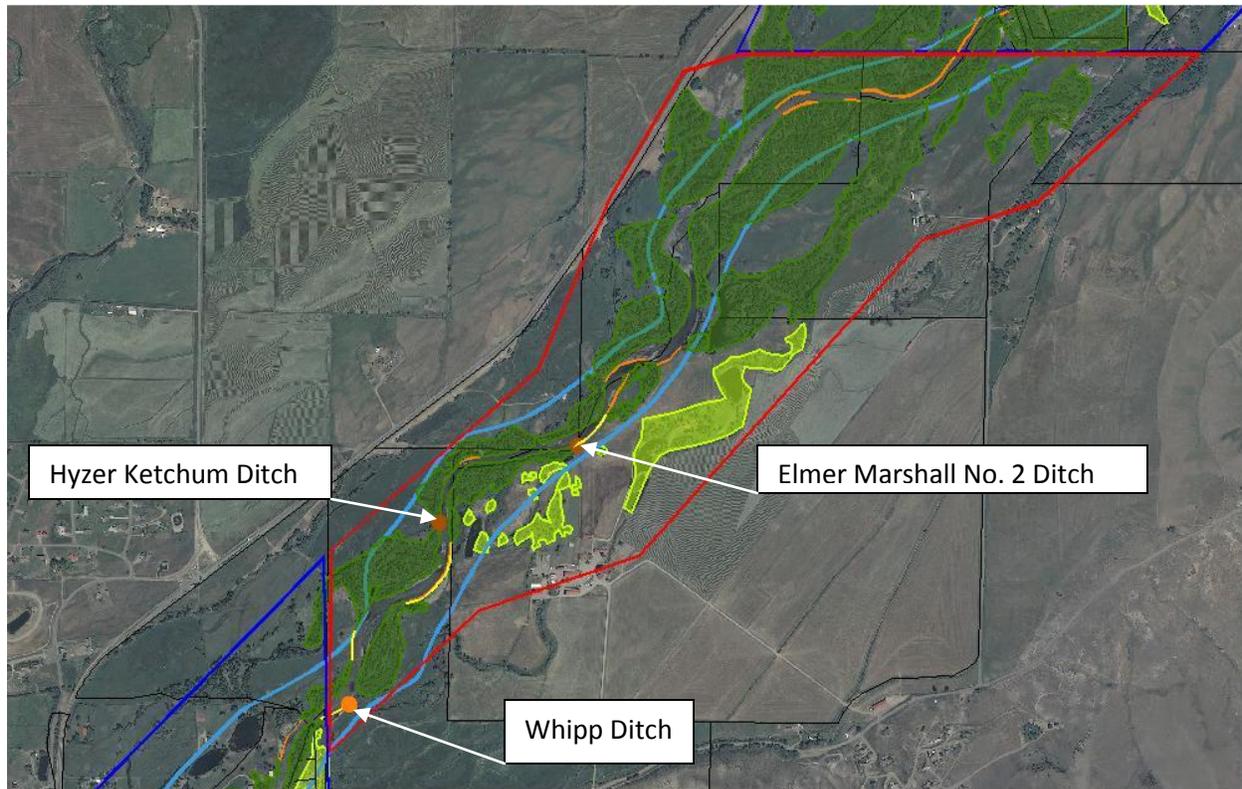
**Photograph 5.** Aerial overview of Segment 5 (2009 NAPP imagery of Gunnison County).

Soils associated with the riparian areas along both banks in Segment 5 are generally the Alluvial Land, occasionally flooded (Ao) soil type with some adjacent areas associated with the Gas Creek sandy loam, 0 to 1 percent slope (GaA). The decreased slope and expansion of the alluvial and loamy soils in this area result in the widening of the alluvial channel and associated riparian areas (Map 2b). These more extensive riparian areas contribute to the existence of large “nodes” of riparian areas that exist on these ranchlands providing high degrees of riparian values.

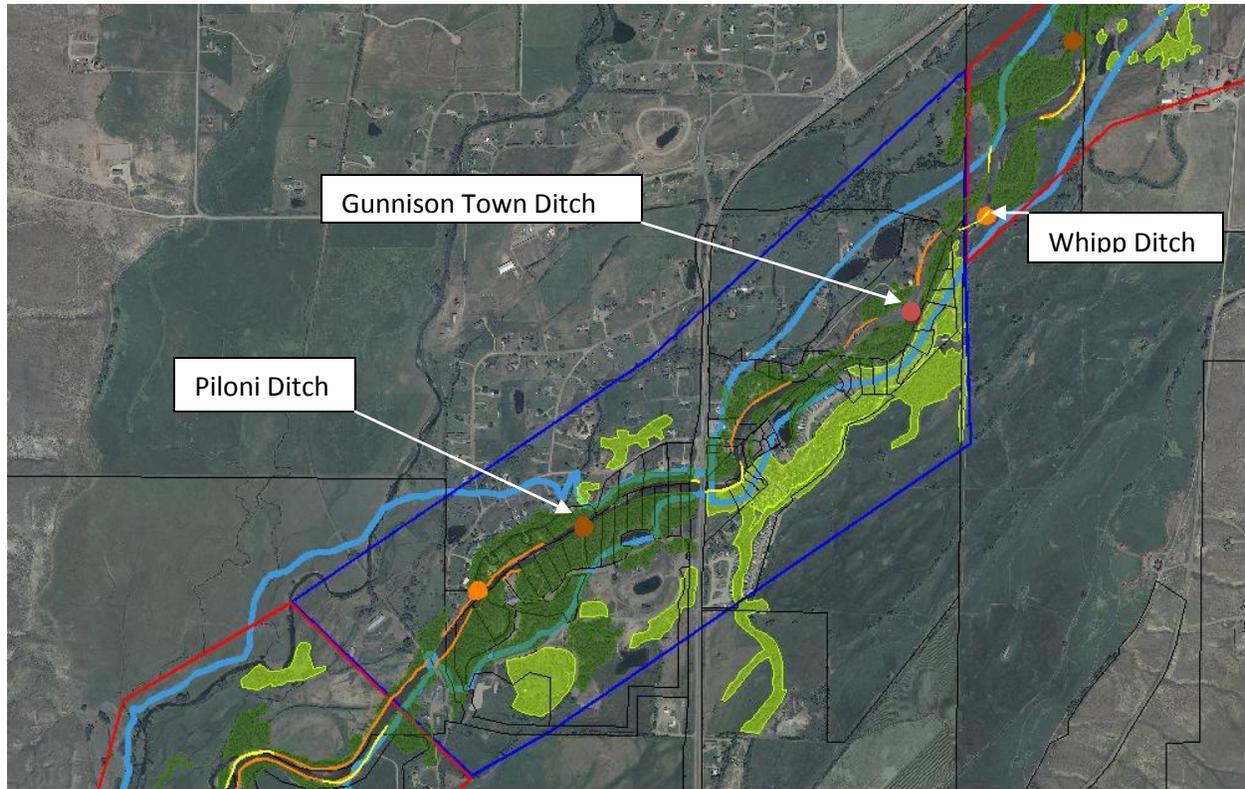
**Photograph 6.** Aerial overview of Segment 6 (2009 NAPP imagery of Gunnison County).

Riparian vegetation in Segment 6 is established on soils similar to that of Segment 5 as the alluvial channel expands on to terrain with little slope (Map 2b).

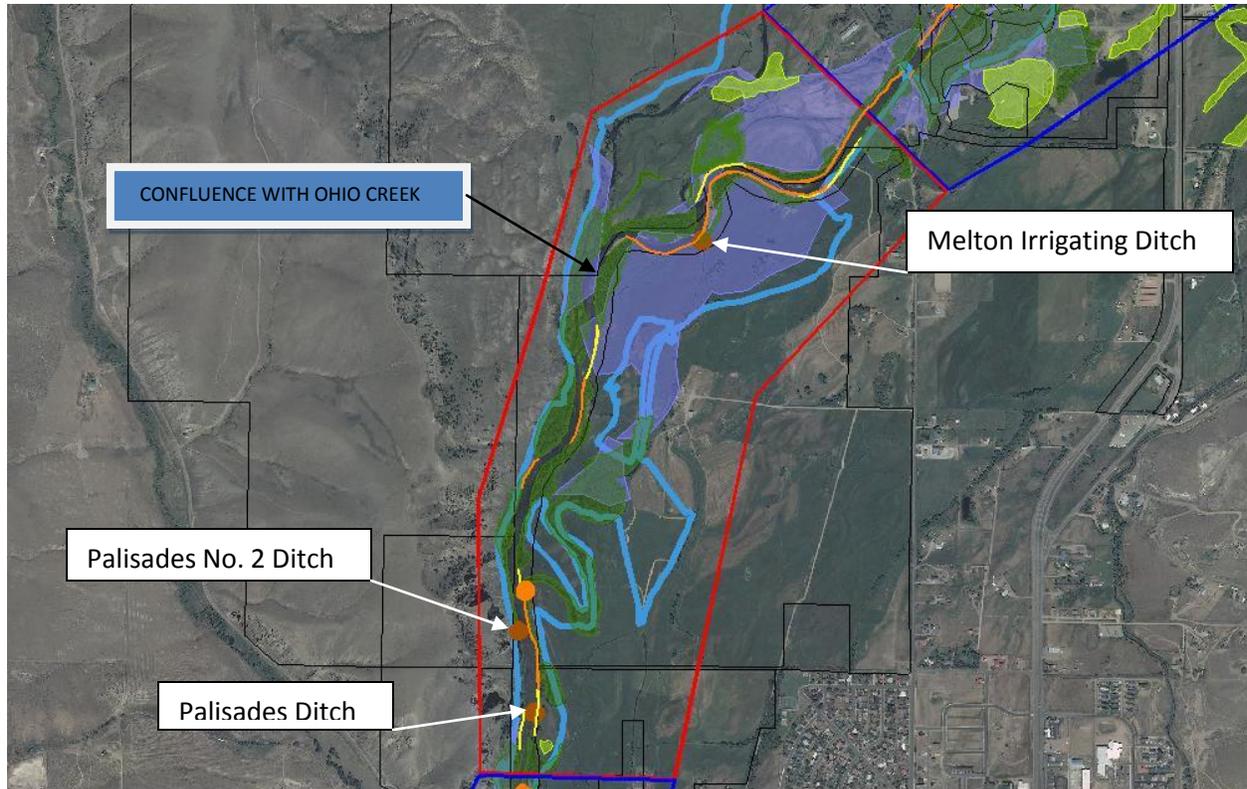
undeveloped rangeland, private property and housing along sections of the west bank. Both the Van Tuyl parcel and the rangeland on the west side of the river are generally comprised of relatively undeveloped hay meadows and include extensive flood plain coverage in the northern 2/3 of the segment. To the north, the river channel becomes more sinuous as it courses through the wide floodplain and robust wet meadows and hay pastures. As the segment extends south, the river channel turns to run due south and is confined by the Palisades rock formation along the western streambank and a narrower flood plain and agricultural practices to the east of the river channel. The segment includes three irrigation diversion structures and one irrigation return feature. The river channel, particularly in the northern section, has been impacted by extensive channelization and streambank armoring that result from efforts to mitigate large areas of overbank and overland flooding that occurs in this region during high water events. The re-configuration and armoring of the streambank in the northern section of Segment 7 appears to be causing the hydrologic energy of the river to “bounce” from armored streambank to armored streambank as the river courses south, causing an imbalance in the channel within the landscape, channelization of the stream and downcutting into the stream bed. This segment also includes the confluence with Ohio Creek along the western bank and represents the point at which Ohio Creek contributes biological, chemical and physical components to the Gunnison River system. This segment also encompasses the area where the flood plain of the Ohio Creek drainage joins the flood plain of the Gunnison River resulting in the expansion of the aforementioned floodplain in this region (Photograph 7).

**Photograph 7.** Aerial overview of Segment 7. The area in the photograph that is shaded in purple represents the riparian area that was assessed on 1950 aerial photography (GIS assessment of 1950 USDA aerial imagery, 2009 NAPP imagery of Gunnison County).

Soils that exist within this segment are the Alluvial Land, occasionally flooded (Ao) within the expanded flood plain. The poorly drained Gas Creek (GaA) and Irim loams (IrA) border much of the alluvial channel to the north and east while rocky upland soils consisting of the Duffson Spring Creek stony loams (Dse), the Stony rock land (St), and the Rock outcrop (Ro) soil types bound the channel to the west along the Palisades formation (Map 2b).

- The Van Tuyl Ranch was listed above as an area for conservation but it is also in need of restoration. Based on aerial photographs from 1950 to the present, this area has lost much of its riparian forest and thus some of the functions of a riparian area. To maximize this publicly owned land for these benefits, we recommend the restoration of the riparian community, restoration of active side channels and overland high water flow in this area to maximize the benefits of water storage, aquifer recharge, water quality protection, a productive riverine/fisheries ecology and additional flood protection for the City of Gunnison and downstream.

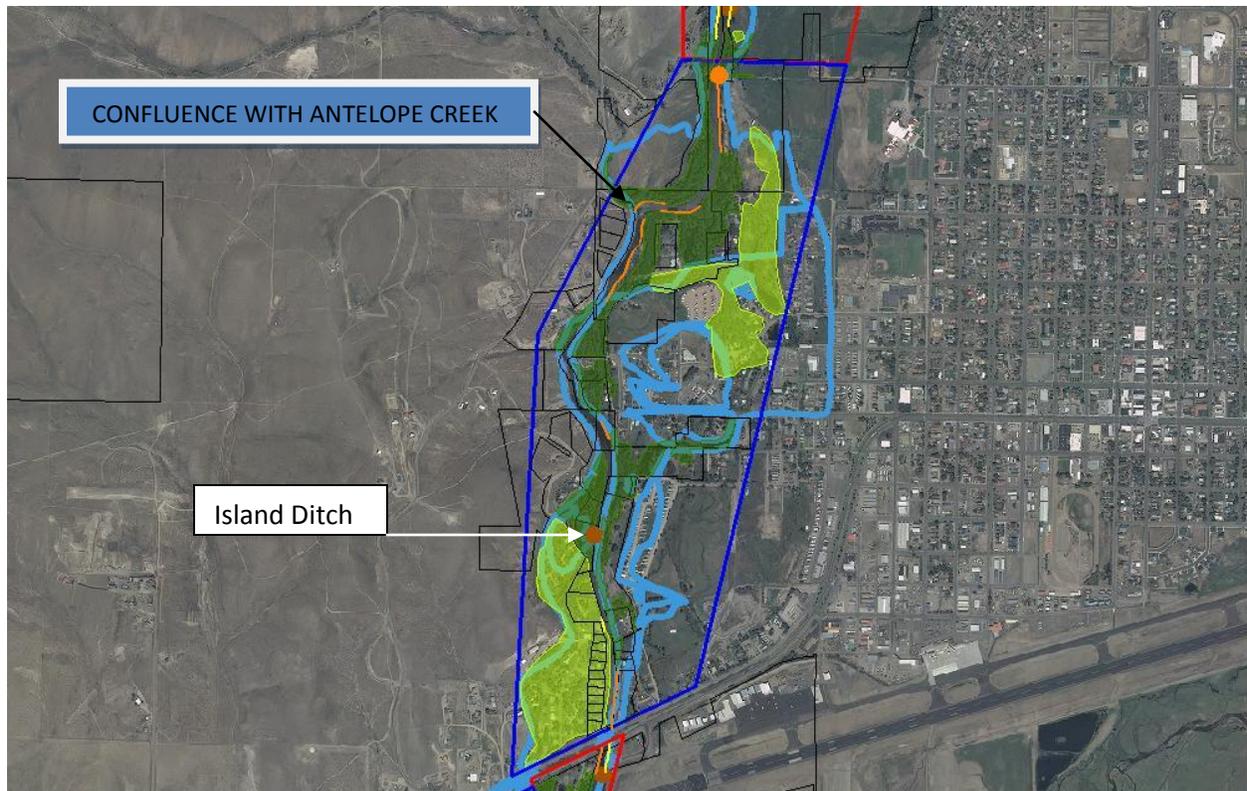
**Photograph 8.** Aerial overview of Segment 8. (2009 NAPP imagery of Gunnison County).

Soils associated with the river channel and riparian areas in Segment 8 are the Alluvial Land, occasionally flooded type common to the river bottom and flood plain in the Gunnison valley with small pockets of the Gas Creek sandy loam (GaA) and the Fola cobbly sandy loam (FoB) in locations along the east side of the river and rocky stony soils that exist along the alluvial channel on the west side of the river (Map 2c).

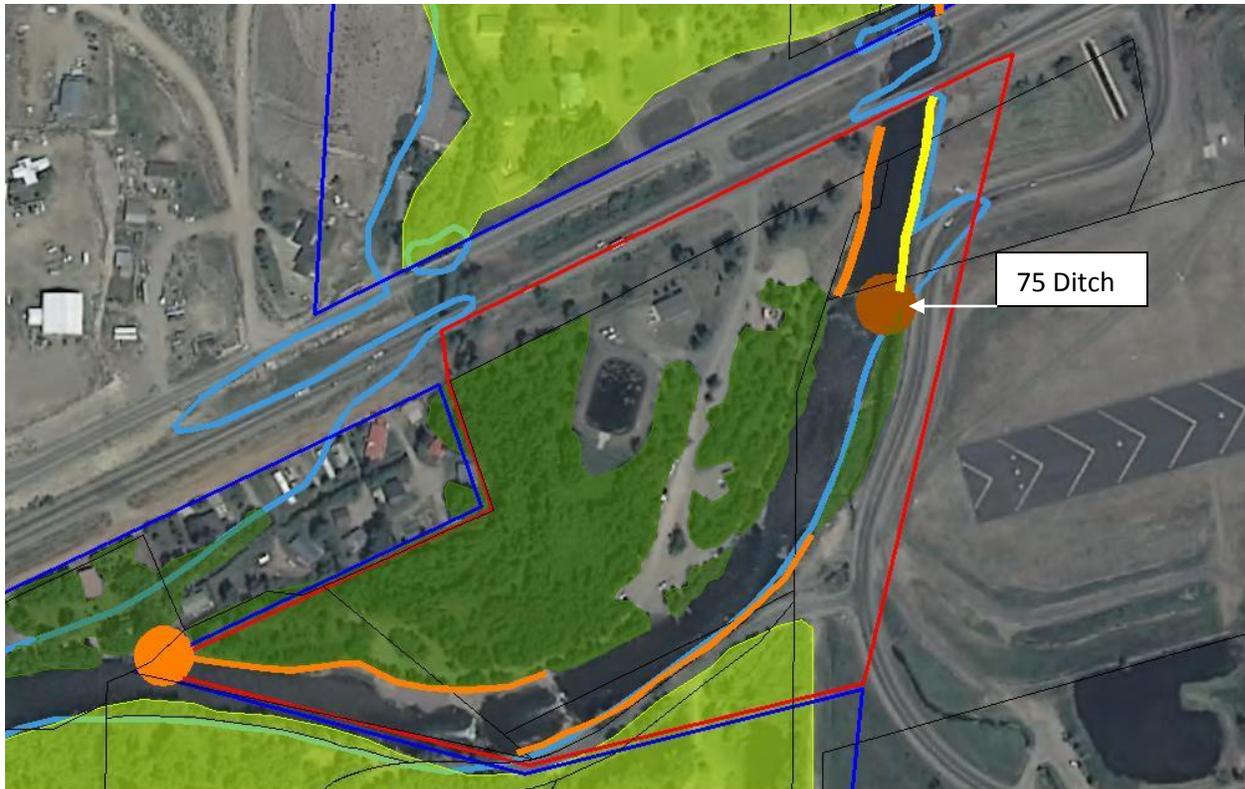
**Photograph 9.** Aerial overview of Segment 9. (2009 NAPP imagery of Gunnison County).

This segment extends approximately 2150 linear feet southwest from the HWY 50 Bridge (Twin Bridges) and is comprised entirely of the Gunnison Whitewater Park and the Dos Rios Water Treatment facility (Gunnison County). The Gunnison Airport is directly east of the area and the Dos Rios Subdivision lies to the south. The western bank that extends southwest from the HWY 50 Bridge down through most of the Gunnison Whitewater Park is prone to overbank and overland flooding during high water events in the river. Riparian vegetation consisting of large mature narrowleaf cottonwoods and associated understory that historically existed in the northern portion of this segment near the highway bridge was removed to meet FAA regulations. The river channel within Segment 9 has recently undergone major reconfiguration to produce much utilized whitewater boating features and to construct a more permanent and stable irrigation diversion feature that enhances irrigation supply and allows better boater navigation of the diversion feature. The segment includes an improved irrigation structure along the east bank to the north and a return feature along the western bank, at the very south end of the property (Photograph 9).

Soils in this segment are comprised entirely of the Alluvial Land, occasionally wet (Ao) soil type (Map 2c).

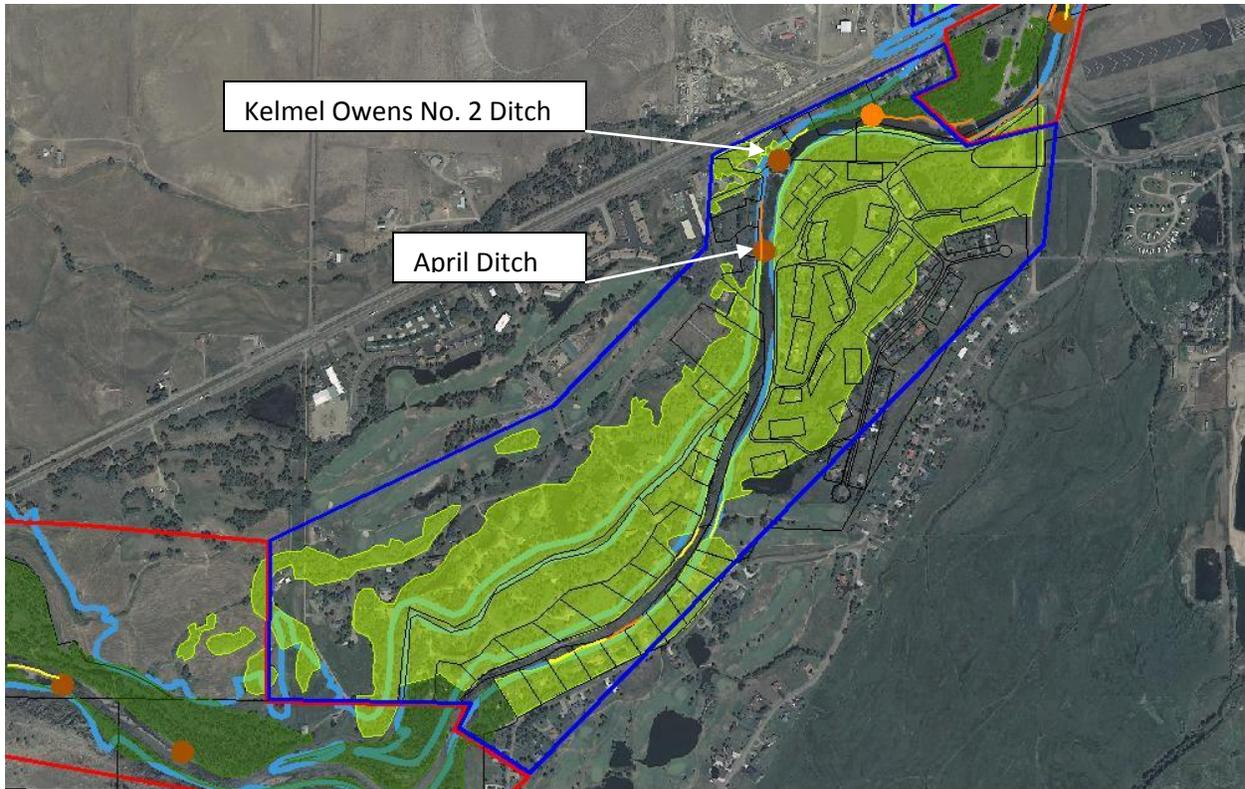
**Photograph 10.** Aerial overview of Segment 10. (2009 NAPP imagery of Gunnison County).

Soils associated with the relatively wide alluvial channel and riparian zone are primarily the Alluvial Land , occasionally flooded (Ao) with the Gas Creek sandy loam adjacent to the east and the Fola cobbly sandy loam (FoB) to the west (Map 2b).

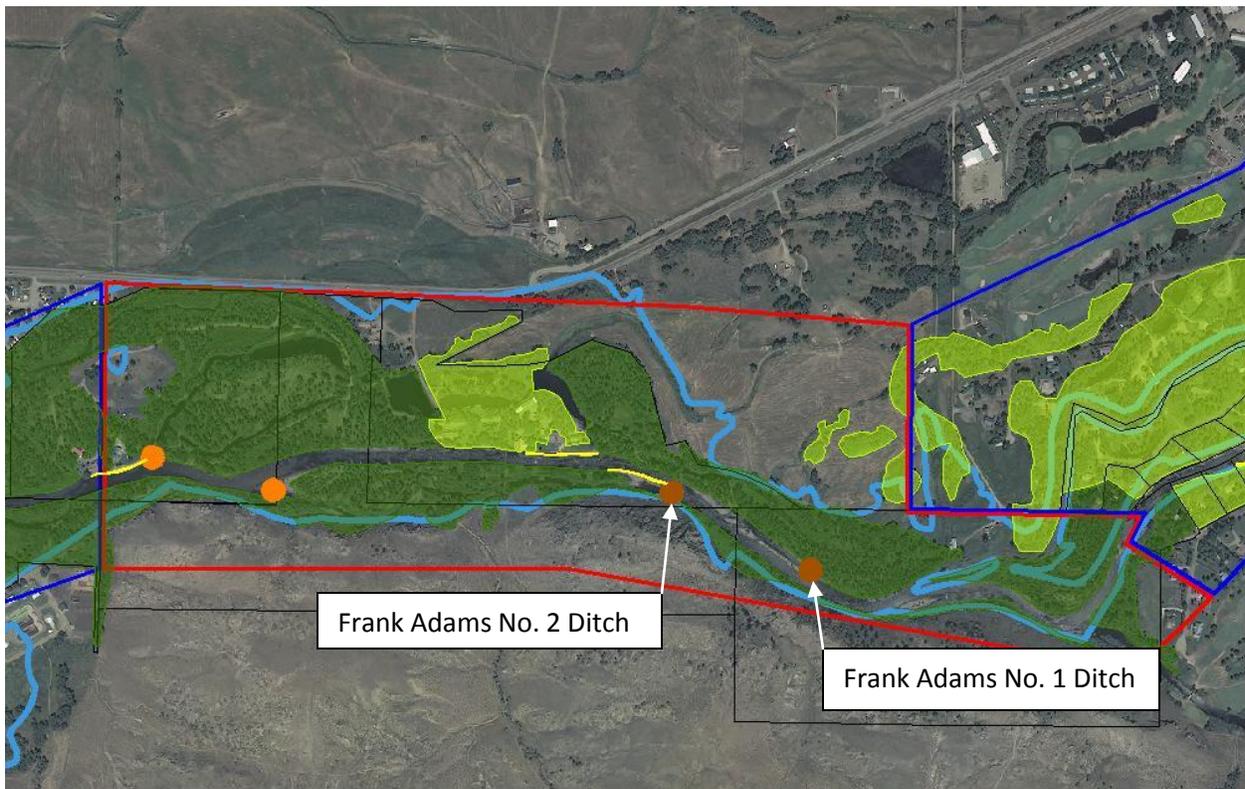
**Photograph 11.** Aerial overview of Segment 11. (2009 NAPP imagery of Gunnison County).

southern bank. The segment has an irrigation diversion structure established along the northern and southern banks in the eastern portion of the segment and an irrigation return feature along the northern and southern banks in the western portion of the segment. The confluence of the Gunnison River with Tomichi Creek is located in the far western portion of the segment. The segment has an irrigation diversion feature and an irrigation return feature along both the northern and southern banks (Photograph 11).

Large reaches of river channel in this segment have been modified with various structures including improved irrigation diversion structures and multiple wing dams and weirs, presumably established for enhanced fish habitat and stream bank protection.

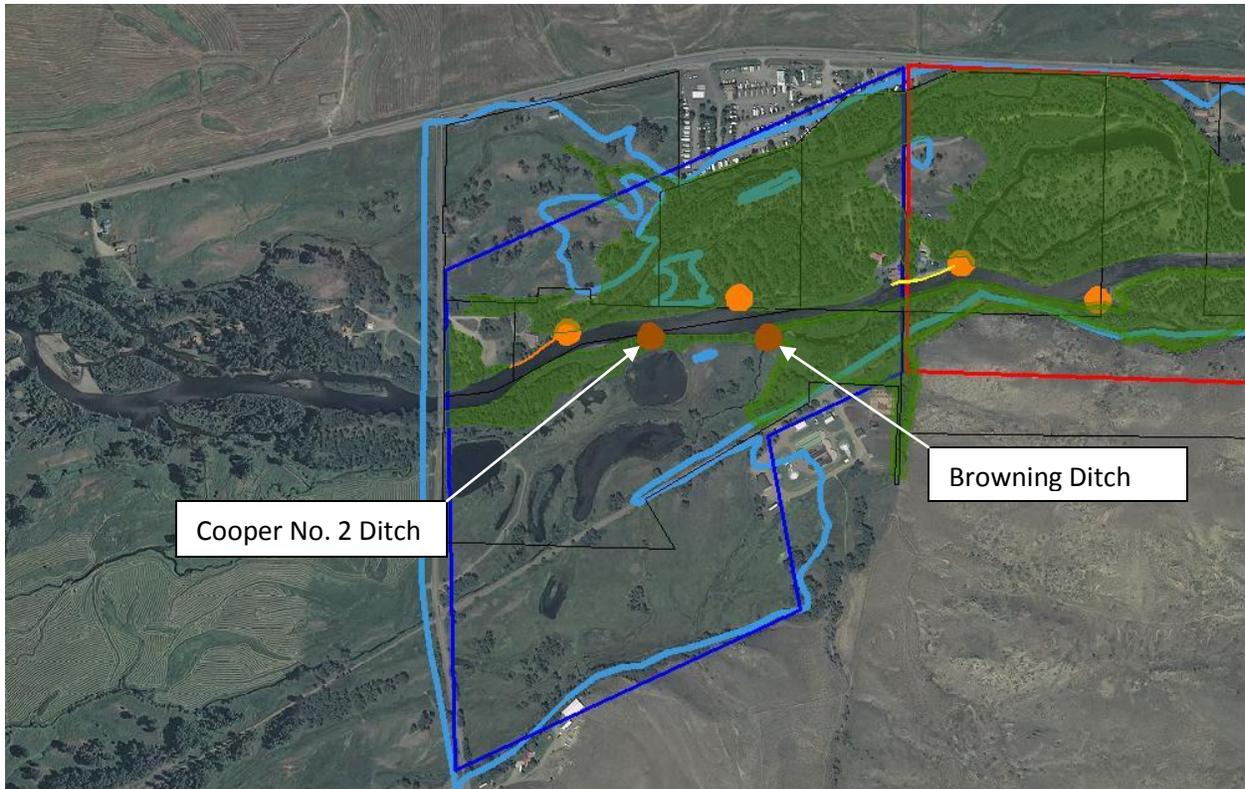
**Photograph 12.** Aerial overview of Segment 12. (2009 NAPP imagery of Gunnison County).

This segment is relatively undeveloped excluding the Gunnison County Water Treatment Plant that is located outside of the floodplain just south of Segment 12 and two residences that are located along the northern bank. The floodplain expands to its greatest extent within the study area within this segment as the river valley broadens to the expansive alluvial plain that exists to the south of the study area, just above Blue Mesa Reservoir. The expanded flood plain and the river support the McCabe's Lane Wetland Area in the southwest portion of Segment 12. This valuable wetland complex is established and conserved as mitigation for wetland impacts associated with an expansion to the Gunnison County Airport. The segment includes two irrigation return features along the northern streambank and two irrigation diversion features along the southern bank (Photograph 12).

Soils that are adjacent to the north of the river channel are the Alluvial Land, occasionally wet (Ao) soil type with the Irim loam (Ia) existing further to the north. The Gas Creek sandy loam is mapped in the McCabe's Lane wetland area to the south of the river channel (Map 2c).

The riparian areas that exist in Segment 12 are generally in Proper Functioning Condition with one large node of riparian vegetation established north of the river channel in the northeastern portion of the segment (i.e.; large areas shaded green in Photograph 12). The less extensive riparian zone to the south of the river is associated with the McCabe's Lane wetlands. Although the wetland area supports limited stands of mature cottonwood and overstory vegetation that would supply large woody material to the river system, the wetland area provides similar valuable ecological functions such as flood water absorption and abatement, ground surface stability and wildlife habitat. Due to the enhanced hydrology and existing hydric soils that are associated with these created wetlands, the establishment and enhancement of more diverse riparian vegetation in the wetland area would contribute to the creation of a larger node of riparian vegetation.

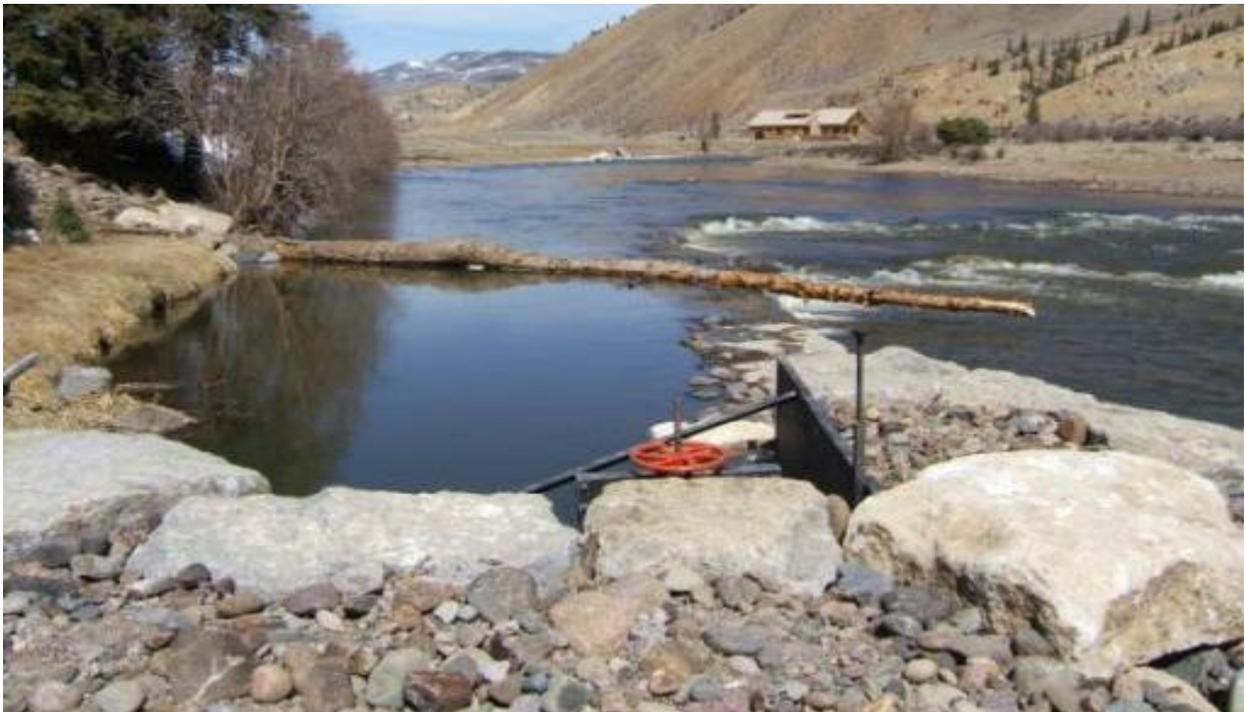
**Photograph 20.** Photograph of engineered diversion structure provided by Elk River Construction, Pagosa Springs, CO.

- Diversion structures and their associated headgates areas are found consistently throughout the study area and have impaired riparian zones and often caused downstream impacts due to diverting and concentrating stream energy. We recommend designing and engineering diversion structures for willing landowners that minimize impact to the riparian zone and reduce maintenance costs while also ensuring water supply to the diversion users.

- Design and engineering of Diversions/Ditches to Reduce Riparian and Instream Disturbance from Maintenance (All Assessment Segments). One pattern that was apparent during this assessment was that near almost every diversion structure was a zone of impaired riparian habitat (Photographs 18 and 19). We recommend the redesign of diversion structures (Photograph 20) along with
