Chapter 6 The East River Basin

Section 1. Basin Characteristics

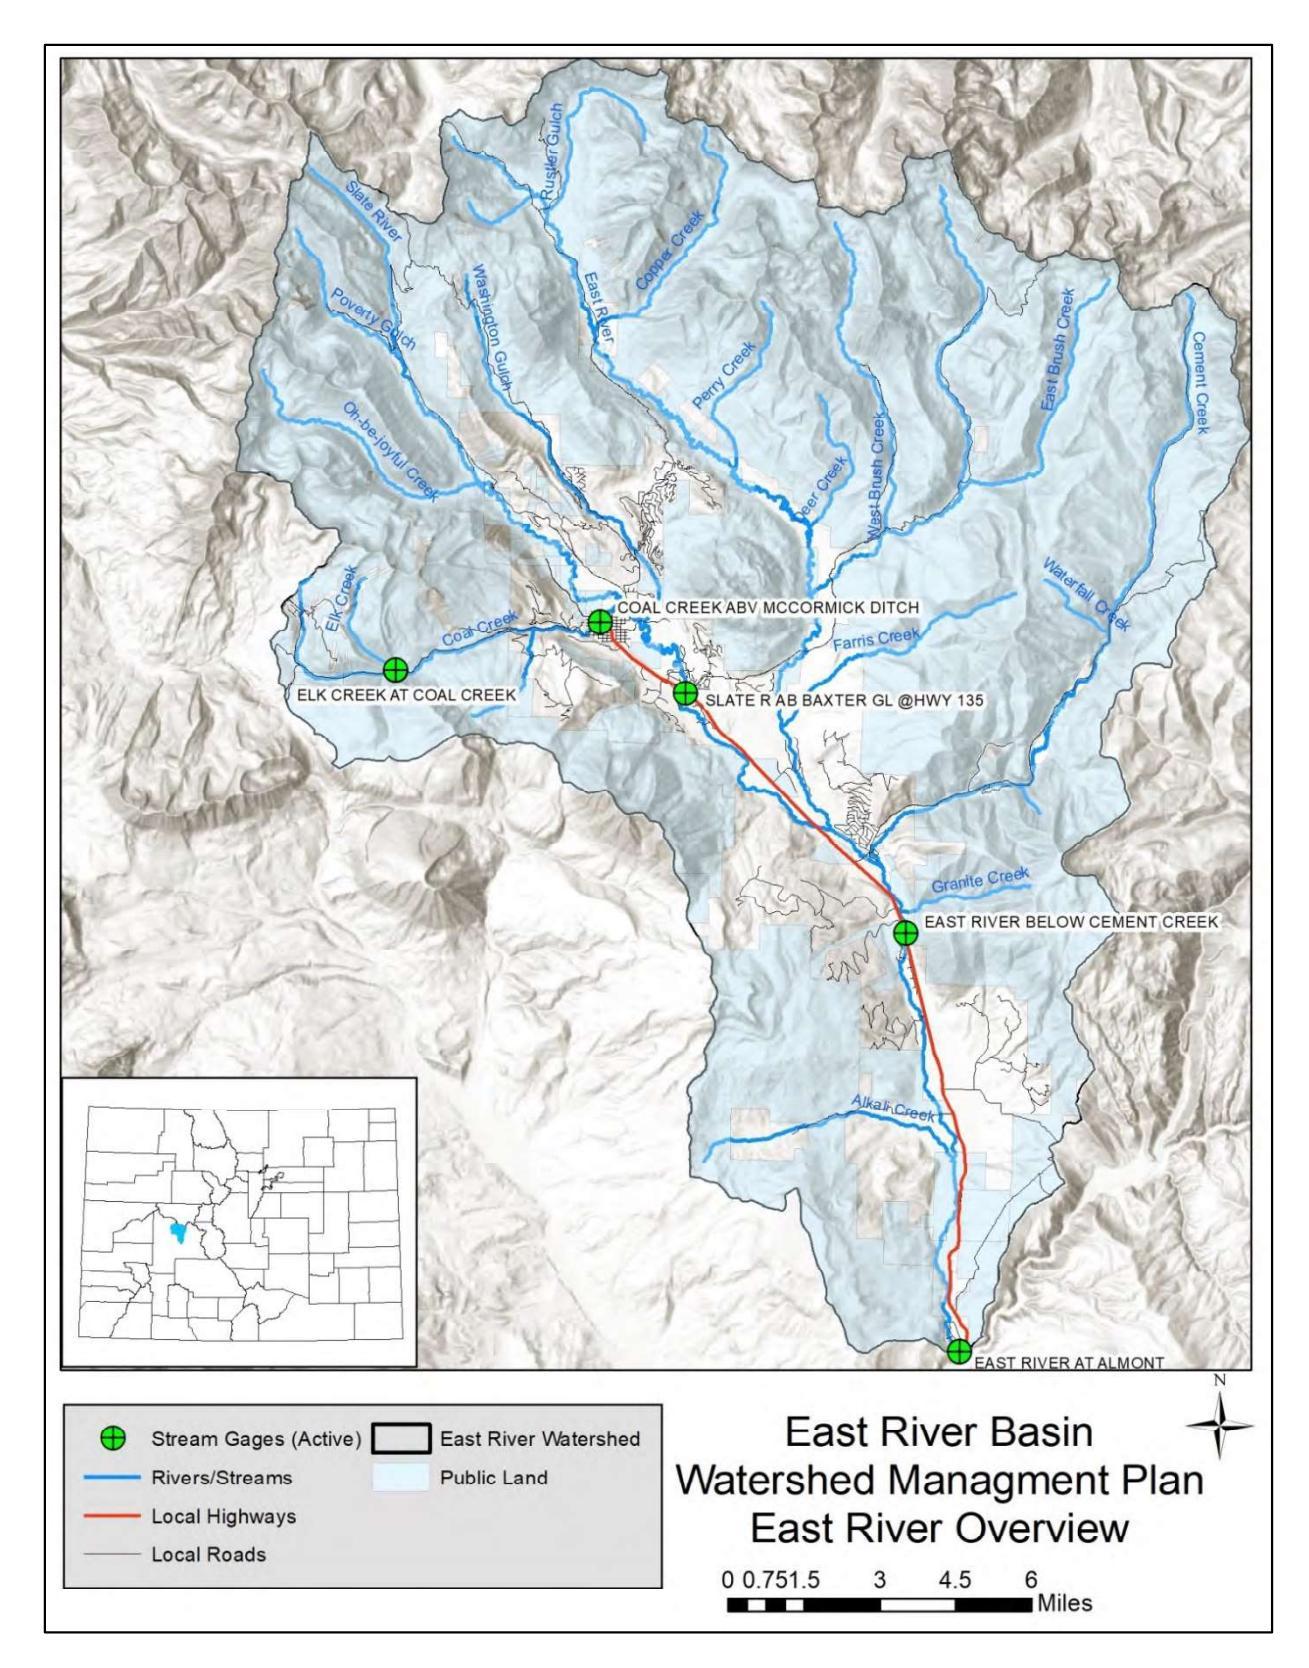
Figure 1-1: East River Basin Overview Map

Figure 1-1 shows the East River Basin boundaries, highways and local roads, active streamflow gages, and public/managed land designation. Approximately 80 percent of the land within the Basin boundary is public. A significant portion of the private land generally follows the East River and other tributaries and includes irrigated acreage, the towns of Crested Butte and Mt. Crested Butte, and other municipal subdivisions.

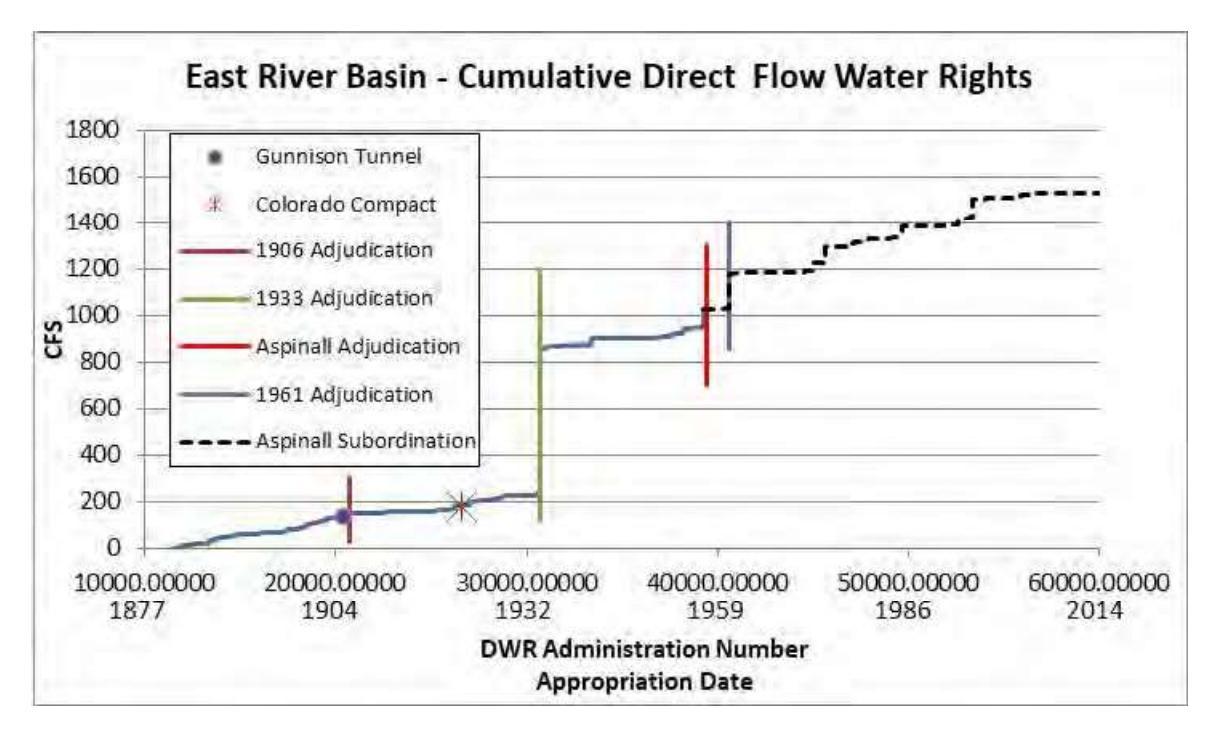
Figure 2-8: East River Basin Cumulative Direct Flow Water Rights

Figure 2-8 represents the cumulative absolute direct flow water rights in the East River Basin, highlighting major Basin adjudication dates and key water rights. The DWR Administration Number indicates the water right priorities based on both appropriation date and adjudication date and is used by DWR for administration throughout the state. As discussed in Section 1.1 of Chapter 2 and shown in the figure, Aspinall Unit water rights are subordinated to current and future Upper Gunnison River Basin water rights junior to the Aspinall Unit water rights up to 40,000 acre-feet of annual depletions.

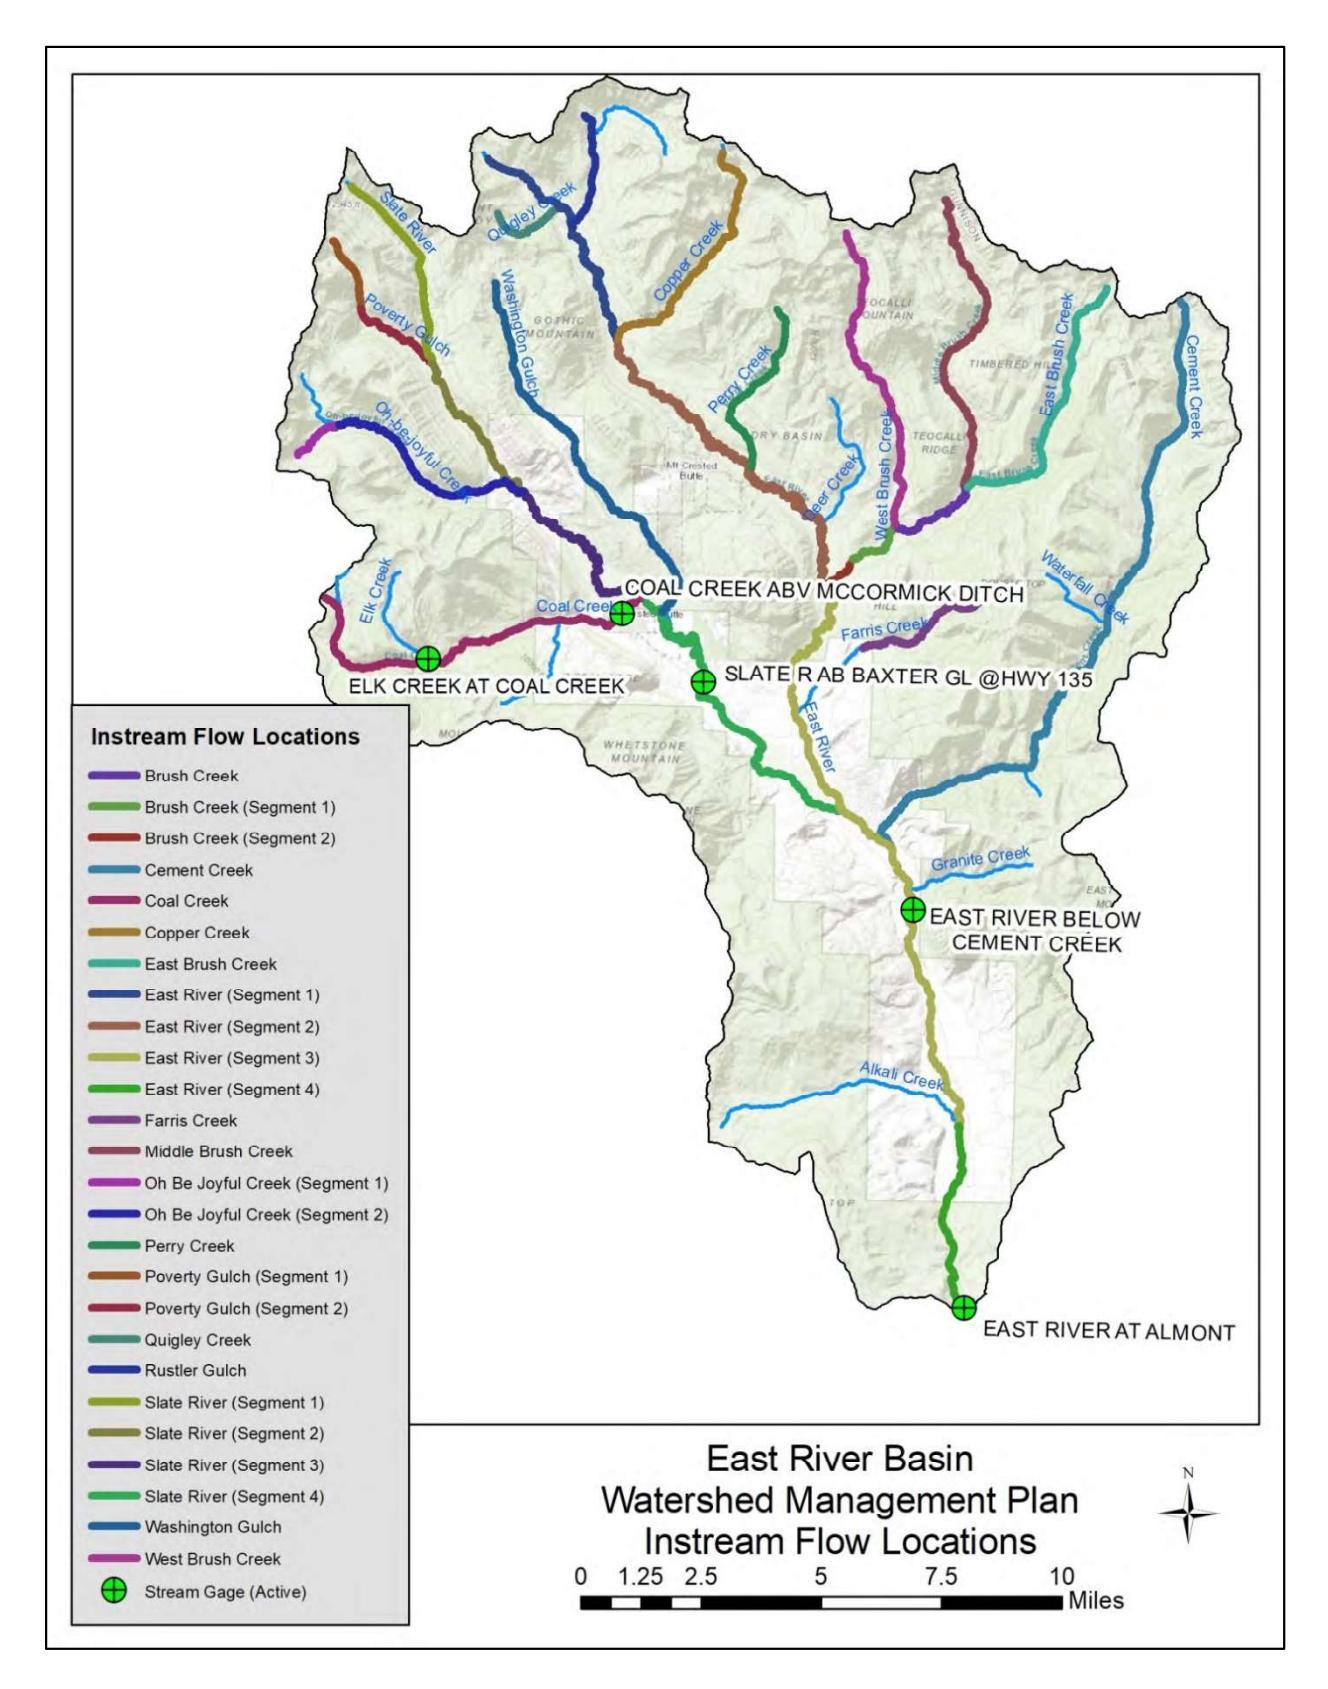
Figure 2-9: Instream Flow Reaches in the East River Basin

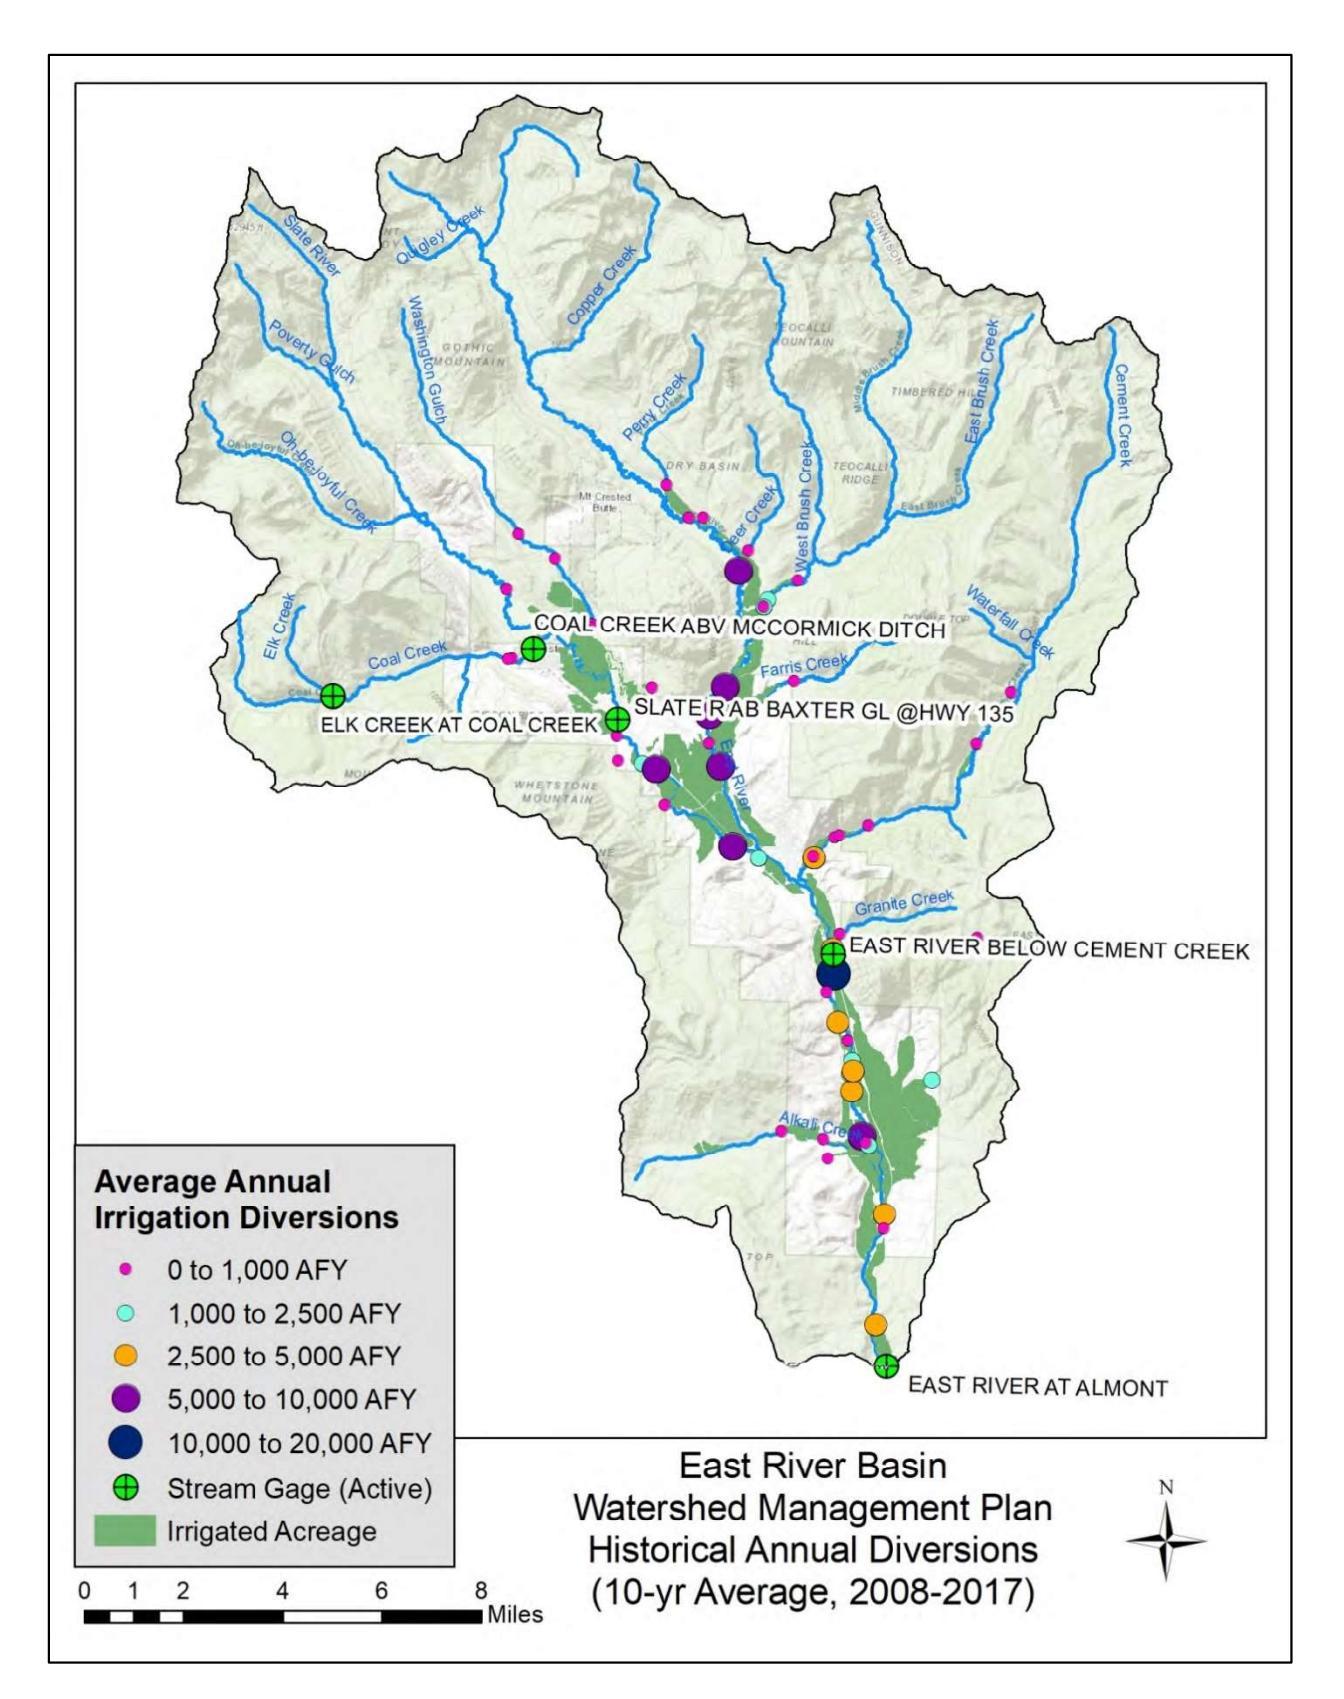
Figure 2-14: Average Annual Historical Irrigation Diversions, 2008-2017

Figure 2-14 shows the location and magnitude of average annual diversions in the East River Basin. In the upper reaches, most of these ditches divert less than 1,000 acre-feet per year. Ditches tend to have larger diversions and irrigate more acreage further downstream in the basin. Average annual diversions from 2008 to 2017 average 119,500 acre-feet. The largest nine ditches deliver almost 60 percent of the total diversions (69,600 acre-feet/Year).

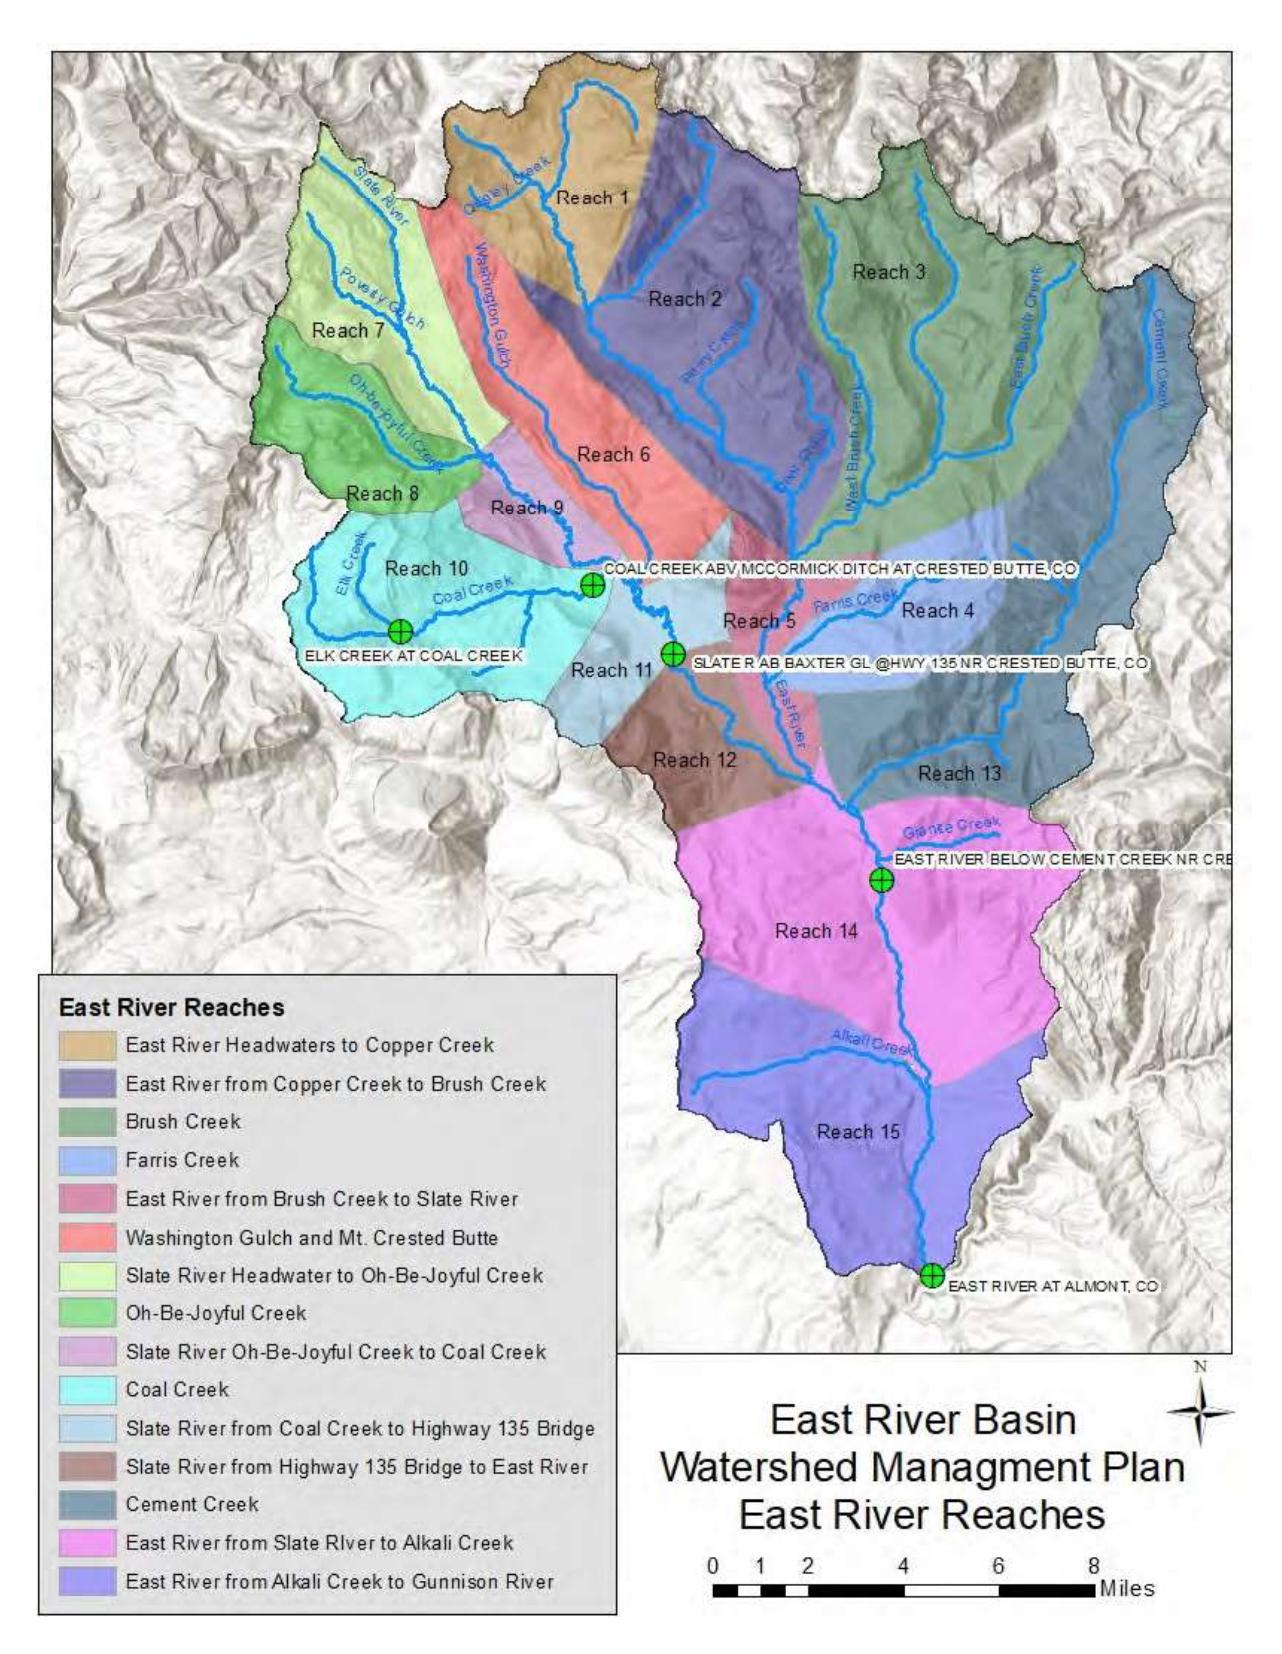
Figure 2-15: East River Reaches

For this Report, the East River Basin was divided into 15 reaches because each has unique characteristics and issues. The approach to investigating agricultural, domestic, environmental, and recreational uses was tailored for each reach. Figure 3-15 shows the reaches. Table 3-3 summarizes general characteristics of each reach and the issues identified by stakeholders. Detailed assessments of the reaches are contained in Sections 5 through 19 of this Chapter.

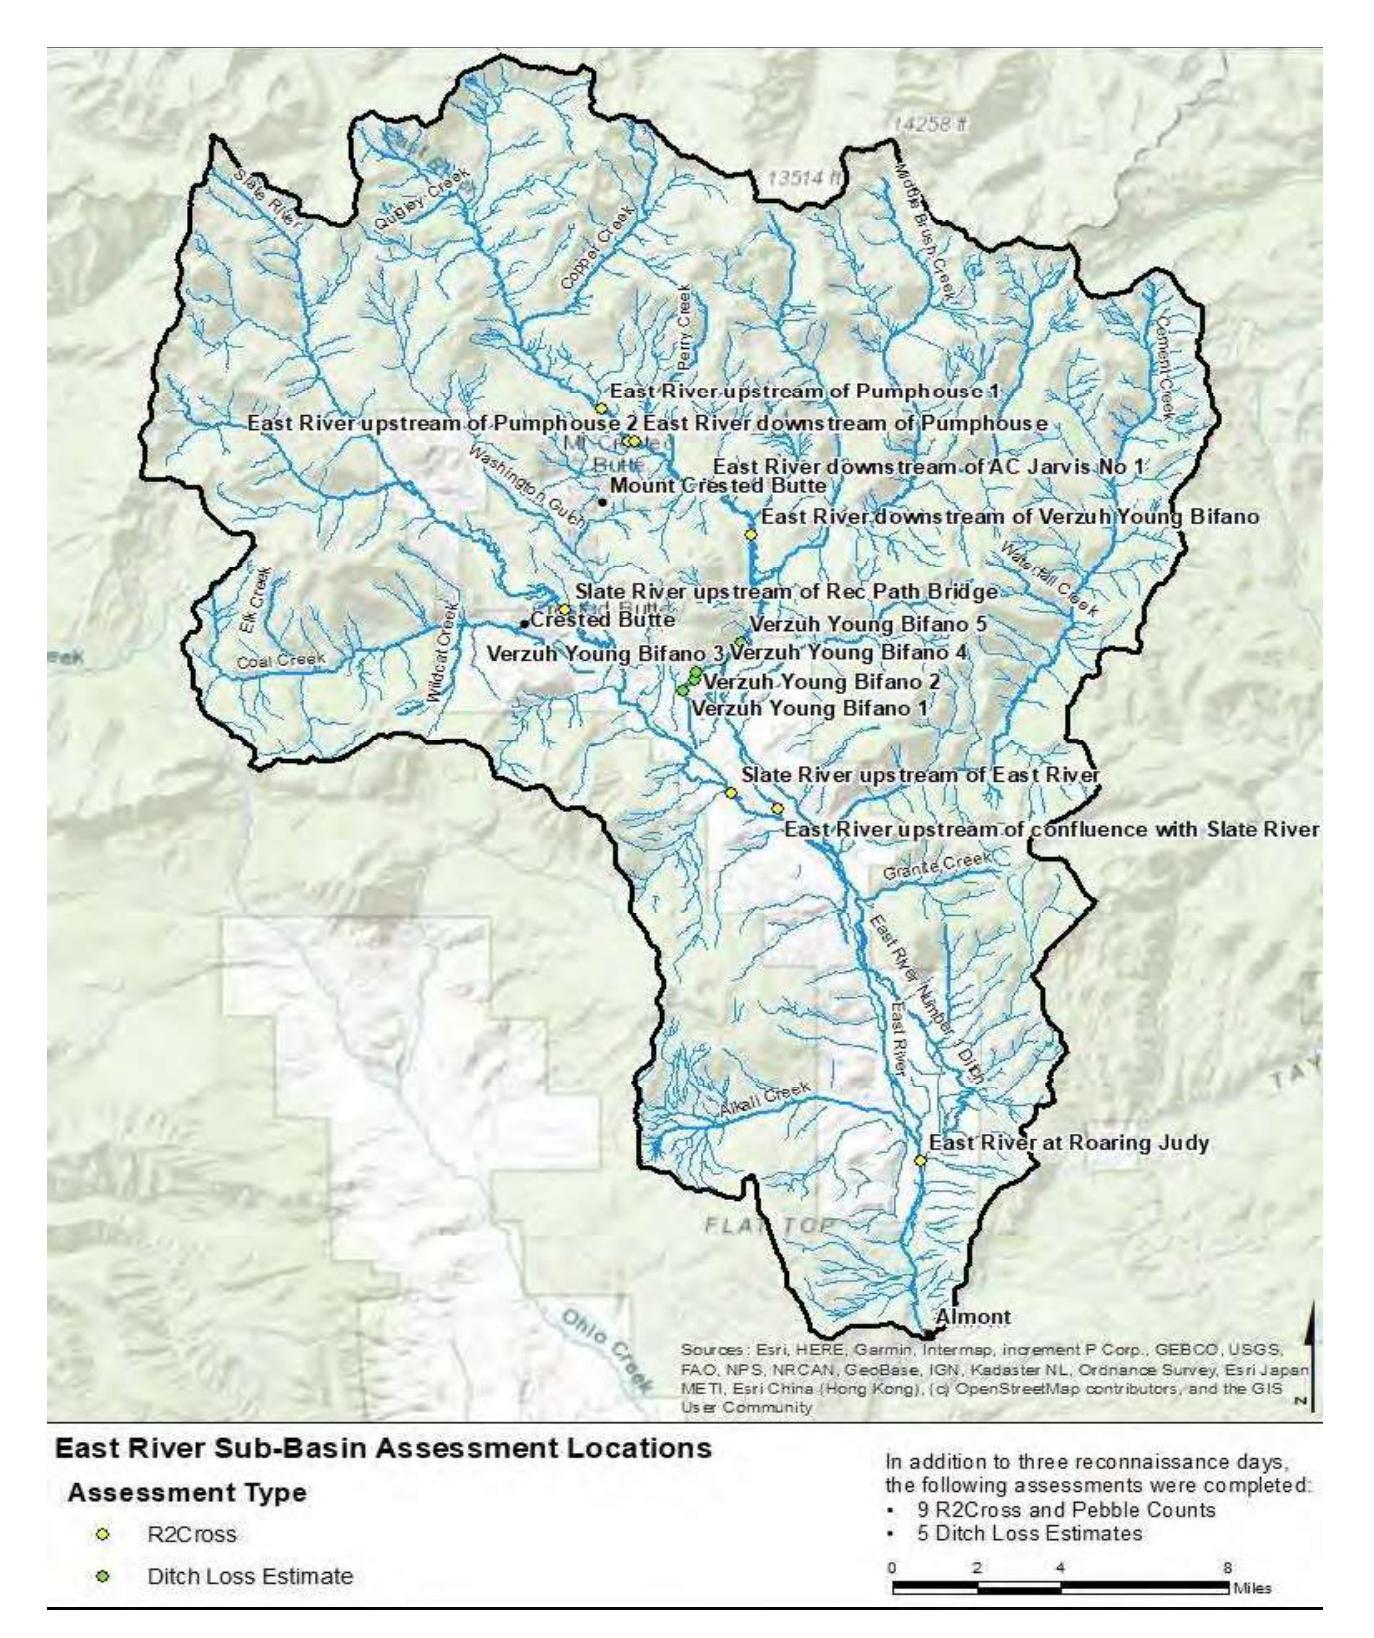
Figure 4-17: Field assessment locations in the East River Basin

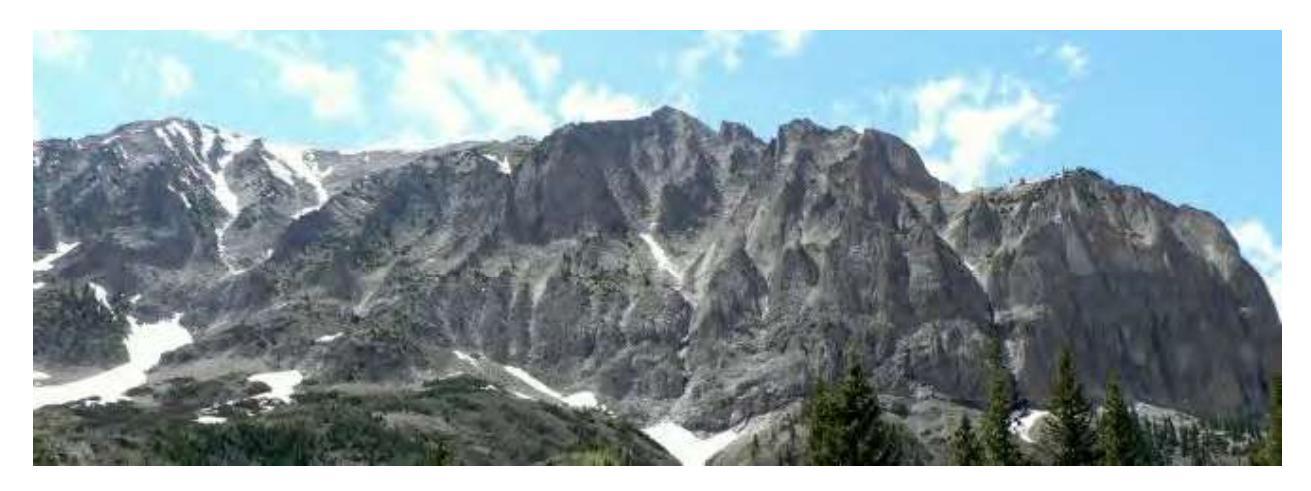
An imposing view of Gothic Mountain, as seen from the valley floor. The exposed bedrock on Gothic Mountain and other peaks are impervious surfaces that can rapidly deliver ample amounts of water to drainages below the peak. These natural conditions make mass erosion events more likely. Photo from the RMBL archives.

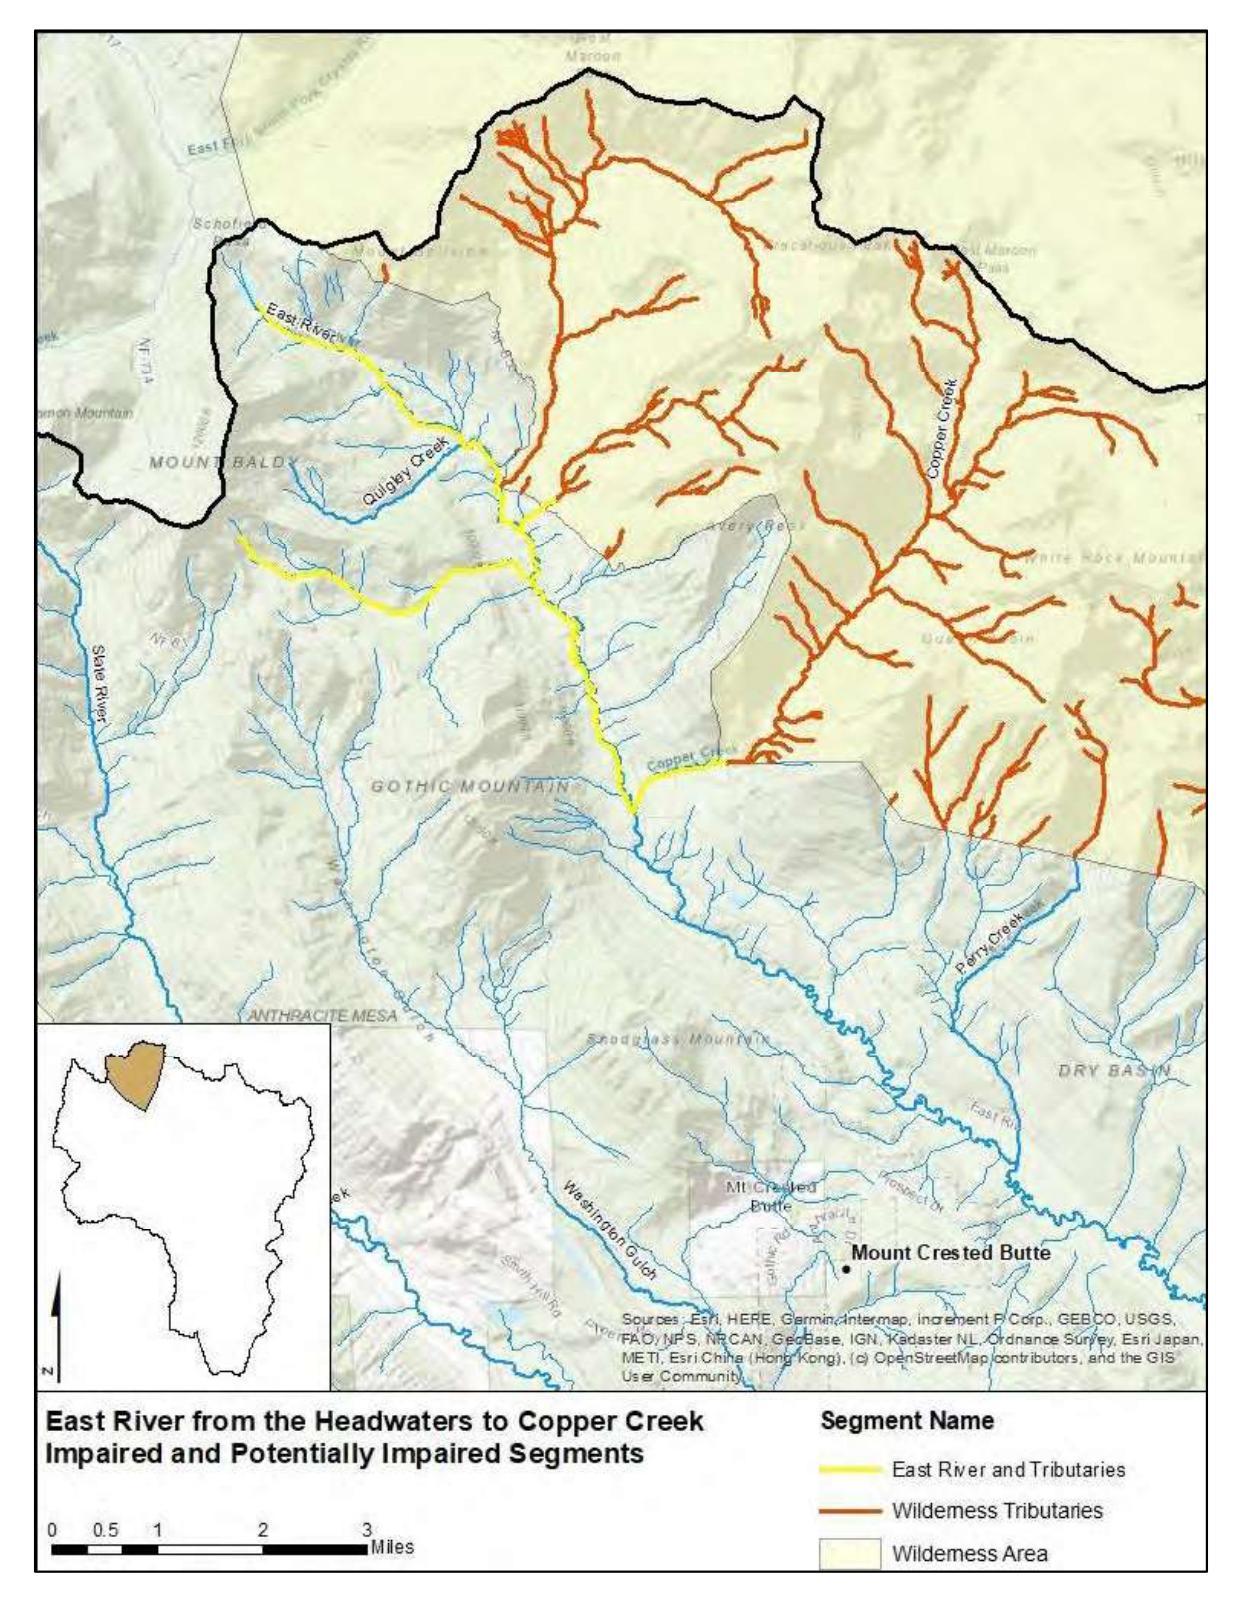
Figure 4-1: Impaired and potentially impaired stream reaches in the East River Headwaters to Copper Creek

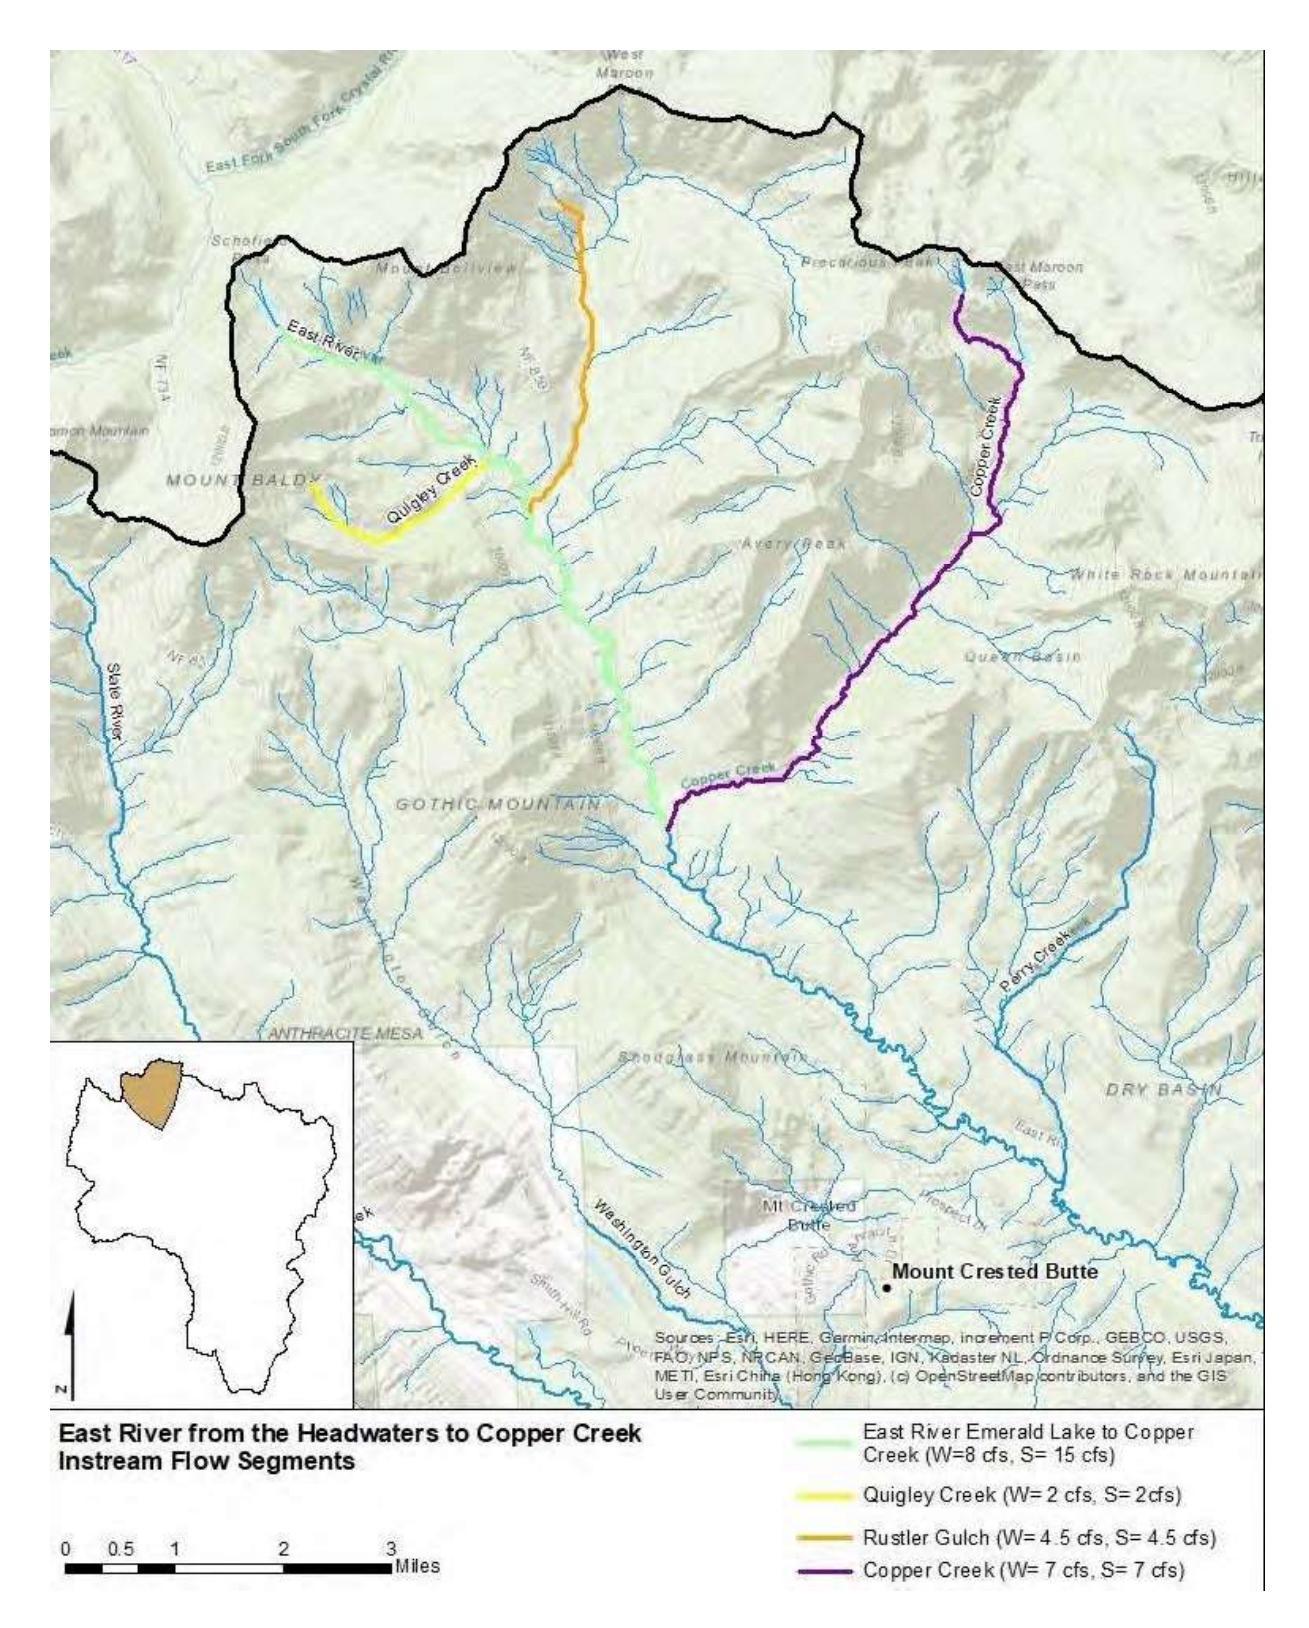
Figure 5-2: Instream flow water rights in the East River and its tributaries from the headwaters to the confluence with Copper Creek.

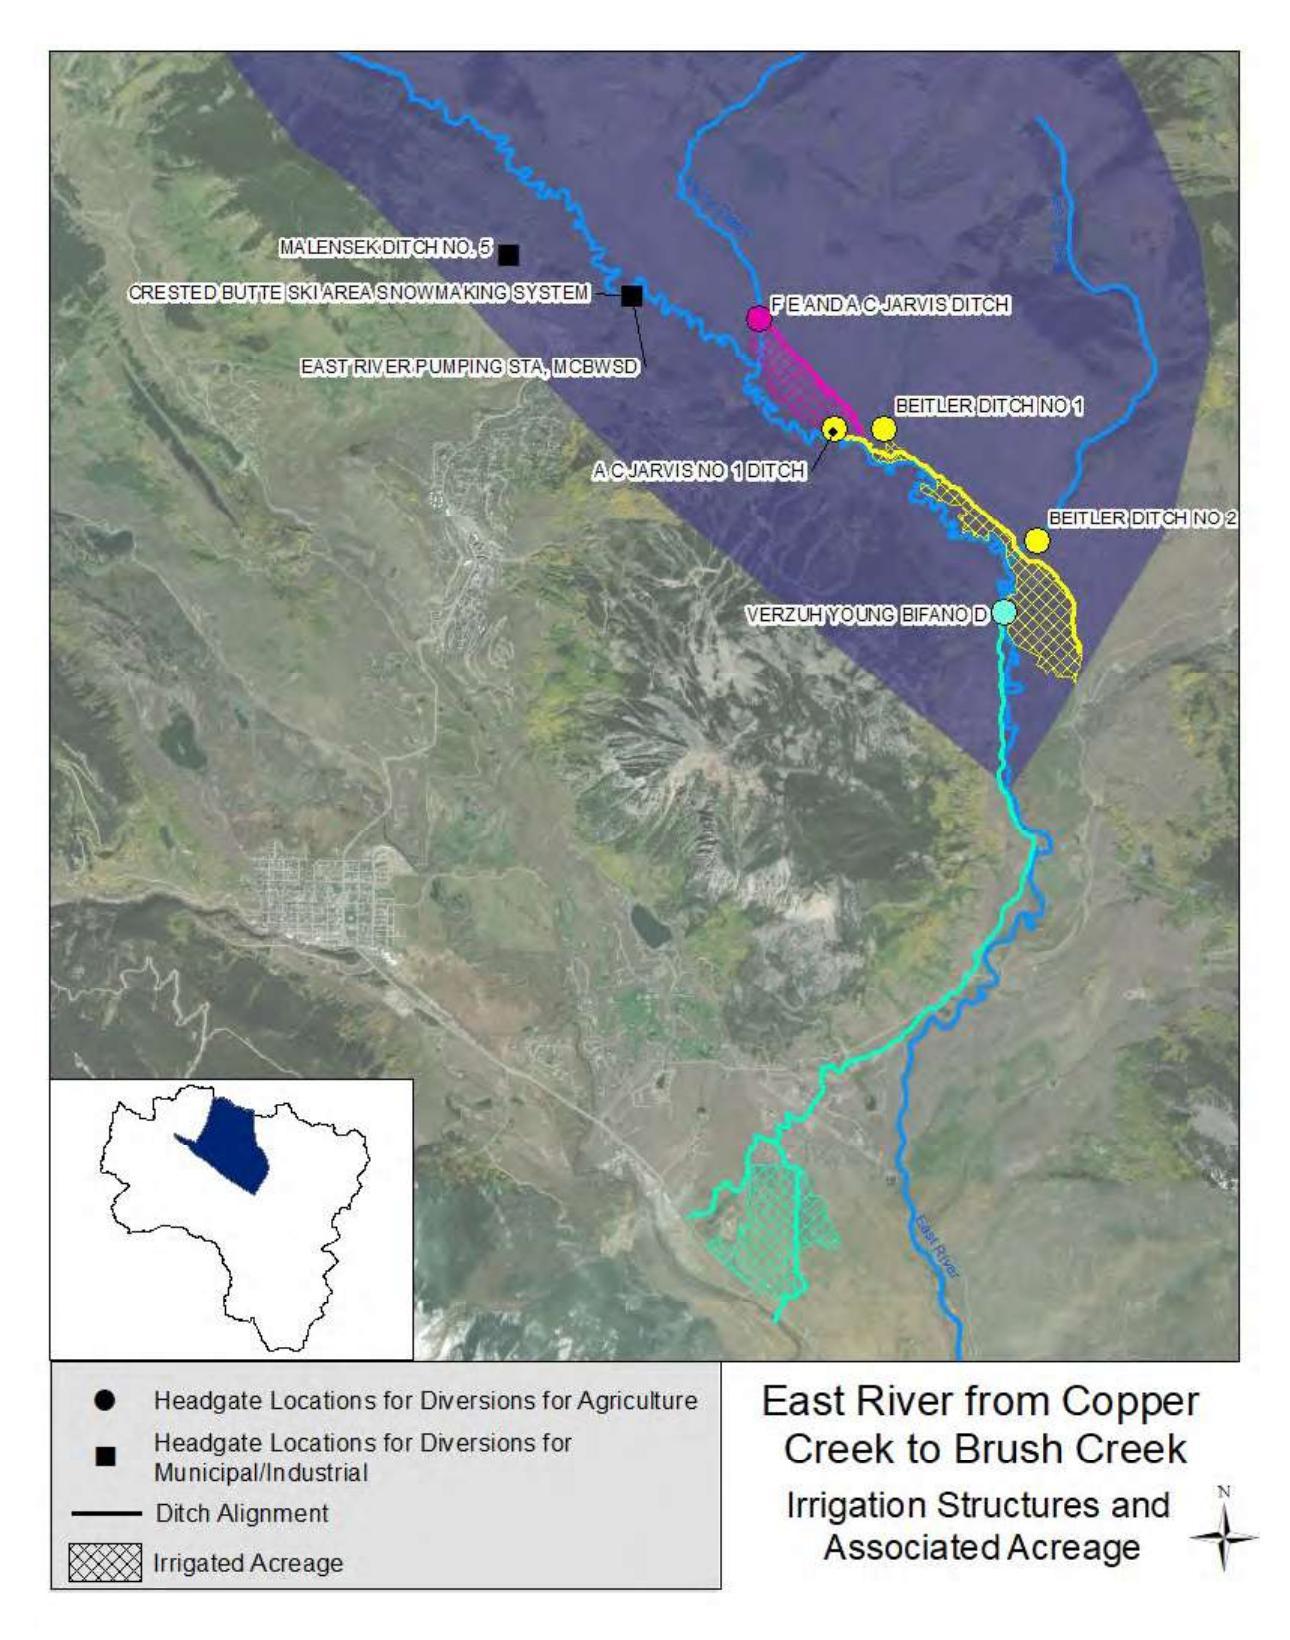
Figure 5-1: Diversion structures and acreage for the East River from Copper Creek to Brush Creek Table 6-2 shows the percentage of water that returns to the East River from Brush Creek to Copper Creek and to adjacent reaches. A significant portion of water diverted from this reach of the East River, an estimated 40%, returns to the Slate River rather than the East River.

Figure 6-1 shows the headgate diversion location, ditch alignment, and irrigated acreage in this reach. As shown, diversions through the AC Jarvis No 1 Ditch, the Beitler Ditch No 1, and the Beitler Ditch No 2 comingle to serve common acreage. Although the Verzuh Young Bifano Ditch diverts within the reach, the associated irrigated acreage is located in downstream reaches. All of the ditches are unlined and are estimated to lose between 20 and 25 percent of diverted water during delivery to the irrigated fields. Conveyance losses reduce the water delivered to irrigated fields. The water lost in transit returns in subsequent days and months. Excess water applied to the fields during flood irrigation returns to the river over time. Due to cobbly and porous soils, the soil zone does not store significant water, unlike other areas of Colorado where a significant amount of water can be stored in the soil root zone from higher diversions during the runoff, and then is consumed by the crop when diversion supply is limited.

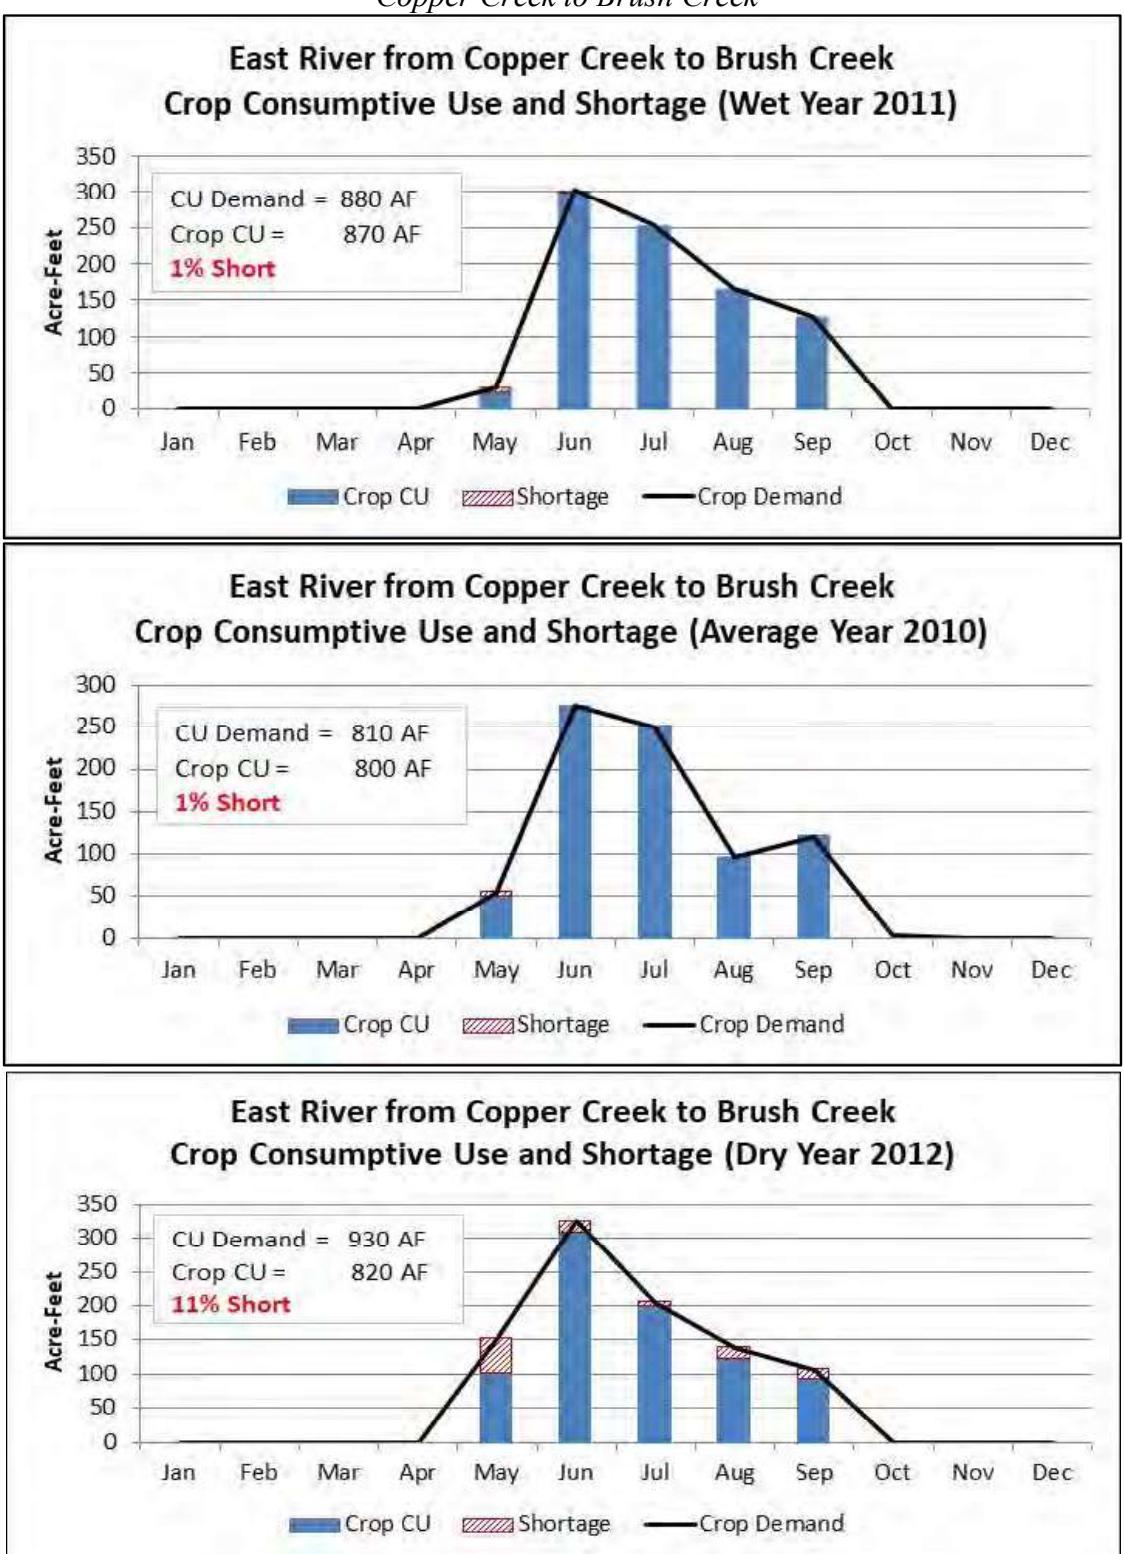
Figure 6-2: Crop Consumptive Use and Shortage for the East River from Copper Creek to Brush Creek

Figure 6-2 shows the monthly crop demands, consumptive use, and associated shortages for three recent years, chosen to highlight hydrologic variability between a wet year (2011), a dry year (2012), and a relatively average year (2010). As shown, there were minimal shortages during the representative wet and average years, with larger shortages in the representative dry year. Precipitation was well above average in August of the 2010 representative average year, resulting in a relatively low crop consumptive use from irrigation supplies. Crop demands were met through the summer and into the fall irrigation season during the representative average and wet years; however, during the dry year in 2012 there was not enough supply to fully meet crop demand in the late irrigation season.
