Chapter 6 The East River Basin

Section 1. Basin Characteristics

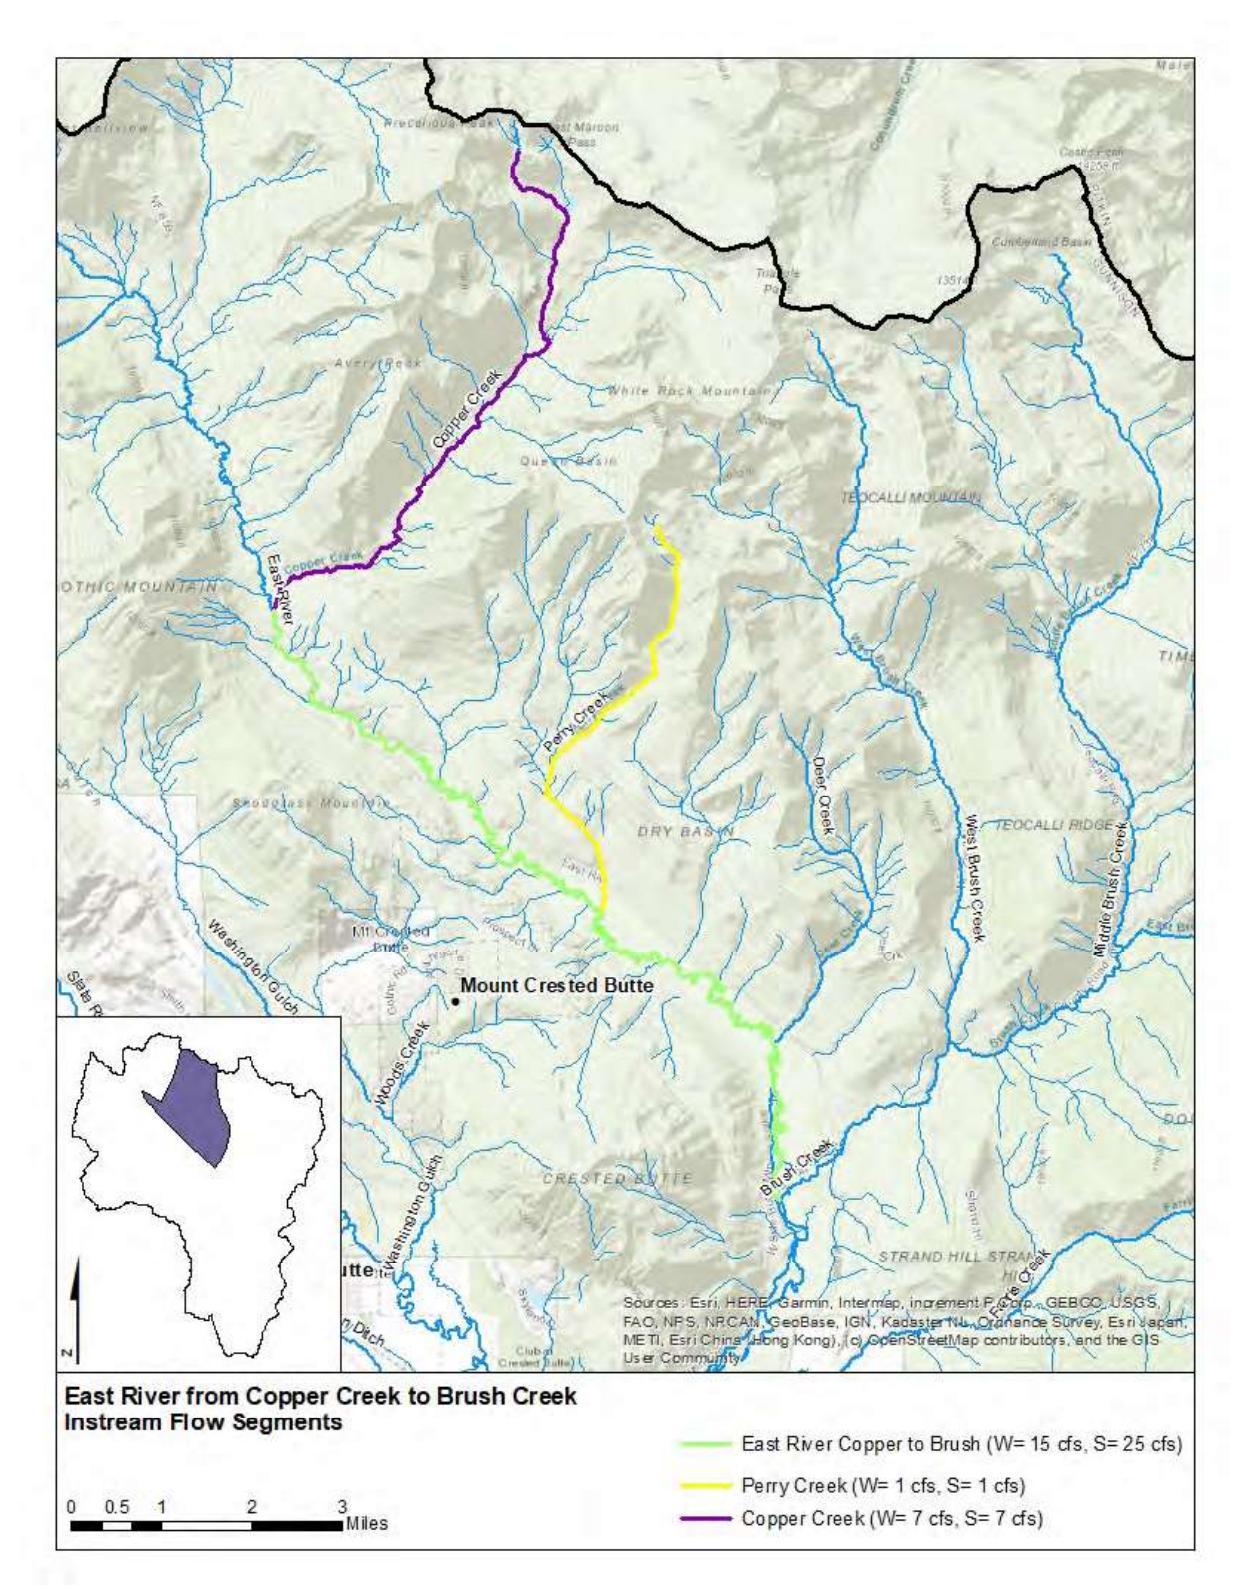
Figure 6-7: Instream flow water rights in East River from Copper Creek to Brush Creek.

Perry Creek has a year-round instream flow water right of 1 cfs as shown in Figure 6-7.

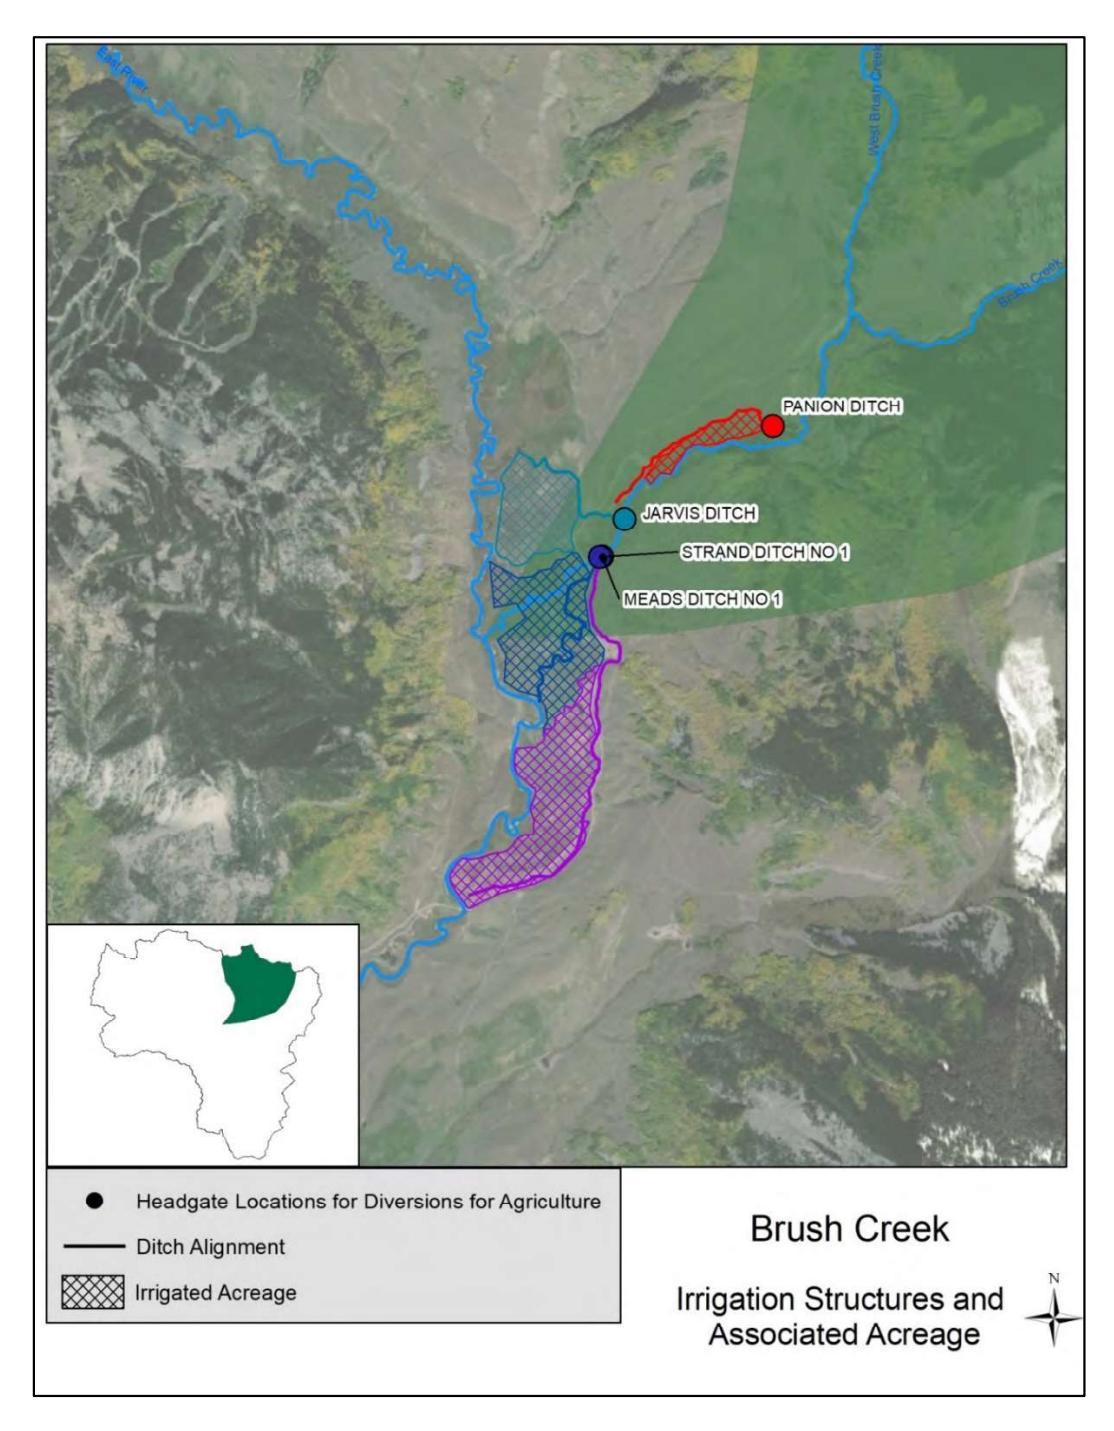
Figure 6-1: Diversion structures and acreage in Brush Creek

Figure 7-1 shows the headgate diversion location, ditch alignment, and irrigated acreage in this basin. All of the ditches are unlined, and the individual ditches are estimated to lose between 10 and 20 percent of diverted water during delivery to the irrigated fields depending on ditch length.

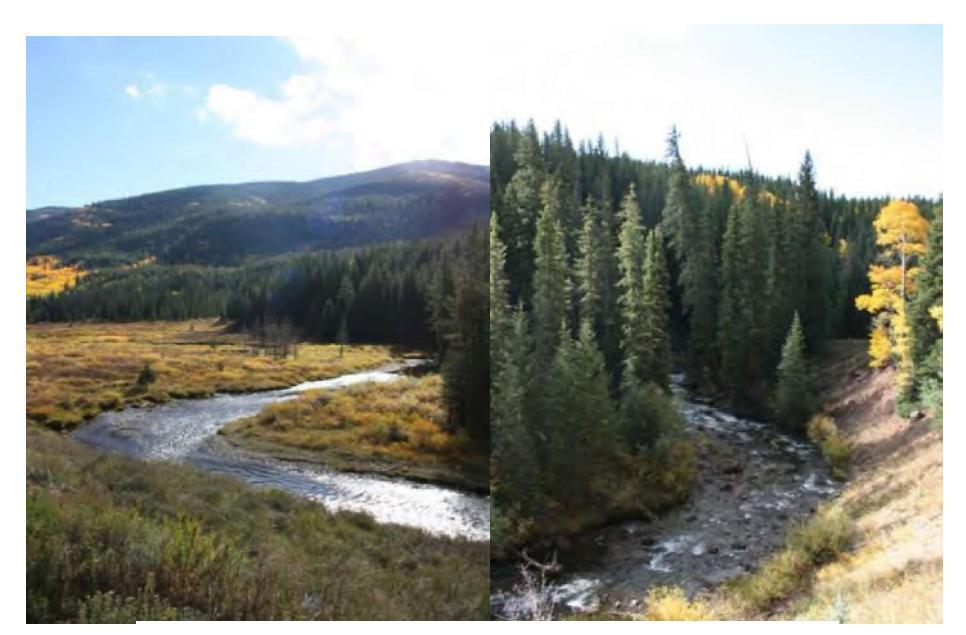
Photo 7-1: East Brush Creek. Left photo is a view upstream and includes healthy riparian wetland. The right photo is a downstream view.

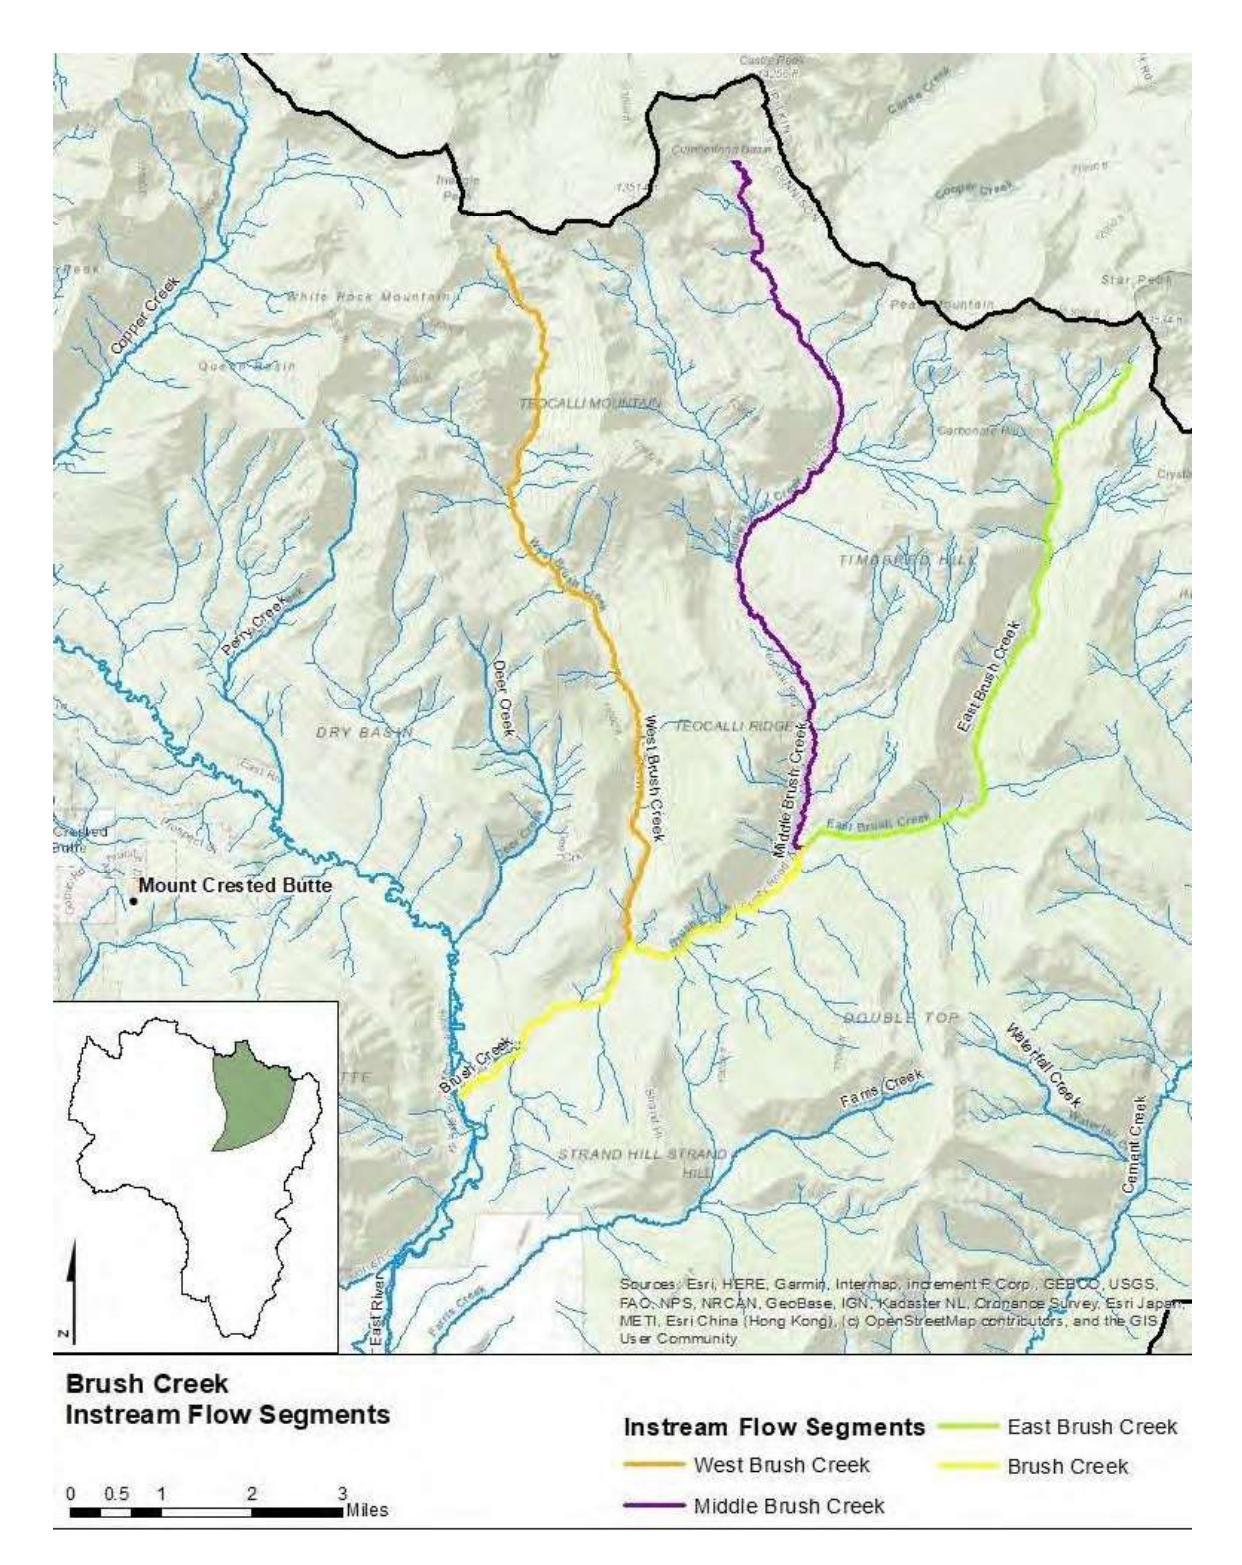
Figure 7-4: Instream flow water rights for Brush Creek and its tributaries.

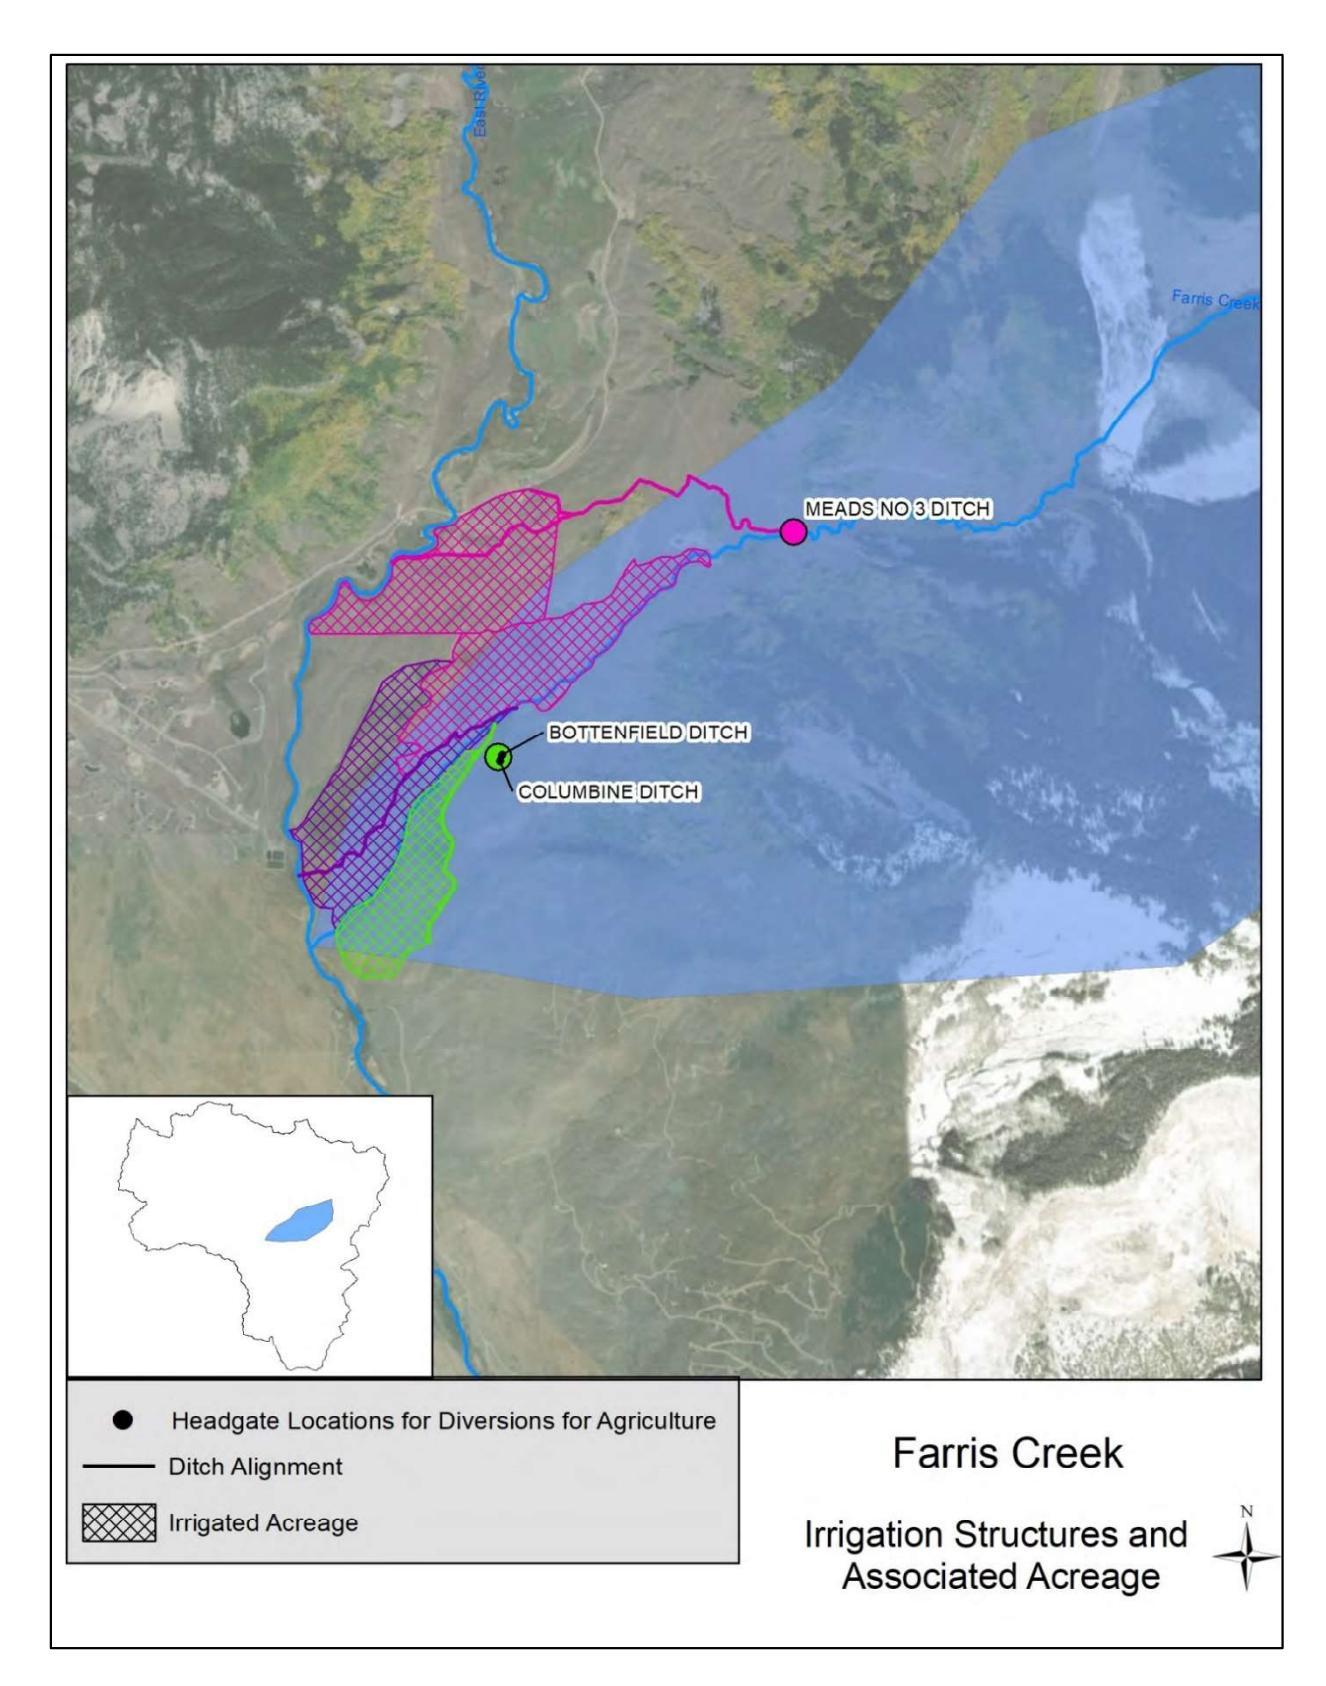
Figure 7-1: Diversion structures and irrigated acreage for Farris Creek

Figure 8-1 shows the headgate diversion location, ditch alignment, and irrigated acreage in this basin.

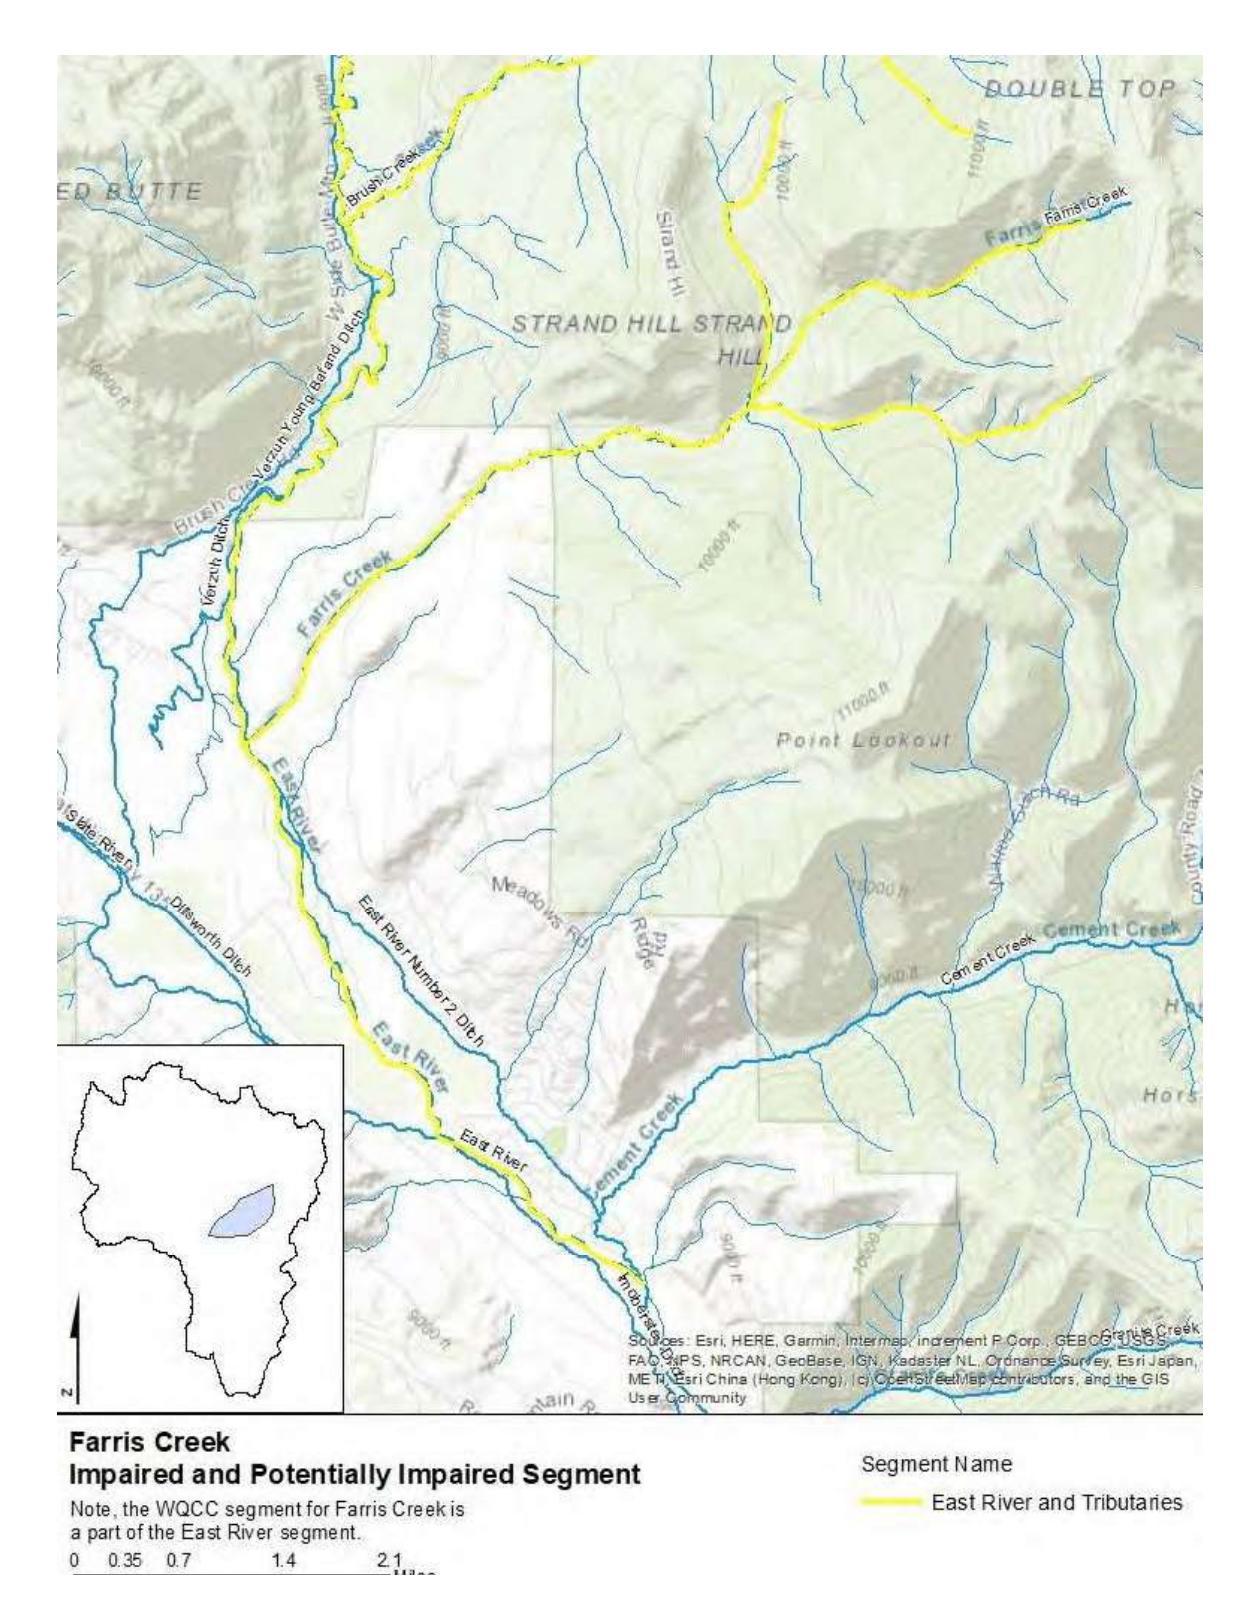
Figure 8-2: Impaired and potentially impaired stream reaches in Farris Creek

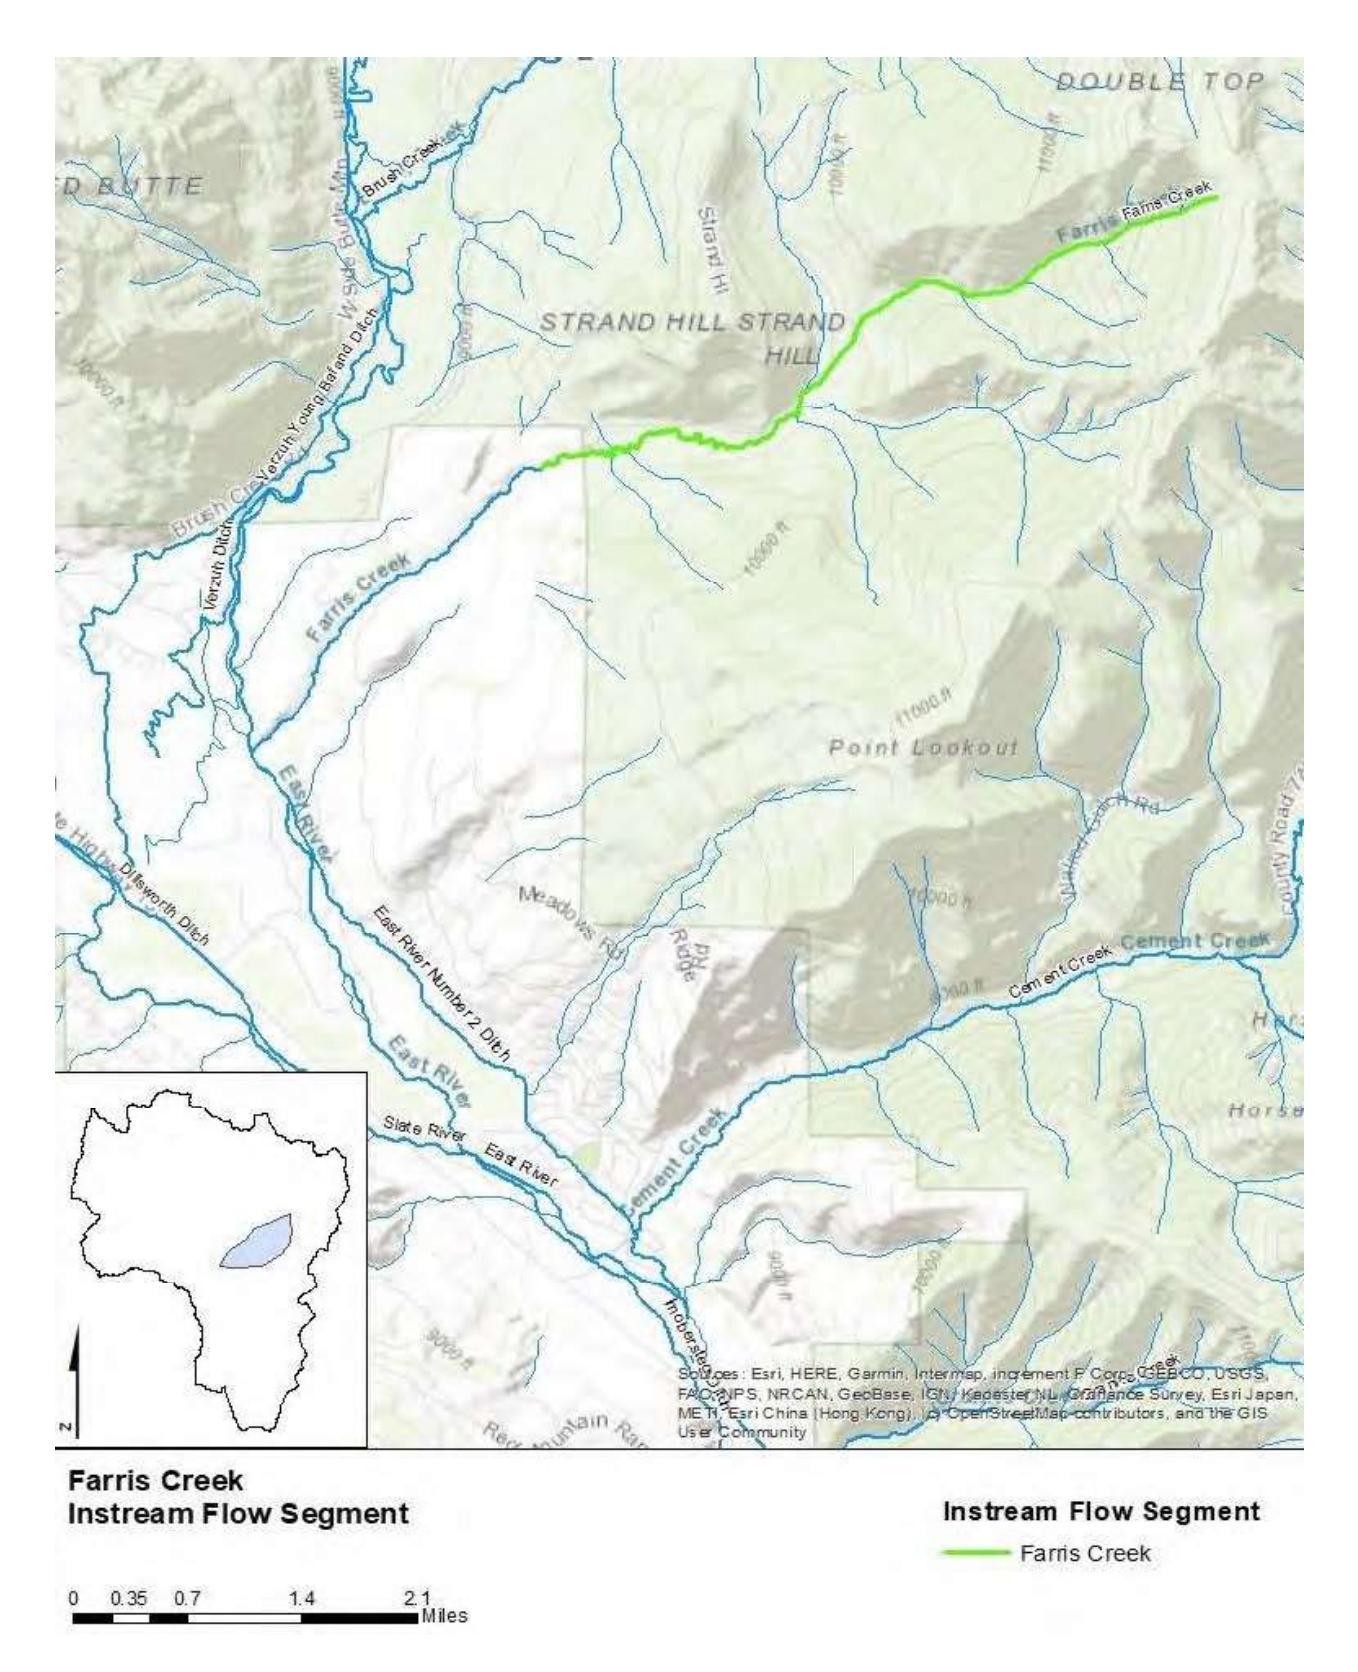
Figure 8-3: Farris Creek instream flow water right

Farris Creek from the headwaters to the Meads Number 3 Ditch headgate has a yearround instream flow water right of 3 cfs as shown in Figure 8-3. The instream flow proposals were developed by CWCB and CPW staff in 1979 and 1980. The instream flow right ends at the Meads Number 3 Ditch headgate due to a lack of physical and legal water availability.

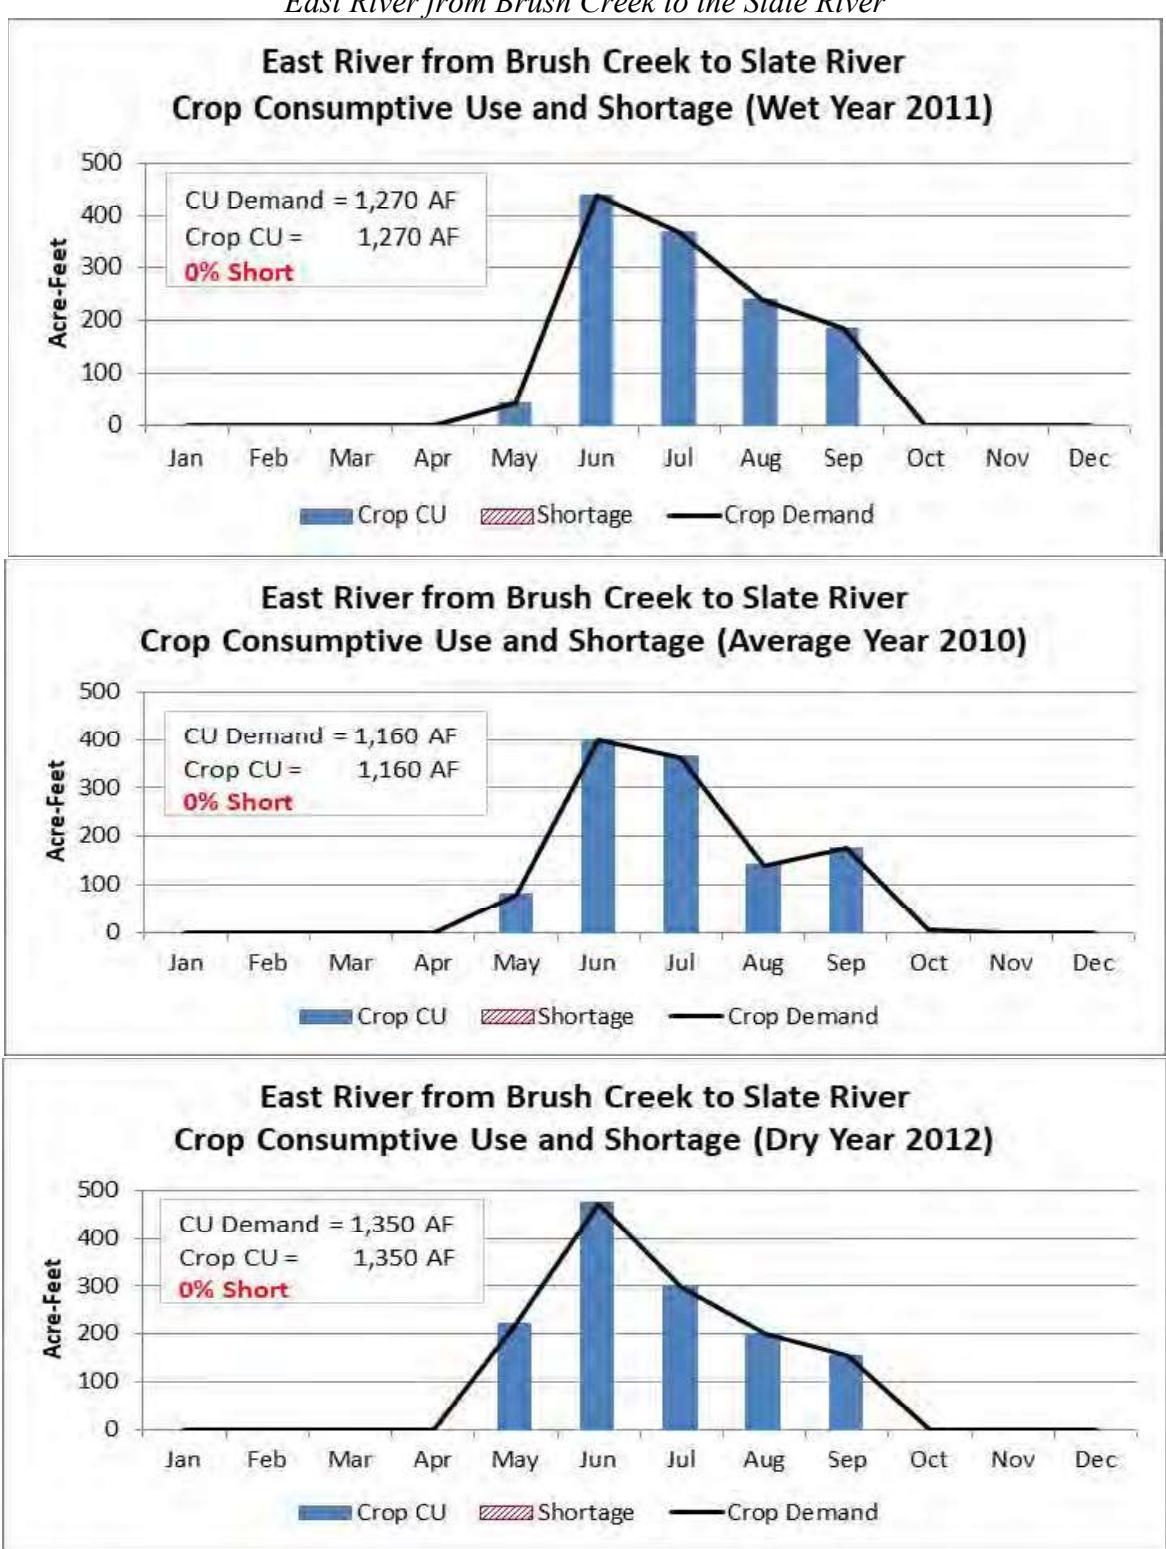
Figure 9-2: Crop Consumptive Use and Shortage on the East River from Brush Creek to the Slate River

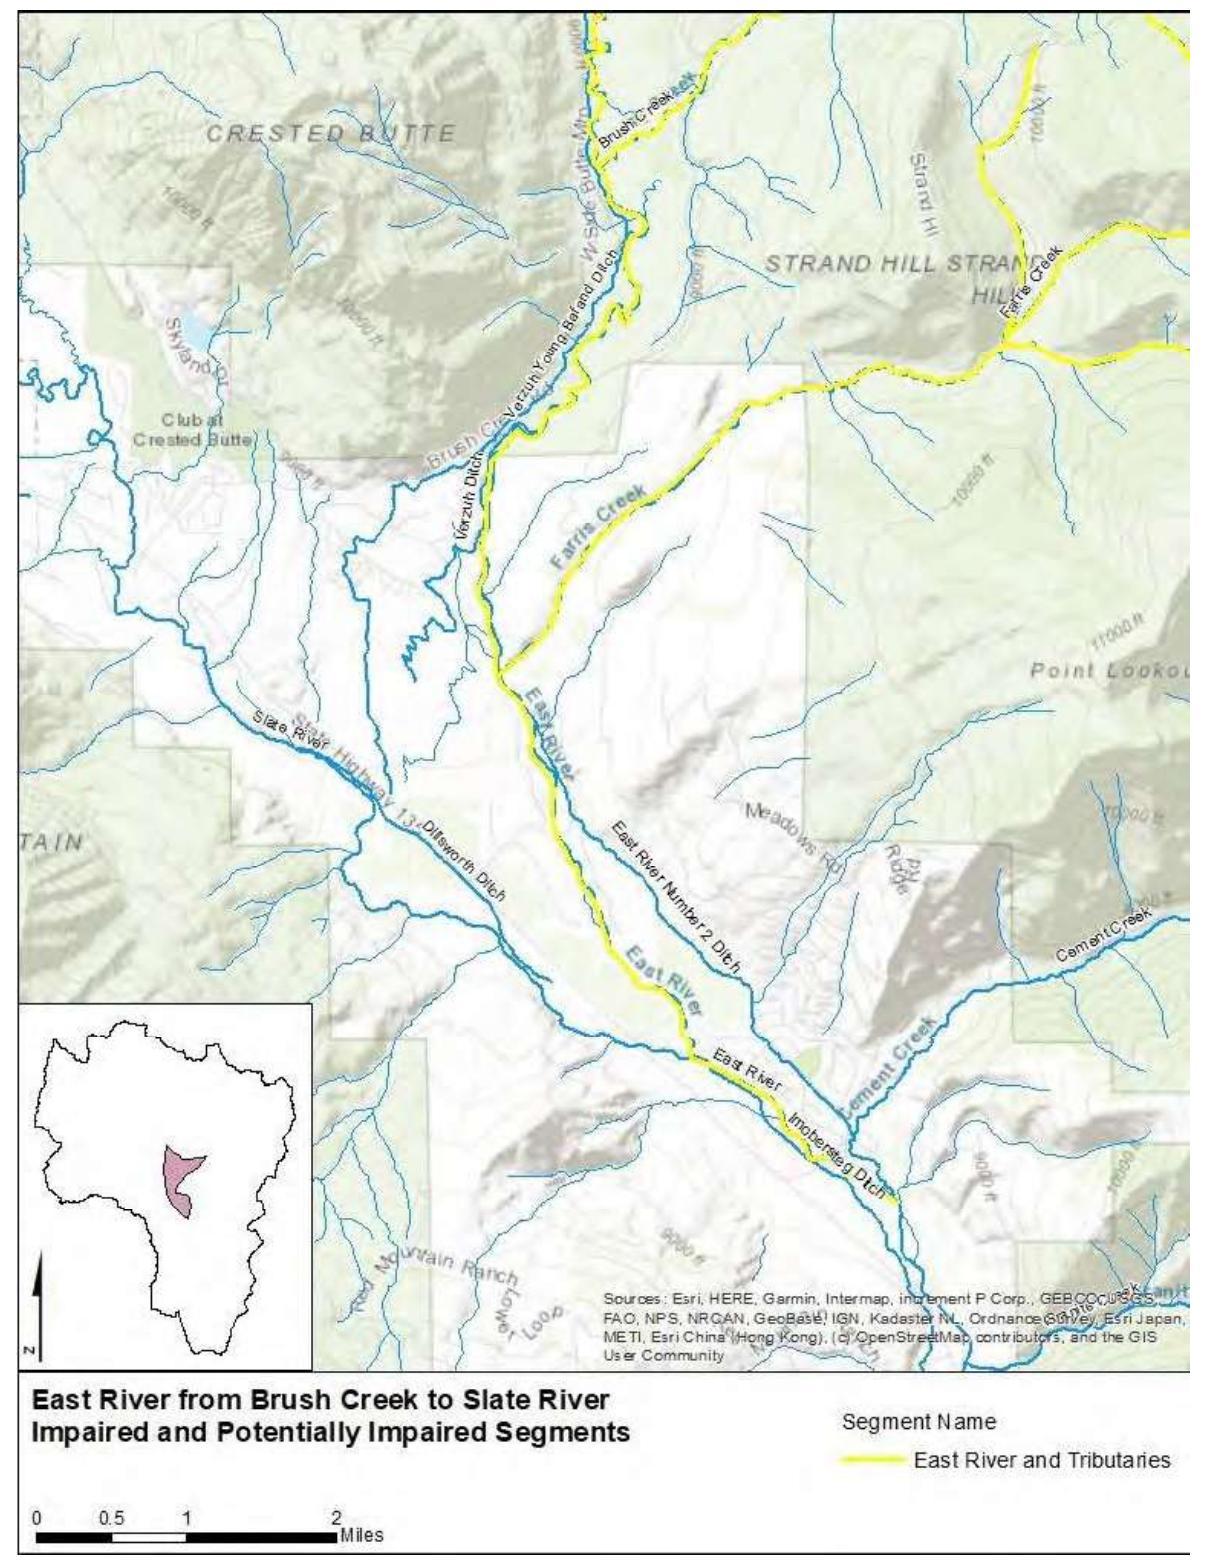
Figure 9-4: Potentially impaired stream reaches in the East River from Brush Creek to the Slate River

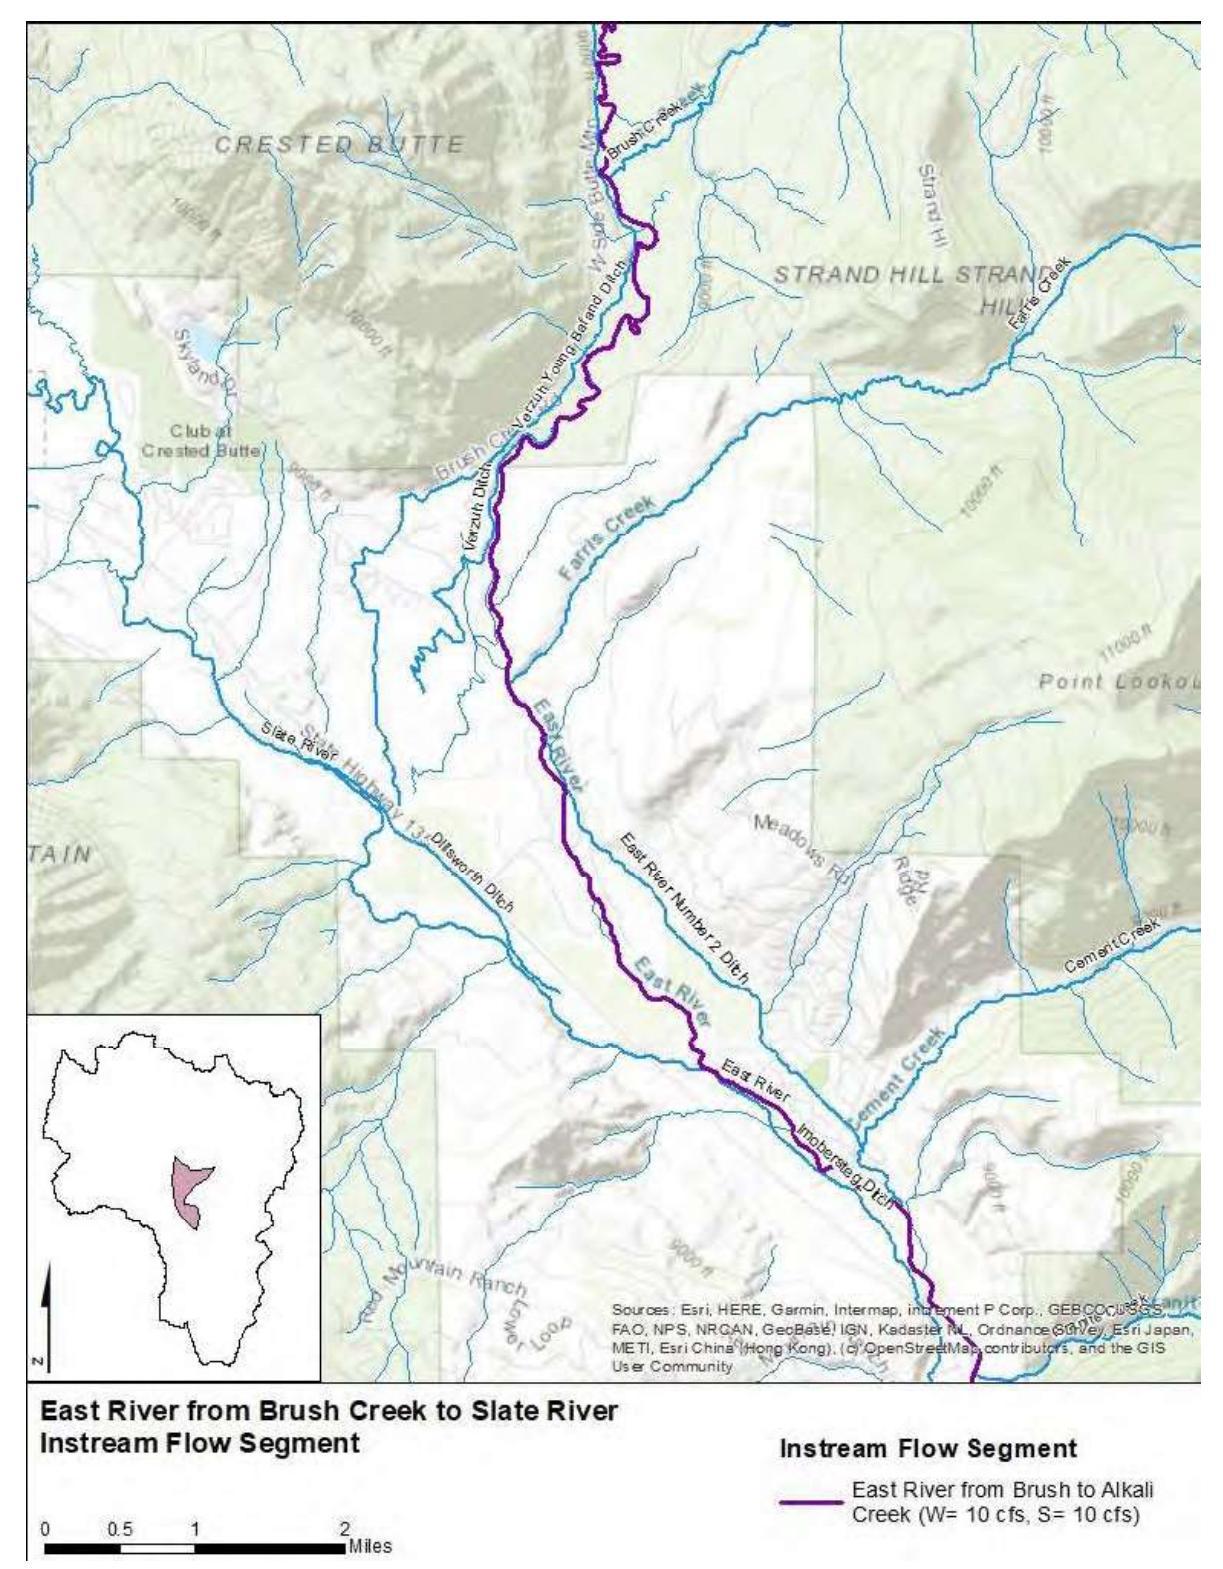
Figure 9-5: East River from Brush Creek to Alkali Creek instream flow water right

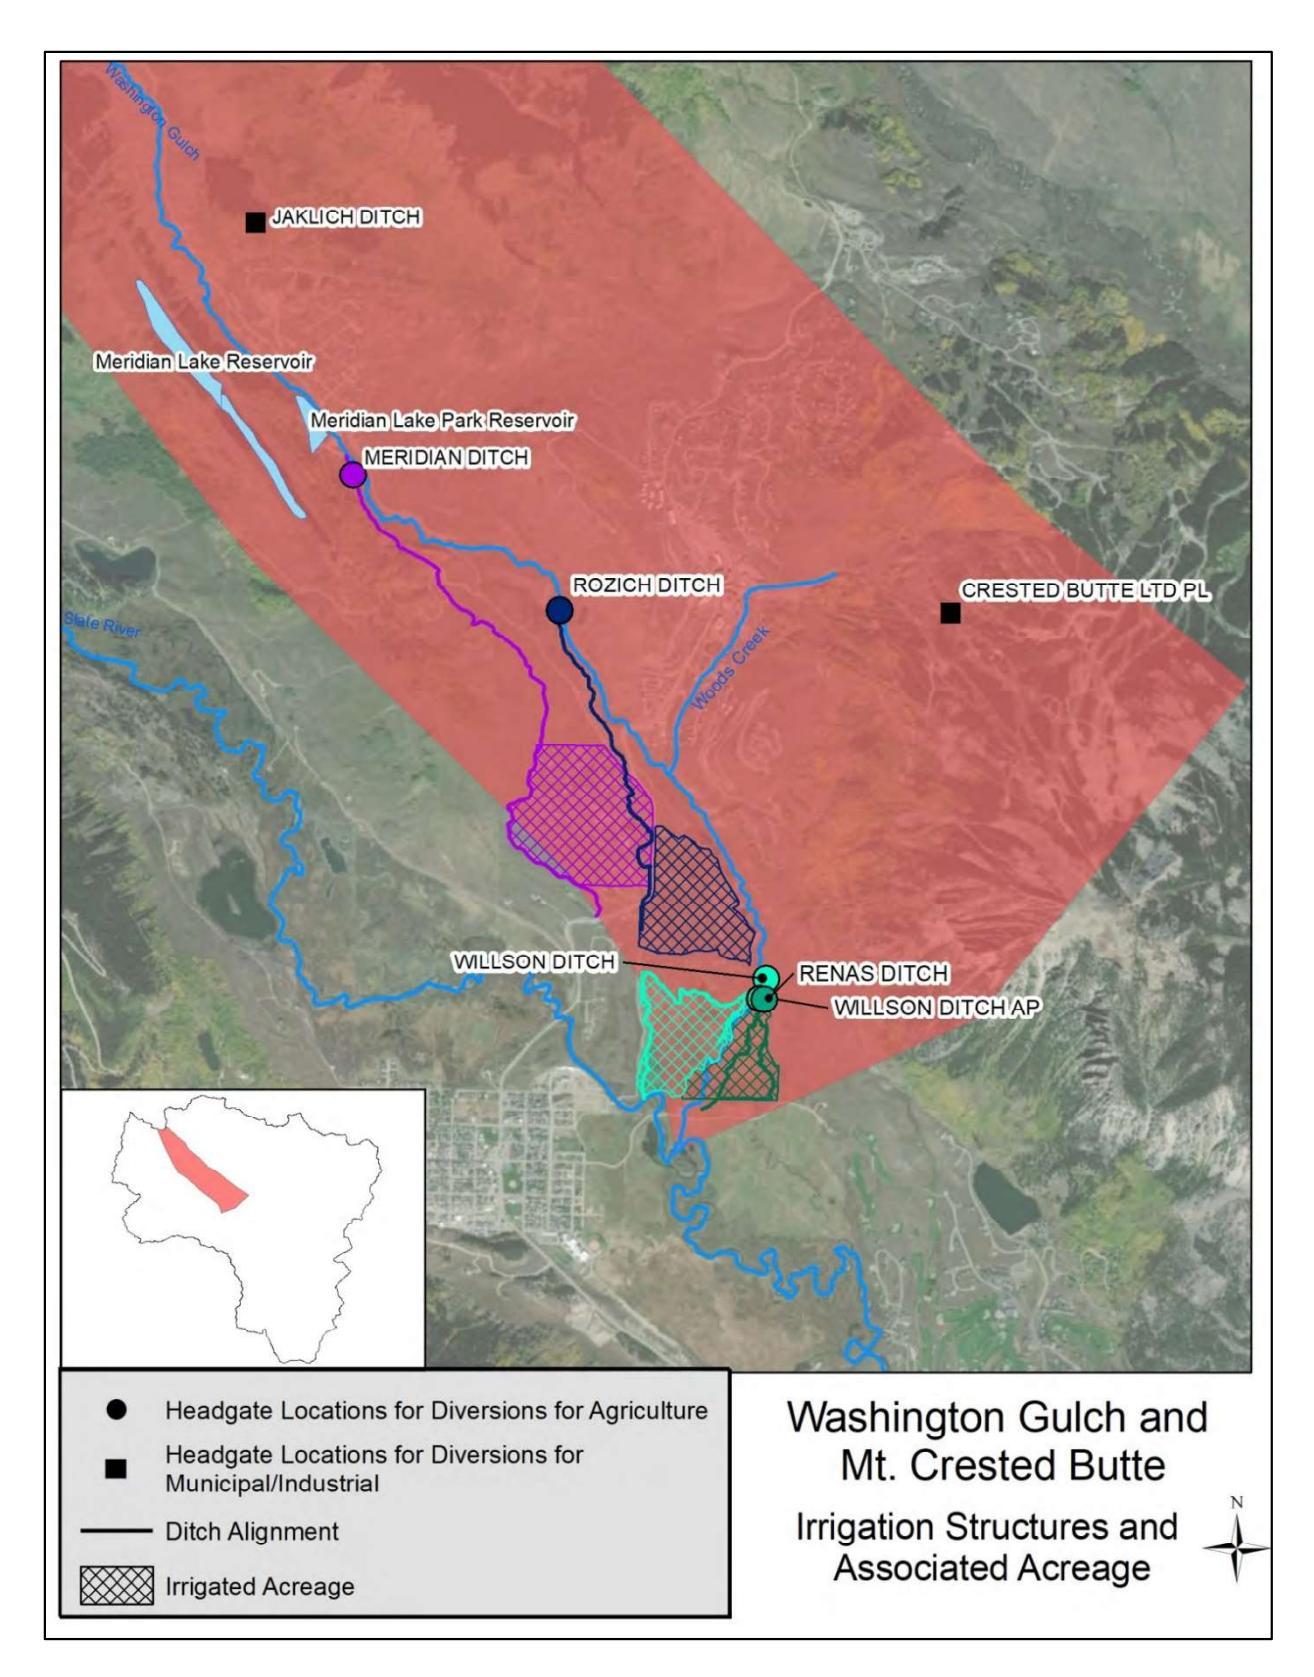
Figure 9-1: Diversion structures and acreage for Washington Gulch and Mt. Crested Butte

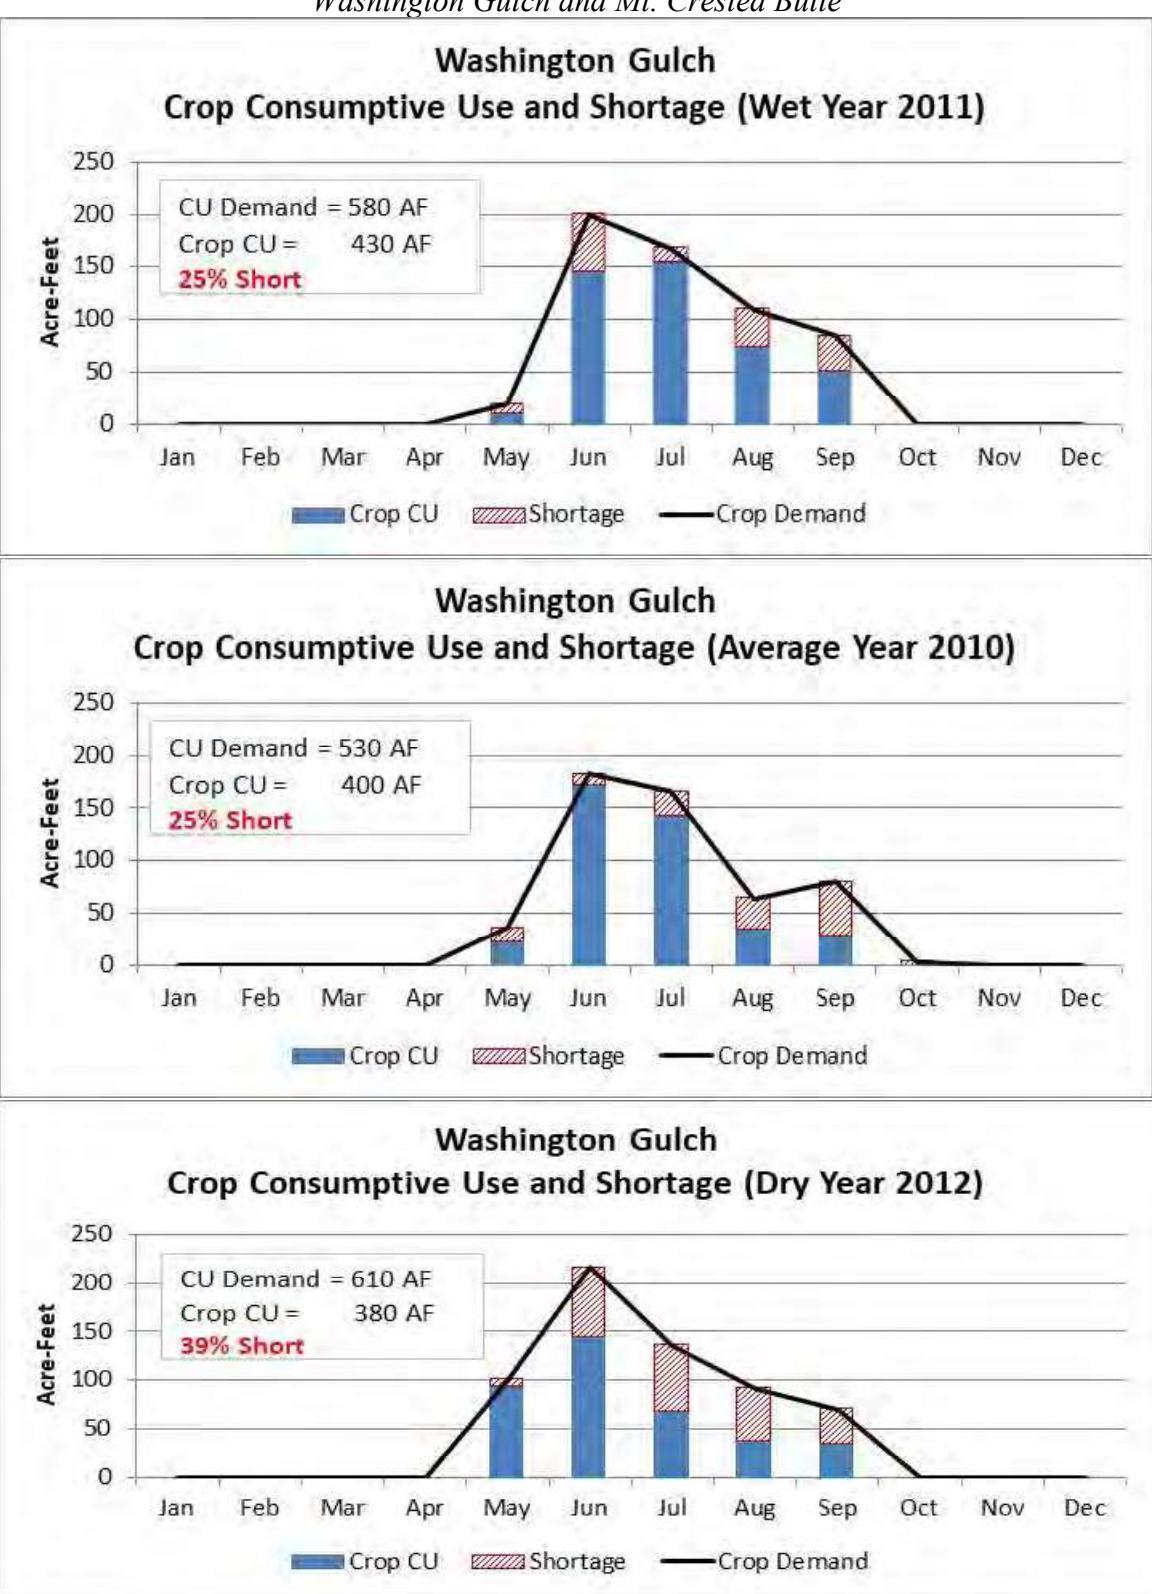
Figure 10-2: Crop consumptive use and shortage for Washington Gulch and Mt. Crested Butte
