Chapter 6 The East River Basin

Section 1. Basin Characteristics

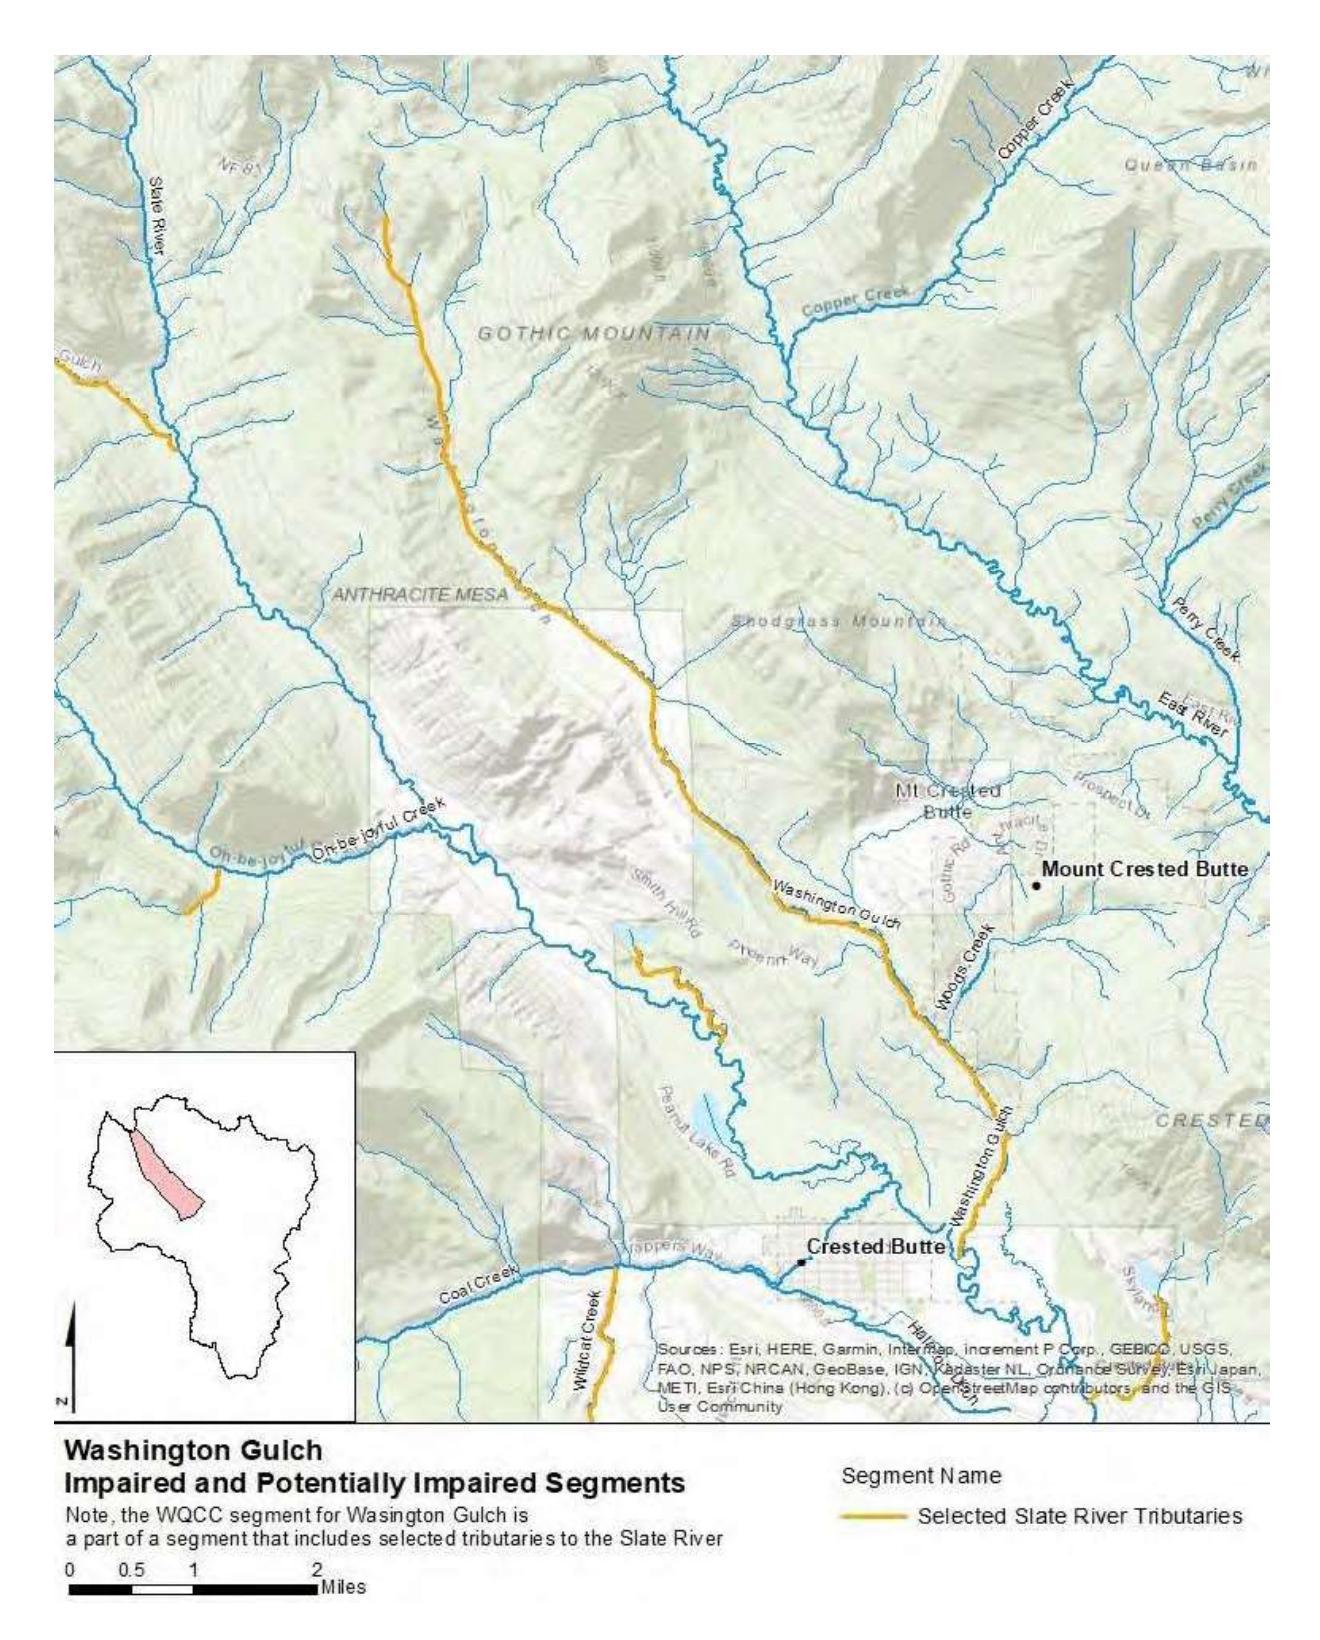
Figure 10-3: Impaired and potentially impaired stream reaches in Washington Gulch

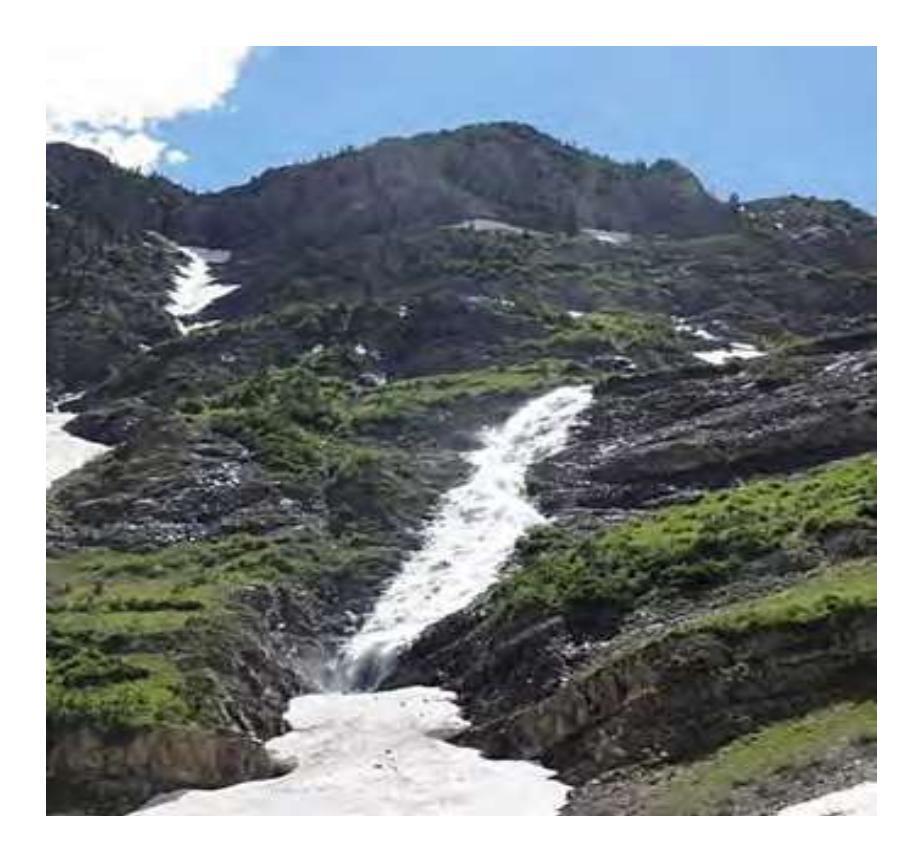
Photo 11-1: Baxter Creek (a local name for the unnamed tributary that drains Baxter Basin) upstream of the confluence with Poverty Gulch in July 2011. The extremely steep slopes and loose bedrock naturally deliver sediment to the valley floor.

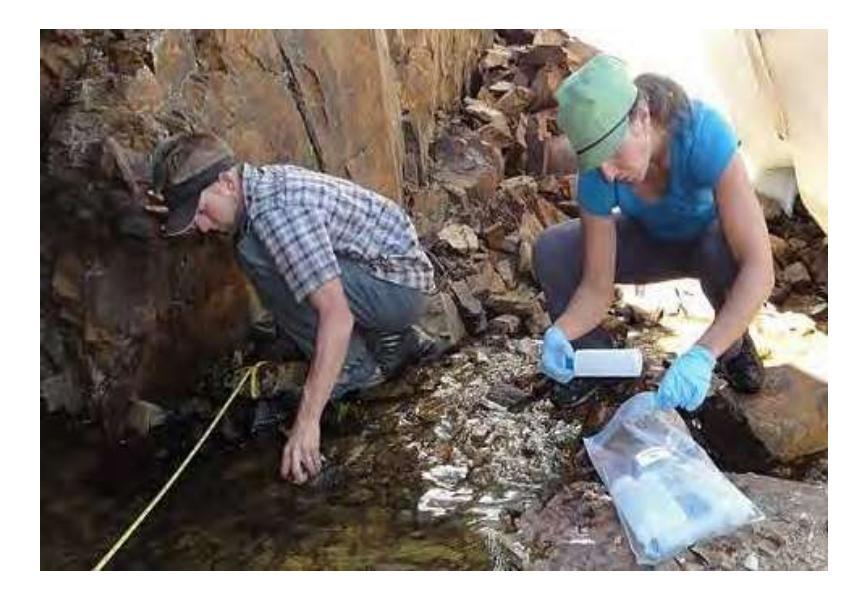
Photo 11-2: Staff from DRMS and a CCWC intern prepare to collect a water quality sample from the Augusta Mine portal in July 2011 as part of a collaborative watershed-wide sampling event to address data gaps.

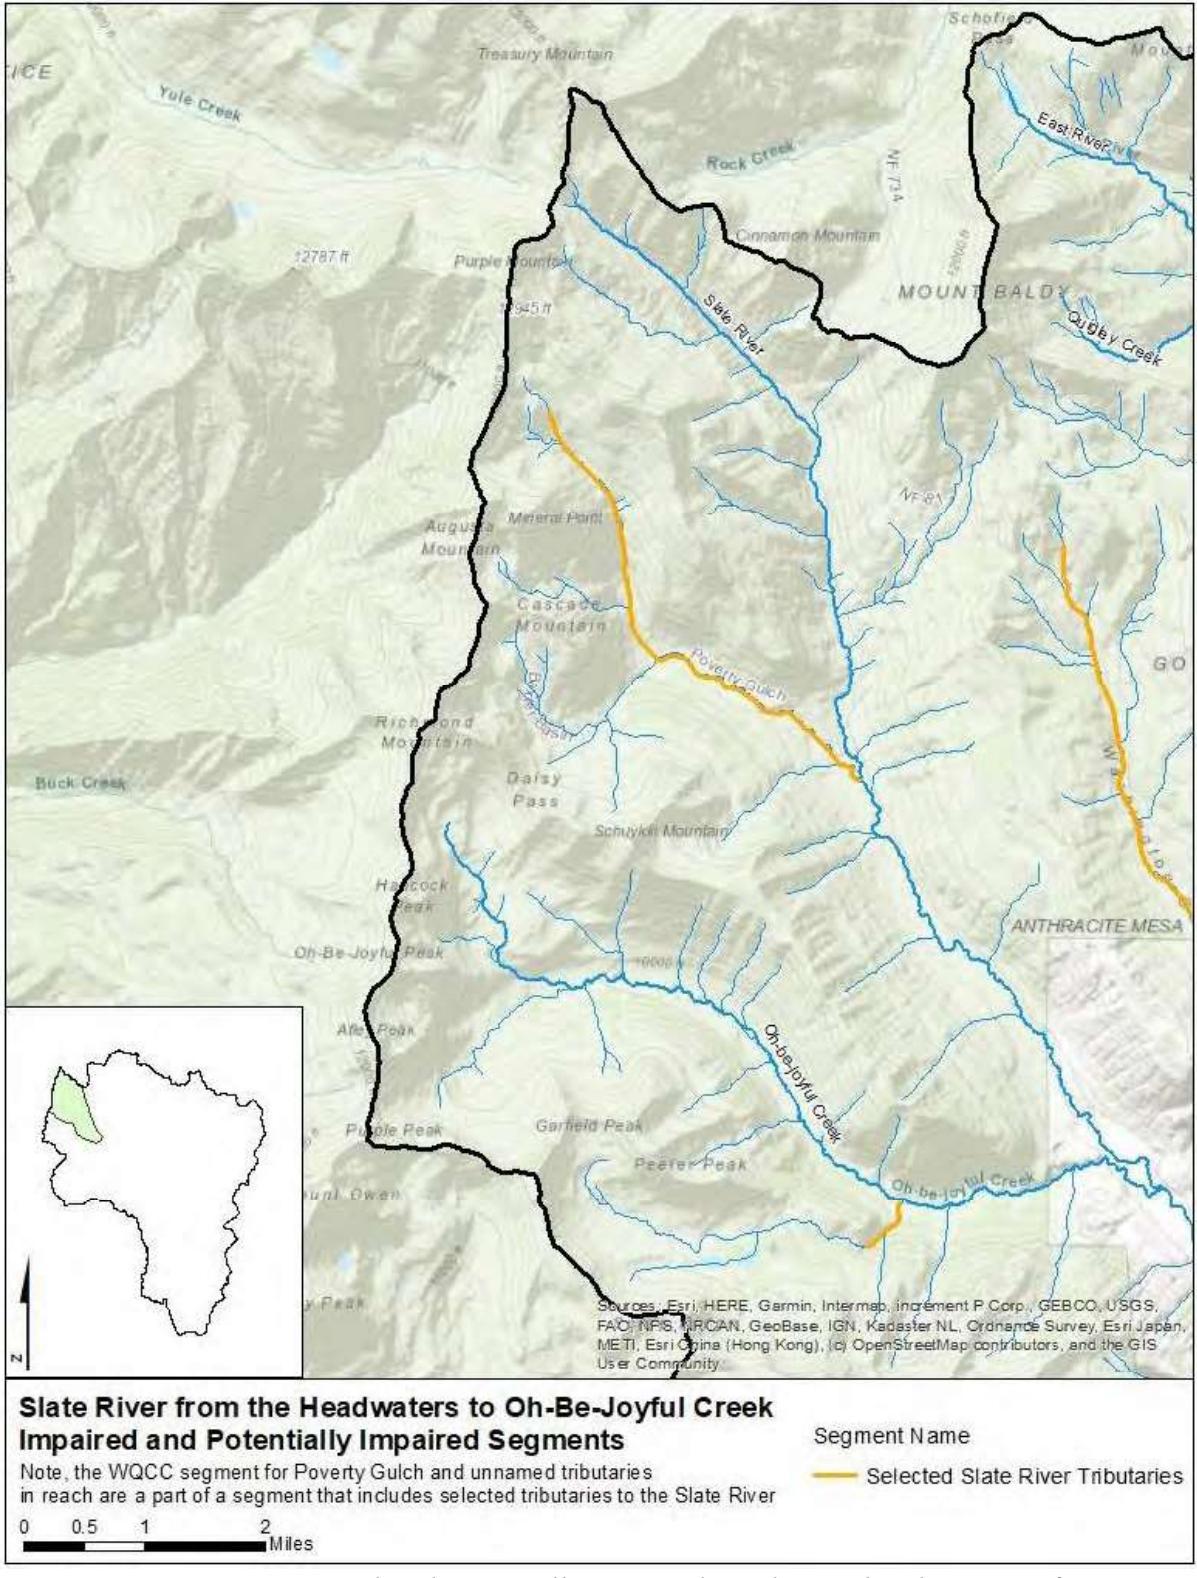
Figure 10-1: Impaired and potentially impaired reaches in the Slate River from its headwaters to the confluence with Oh-Be-Joyful Creek

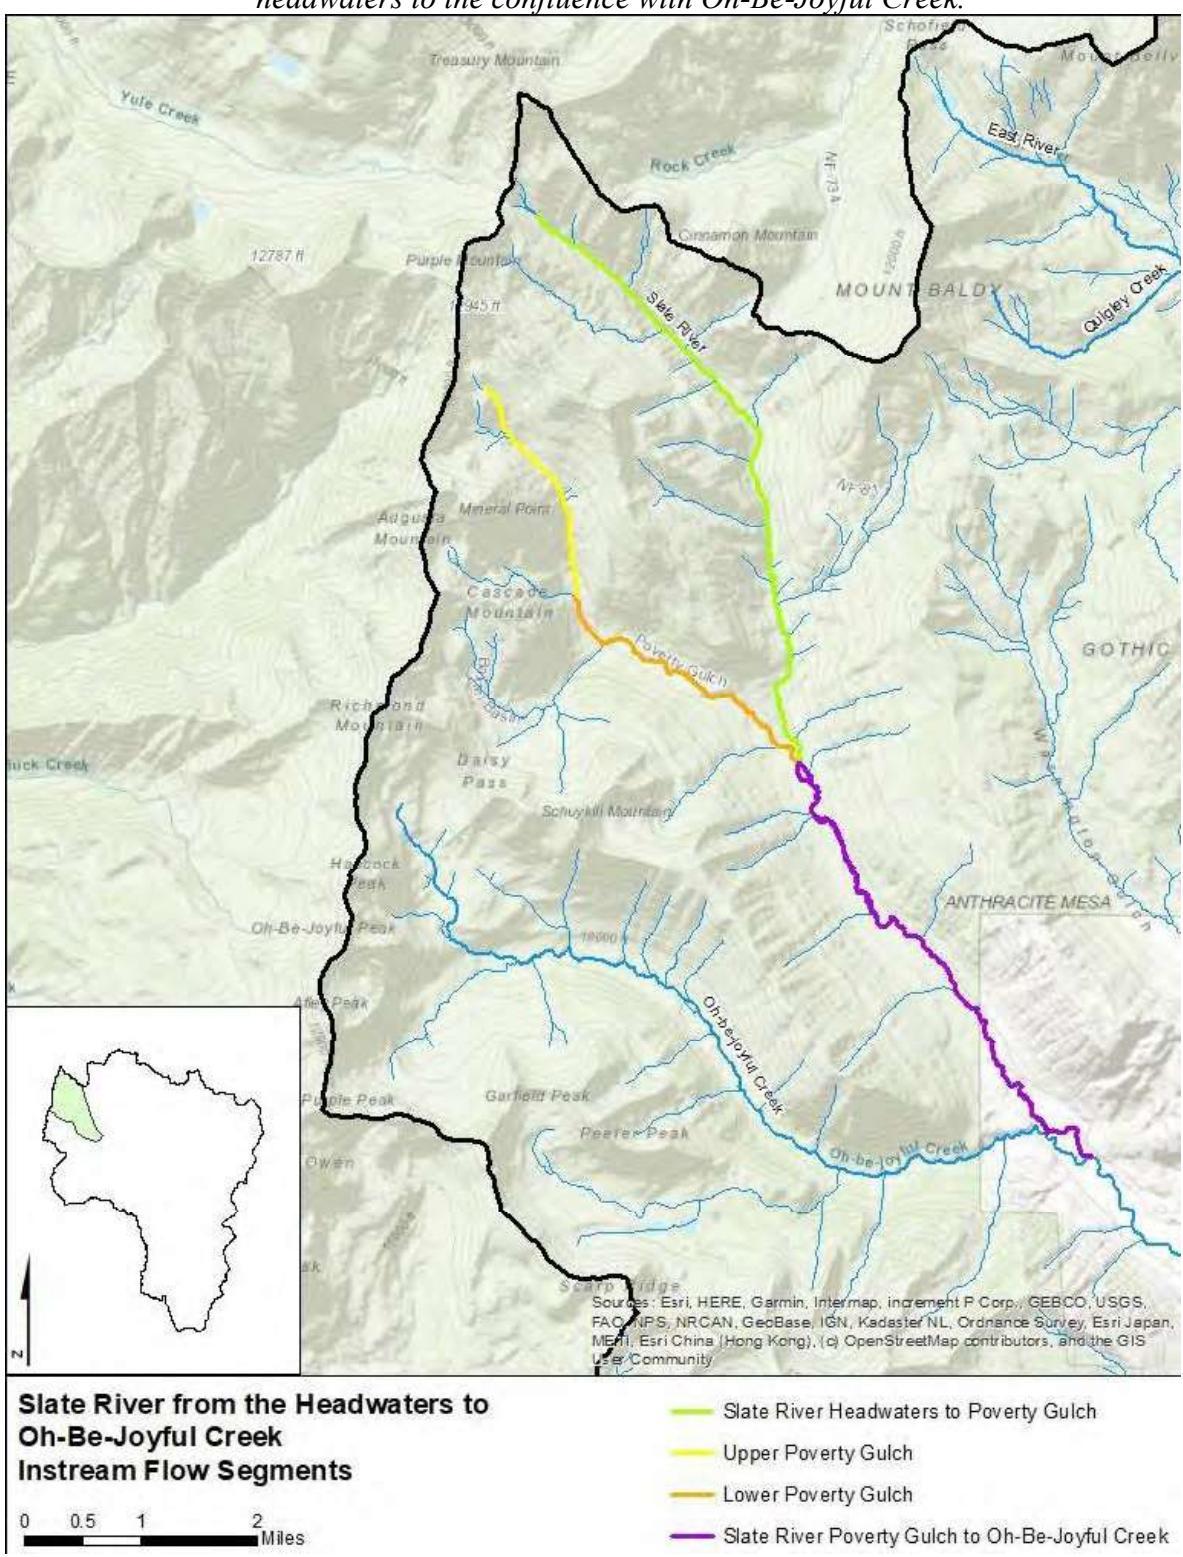
Figure 11-2: Existing instream flow water rights on the Slate River from its headwaters to the confluence with Oh-Be-Joyful Creek.

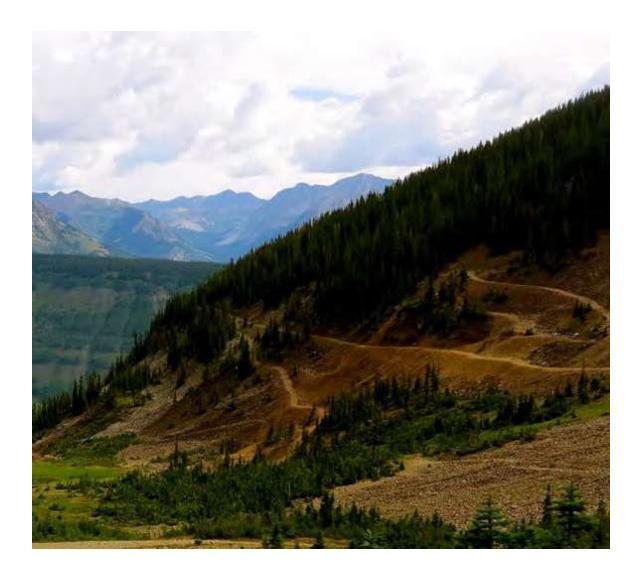
Photo 12-1: The Daisy Mine Complex and Gunsight Pass Road in Redwell Basin, a tributary to Oh-Be-Joyful Creek

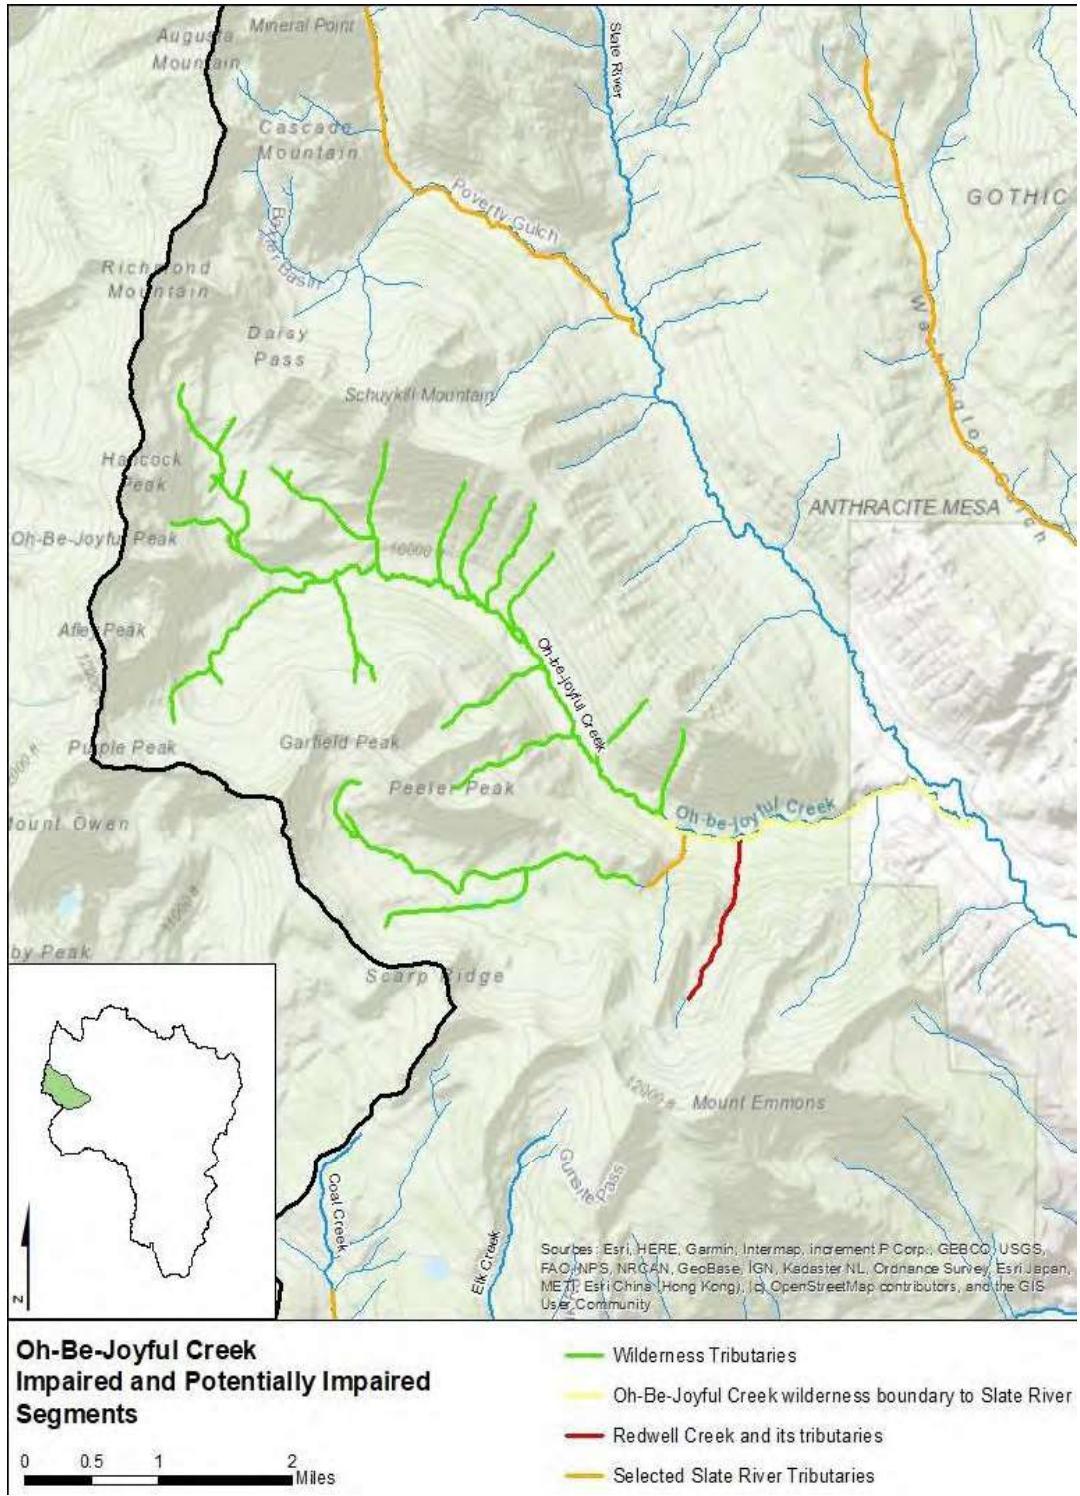
Figure 12-2: Impaired and potentially impaired stream reaches and tributaries in Oh-Be-Joyful Creek

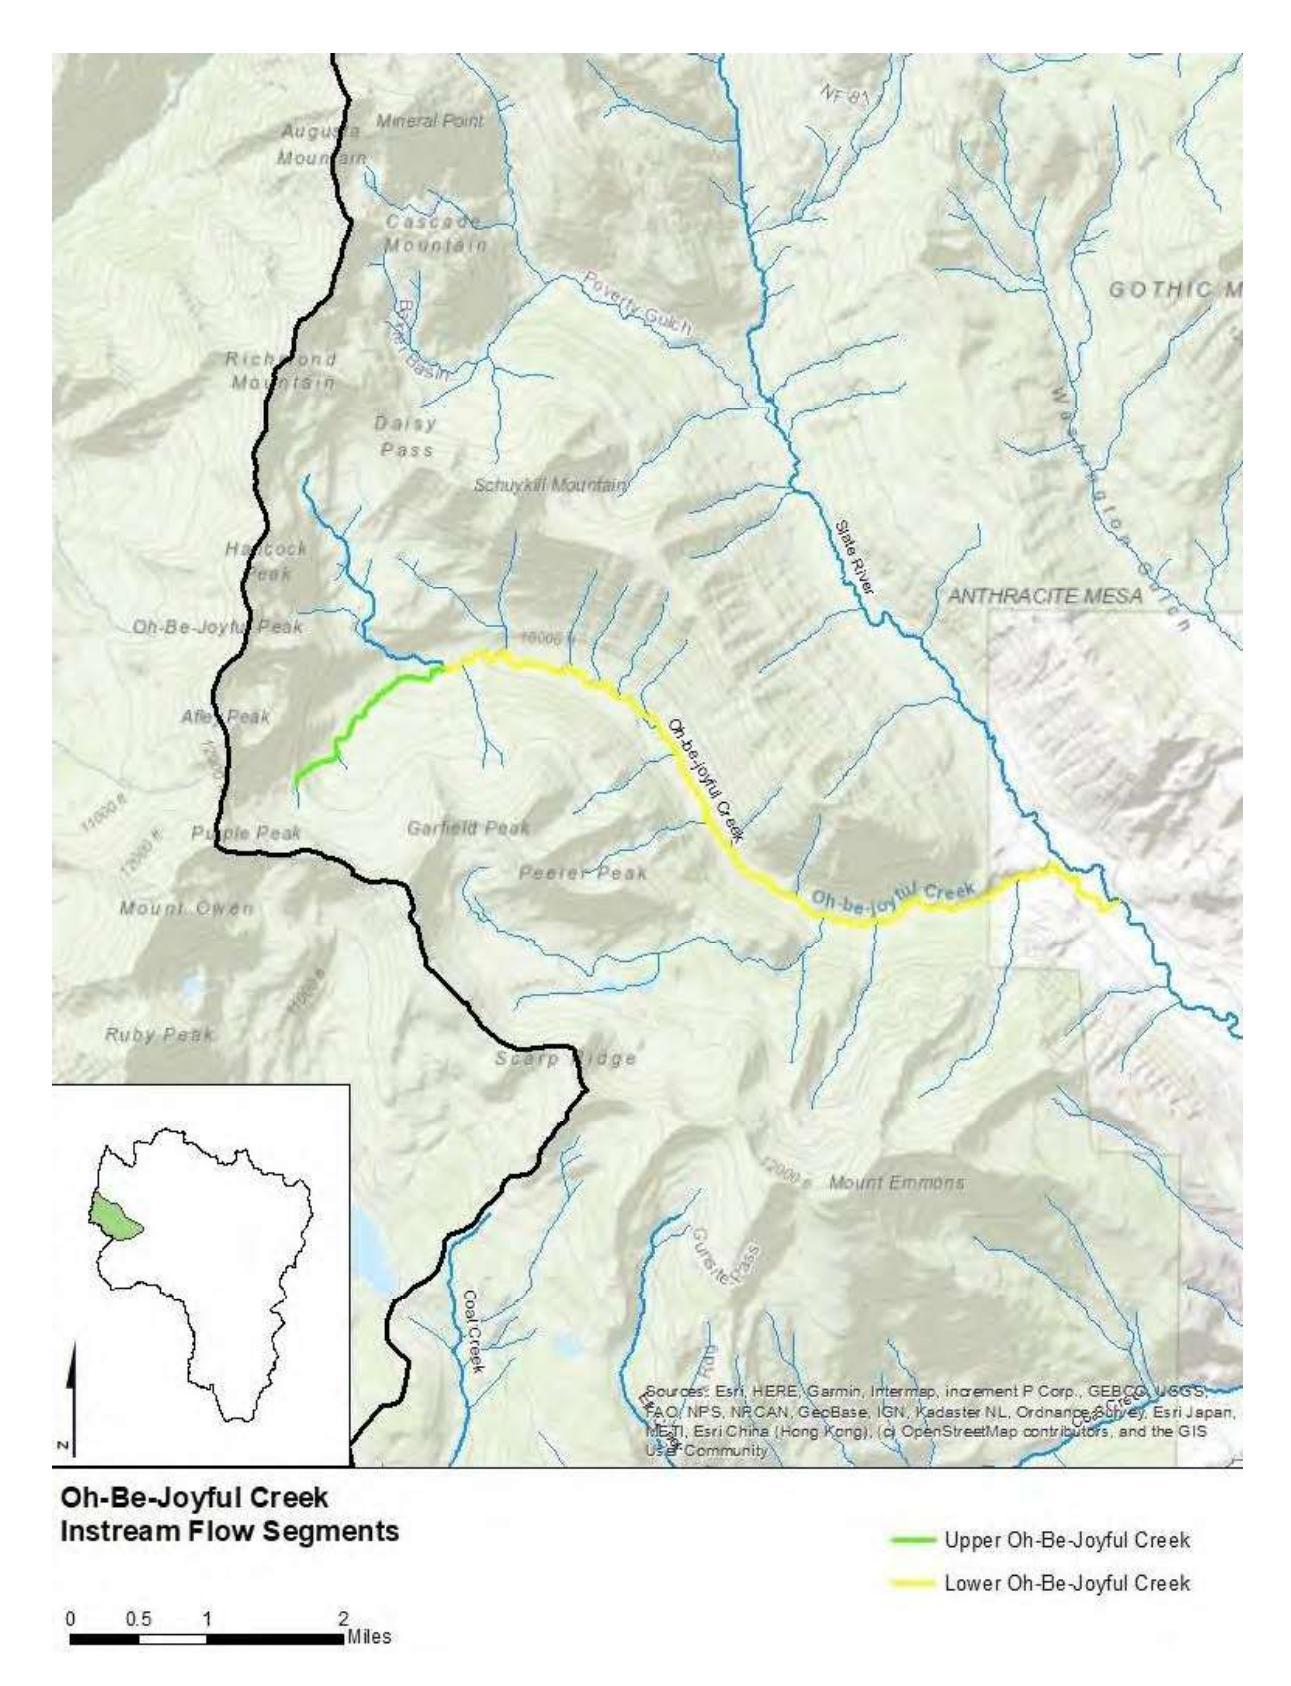
Figure 12-3: Instream flow water rights in Oh-Be-Joyful Creek

The headwaters from the outlet of Blue Lake to the confluence with Oh-Be-Joyful Creek have a year-round instream flow rate of 1 cfs.

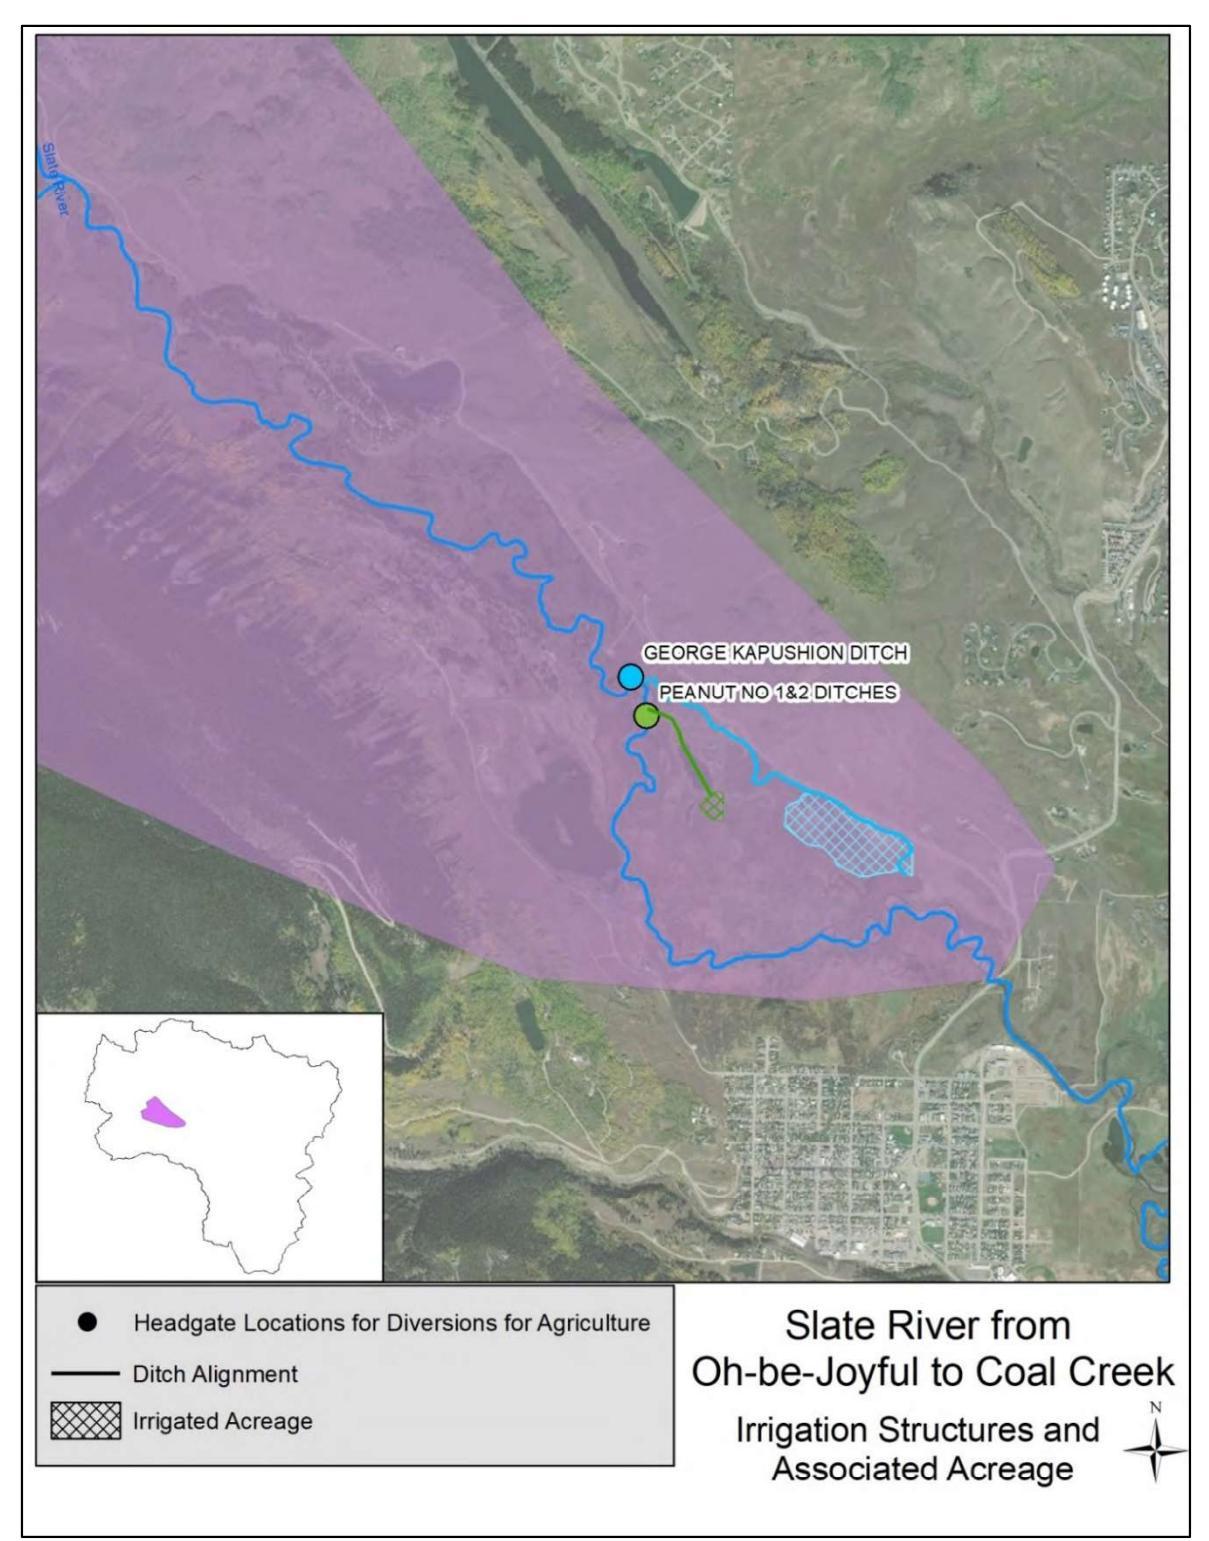
Figure 12-1: Diversion structures and irrigated acreage in the Slate River from Oh-Be-Joyful Creek to Coal Creek reach

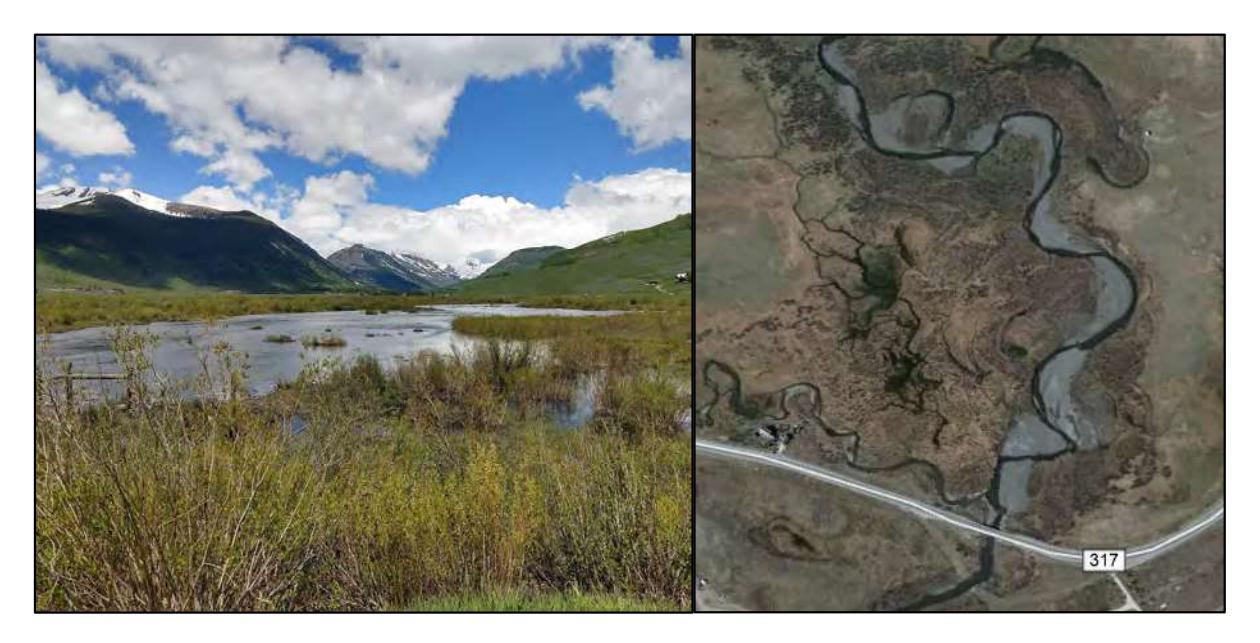
The photo on the left shows the Slate River immediately upstream of County Road 317 during peak flow. Note the pooled water flooding into the wetlands. The loss of velocity contributes to the massive gravel bars visible in the aerial imagery in the right image (image courtesy of Google Earth). The depositional area attributed to the bridge extends approximately half a mile upstream. These gravel bars may contribute to stability issues up and downstream of the bridge.

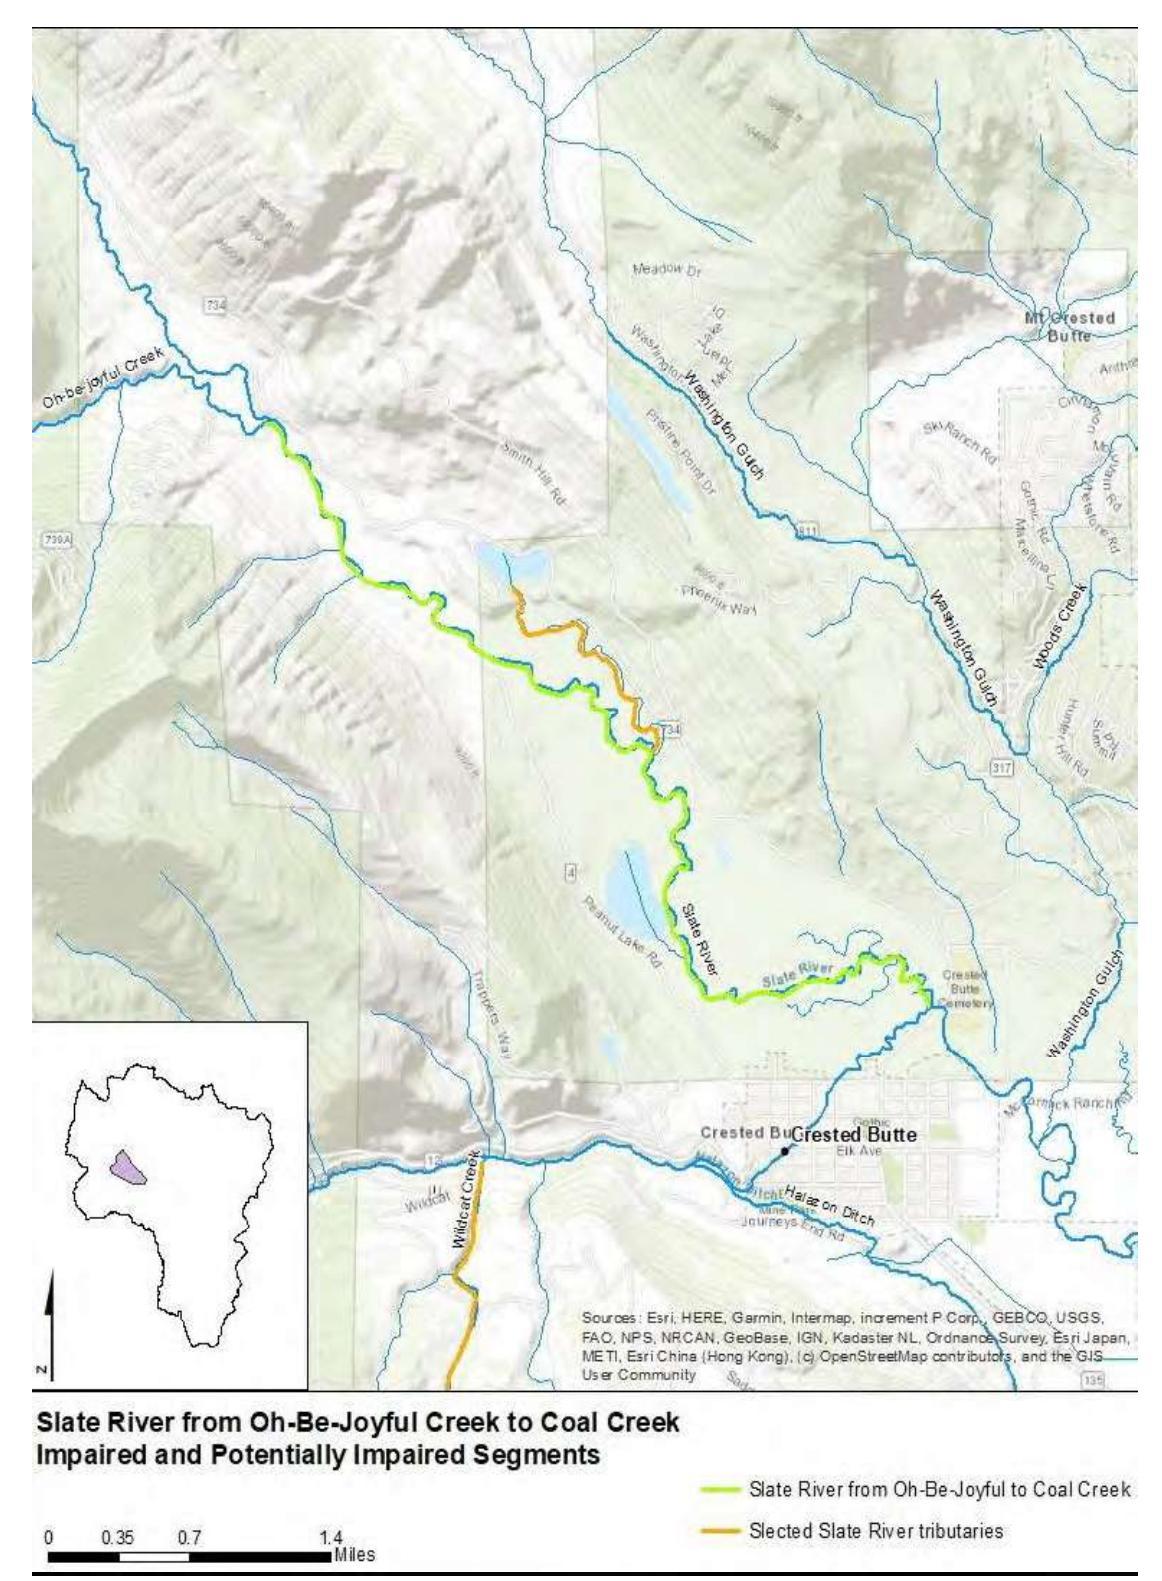
Figure 13-3: Impaired and potentially impaired stream reaches on the Slate River from Oh-Be-Joyful Creek to Coal Creek
13.3.4 Water Temperature

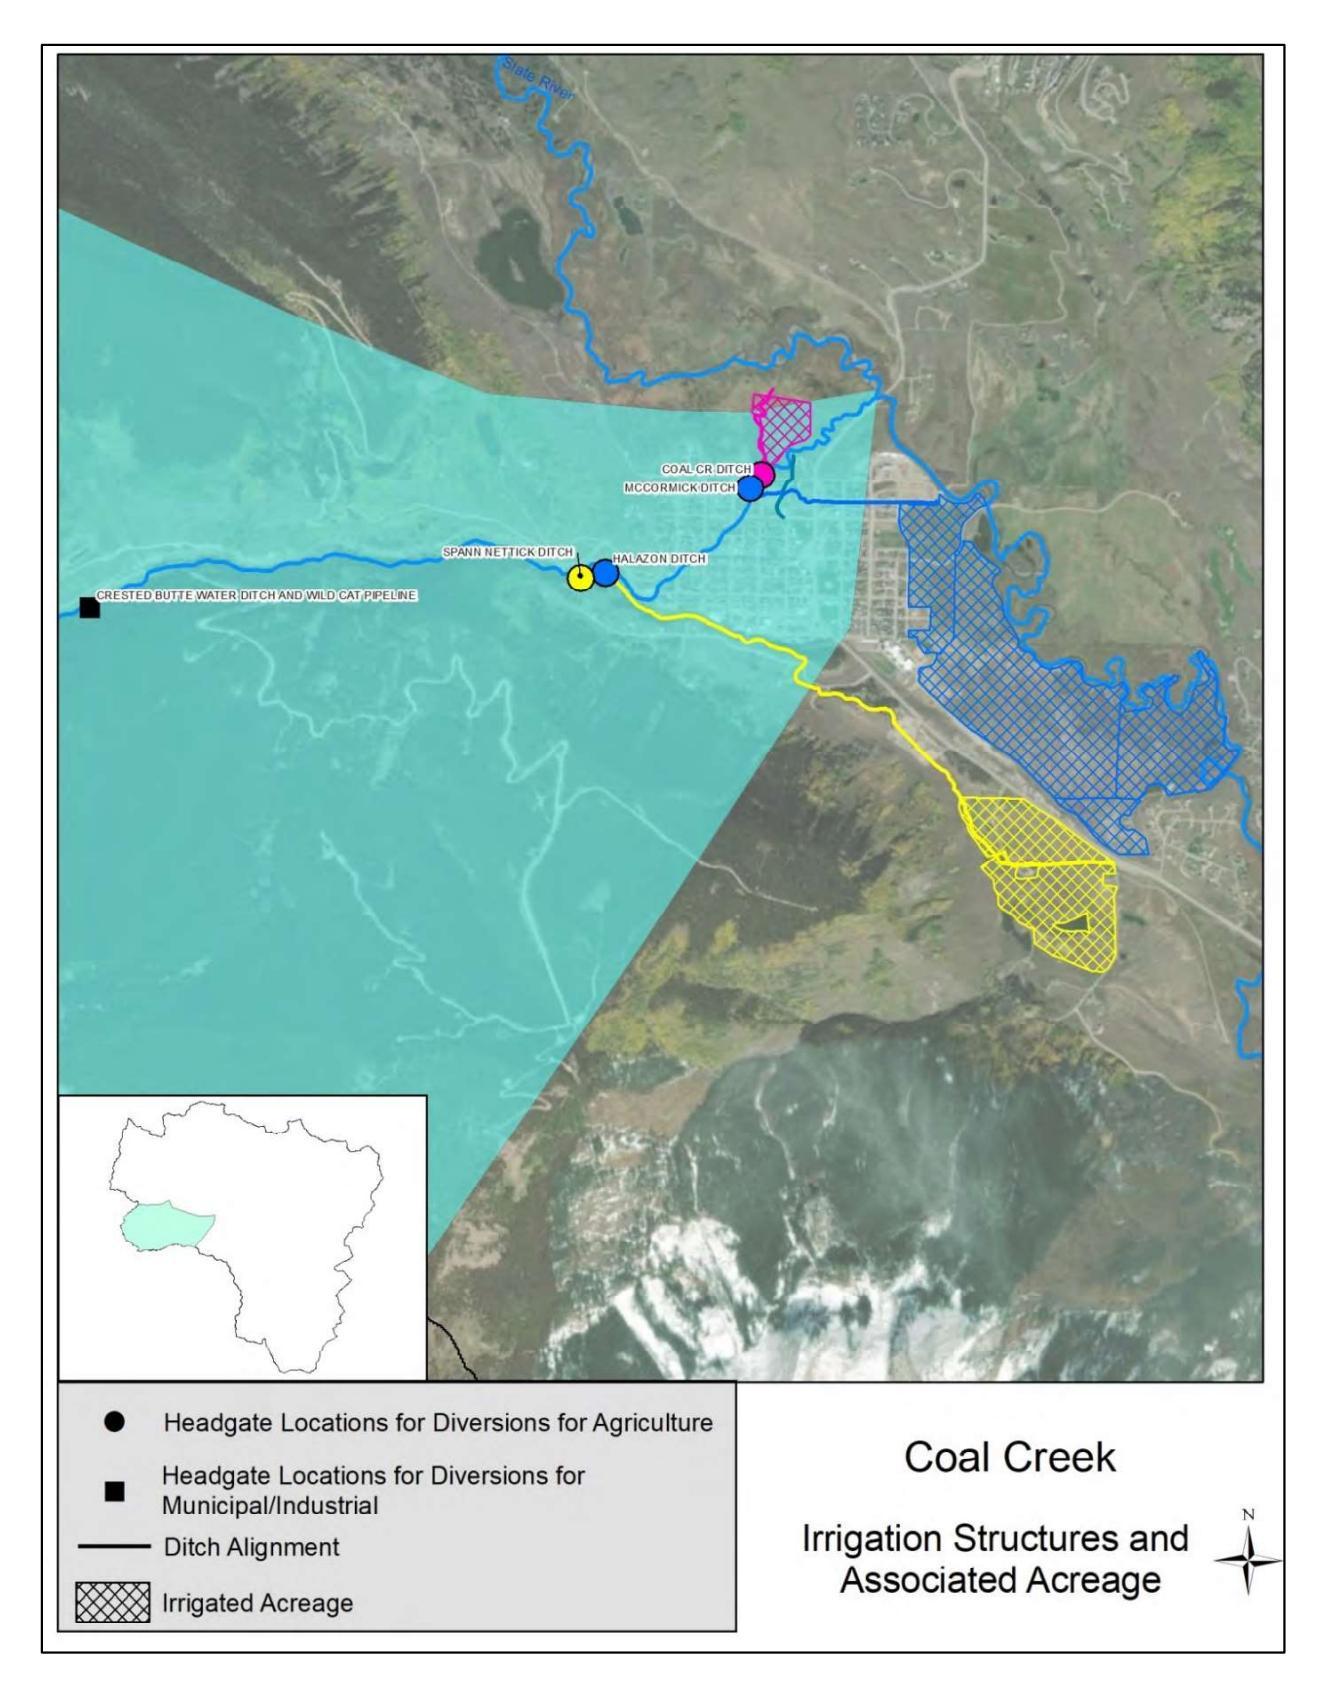
Figure 13-1: Diversion structures and irrigated acreage in the Coal Creek reach

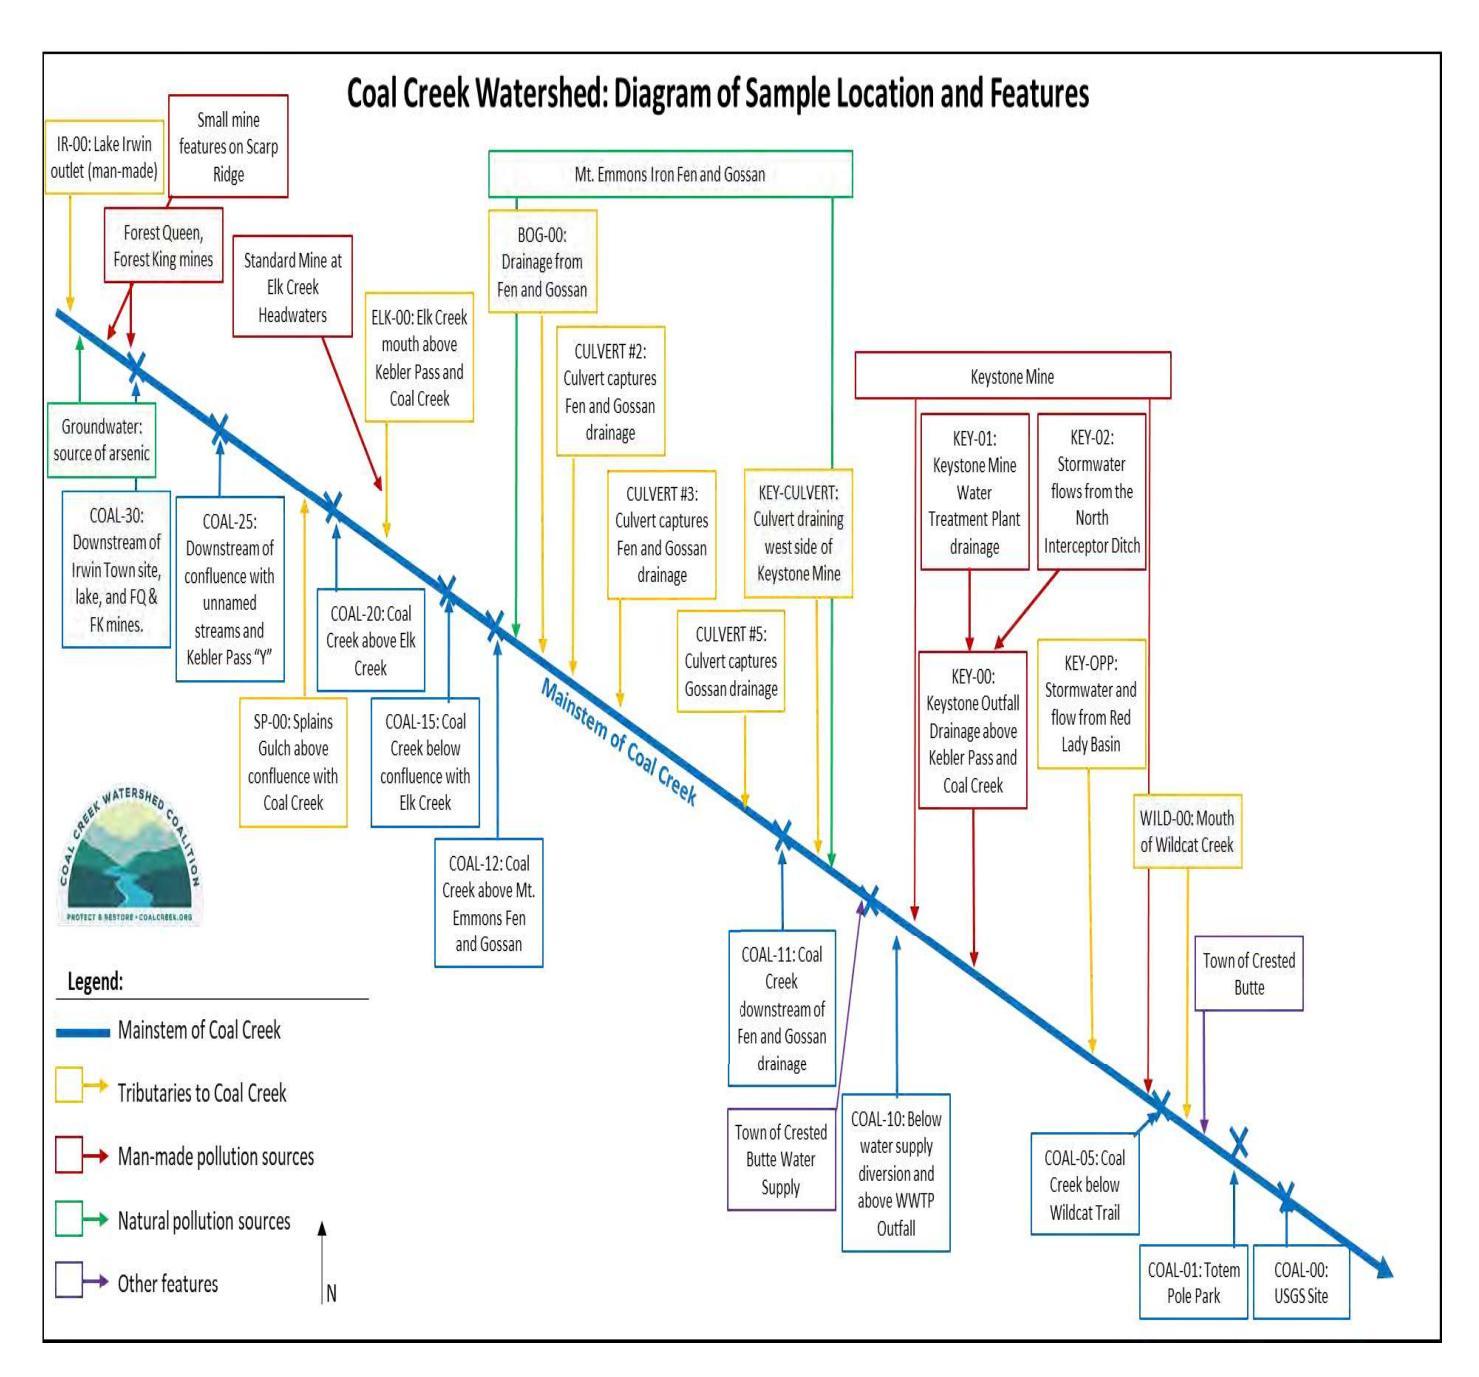
Figure 14-4: Major natural and man-made features in the Coal Creek Watershed. Courtesy of the Coal Creek Watershed Coalition.

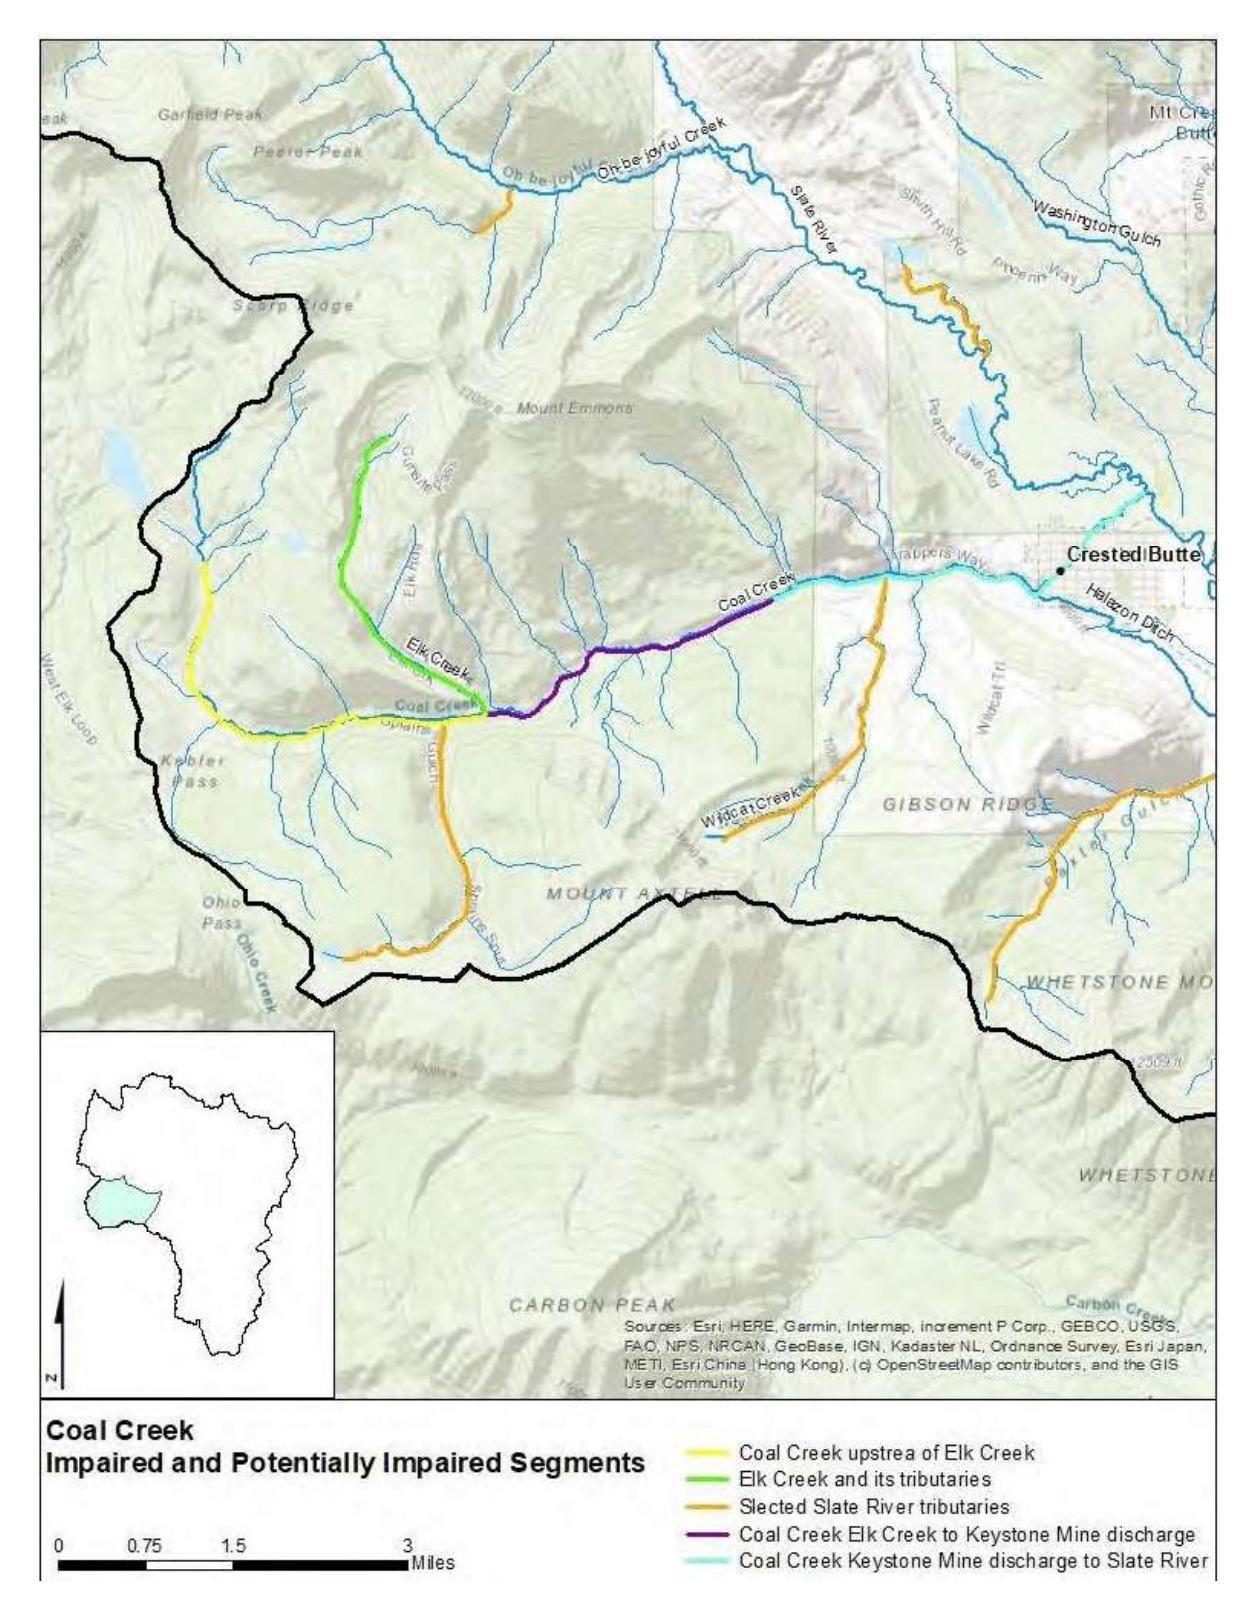
Figure 14-5: Impaired and potentially impaired stream reaches in Coal Creek
