Chapter 6 The East River Basin

Section 1. Basin Characteristics

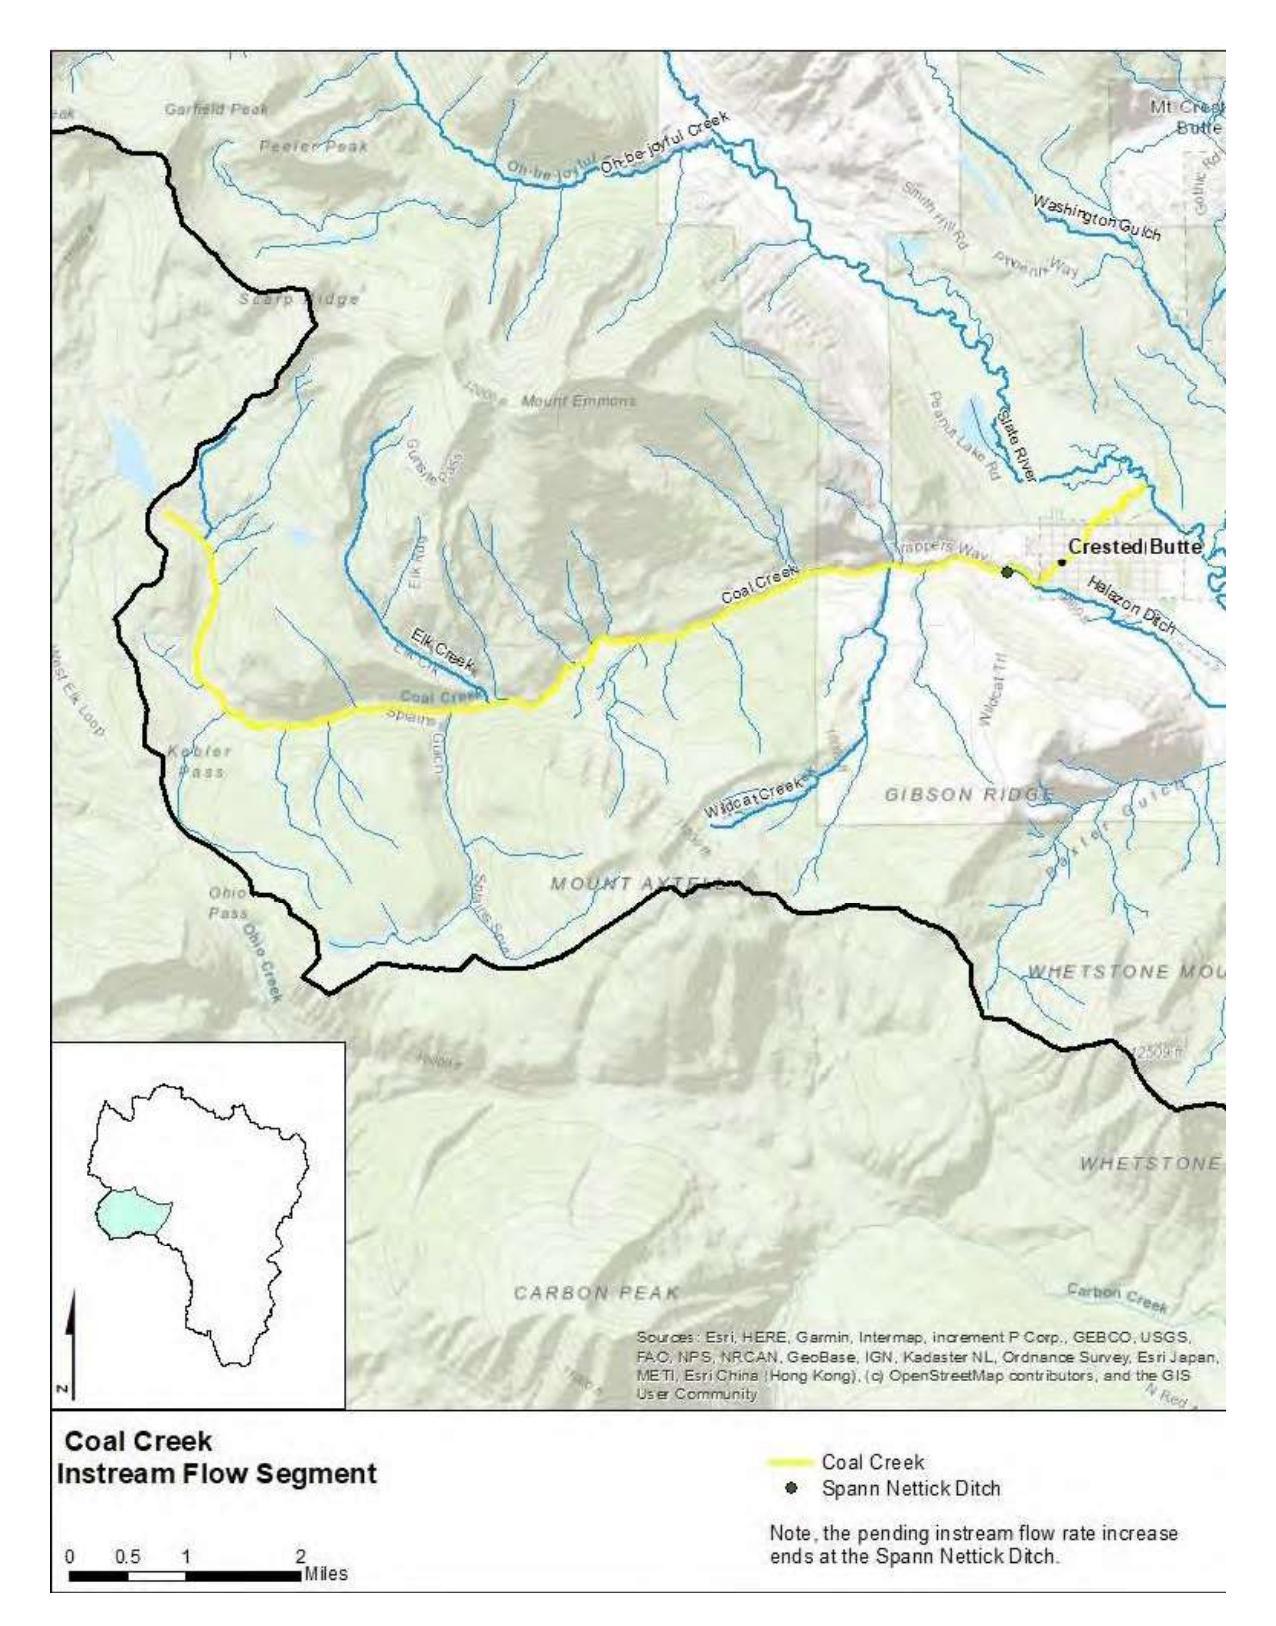
Figure 14-6: Instream flow water rights in the Coal Creek Reach

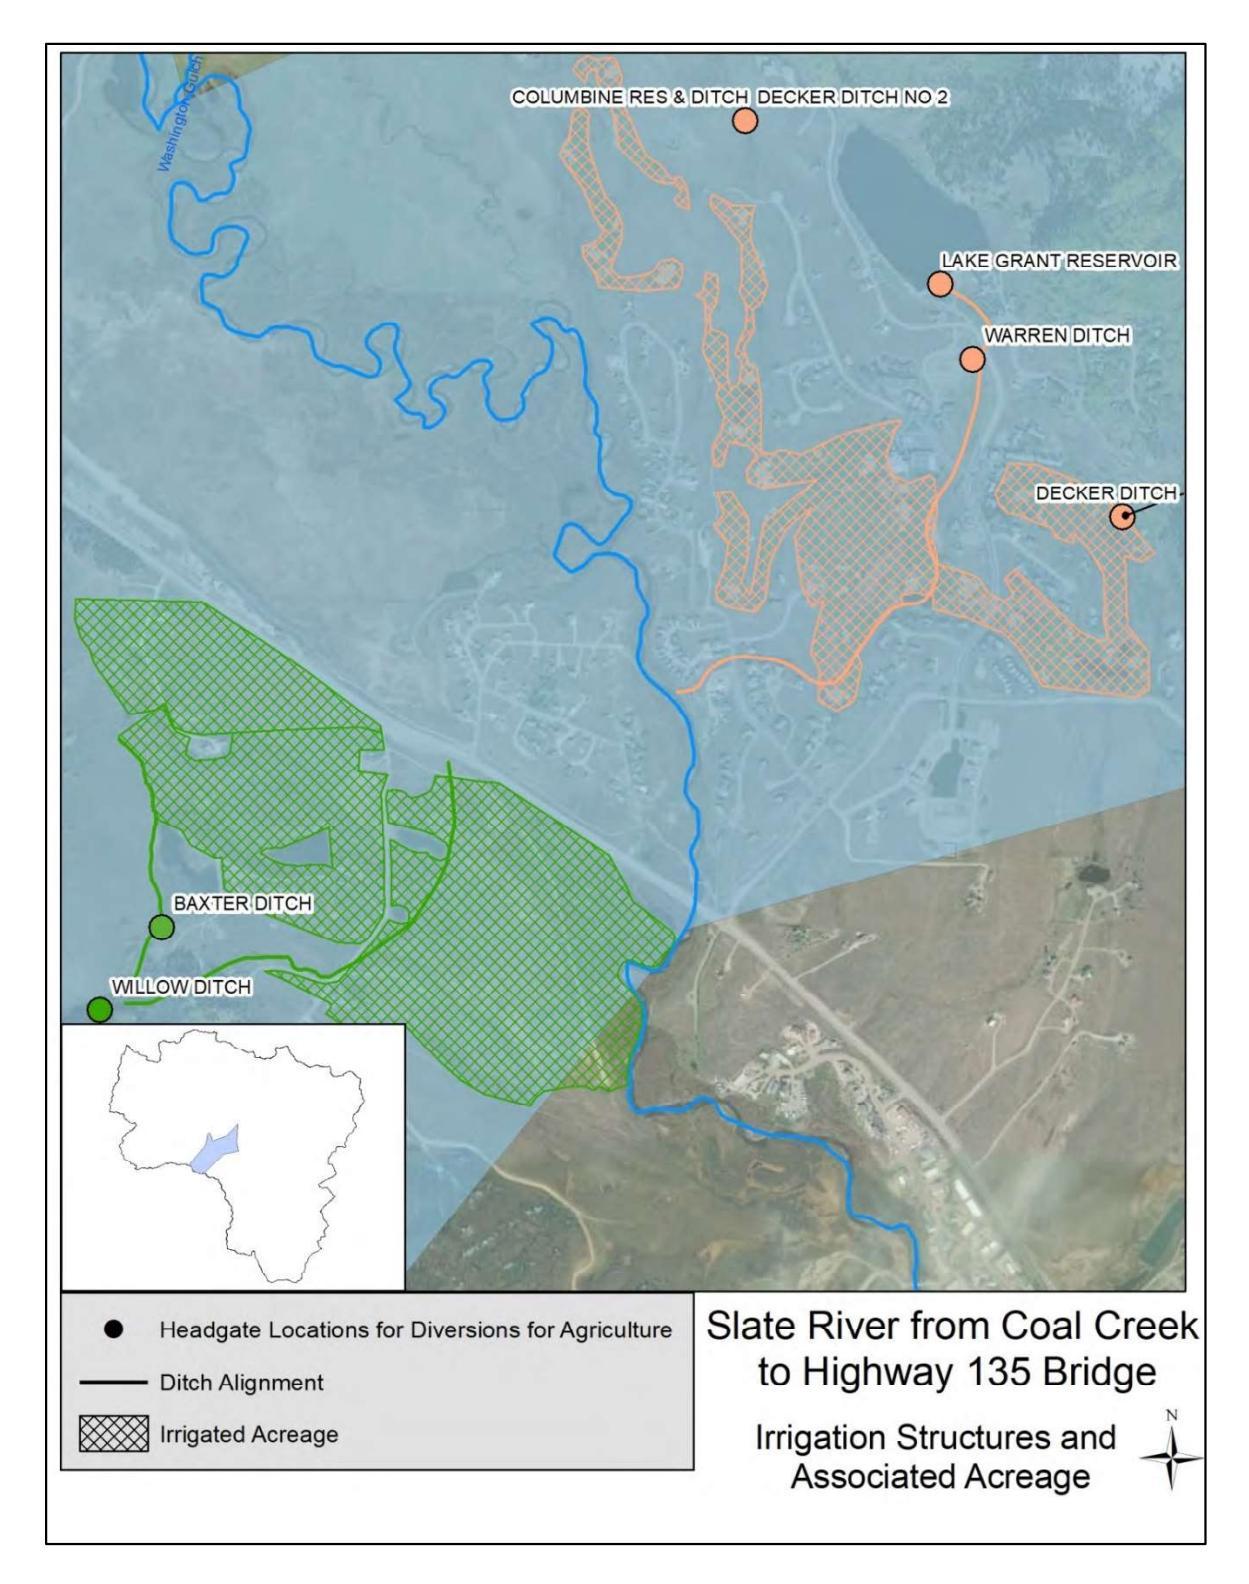
Figure 14-1: Diversion structures and acreage on the Slate River from Coal Creek to the Highway 135 Bridge. All diversions on this reach are located on tributaries
Figure 15-2 shows the monthly crop demands, consumptive use, and associated shortages for three recent years, chosen to highlight hydrologic variability between a wet year (2011), a dry year (2012), and a relatively average year (2010). Both the Baxter Ditch and Willow Ditch divert off a smaller tributary to the Slate River and are limited by physical supply in average and dry years. The northern field receives a full supply more often, in part because of diversions delivered from Coal Creek through the Spann Nettick Ditch.

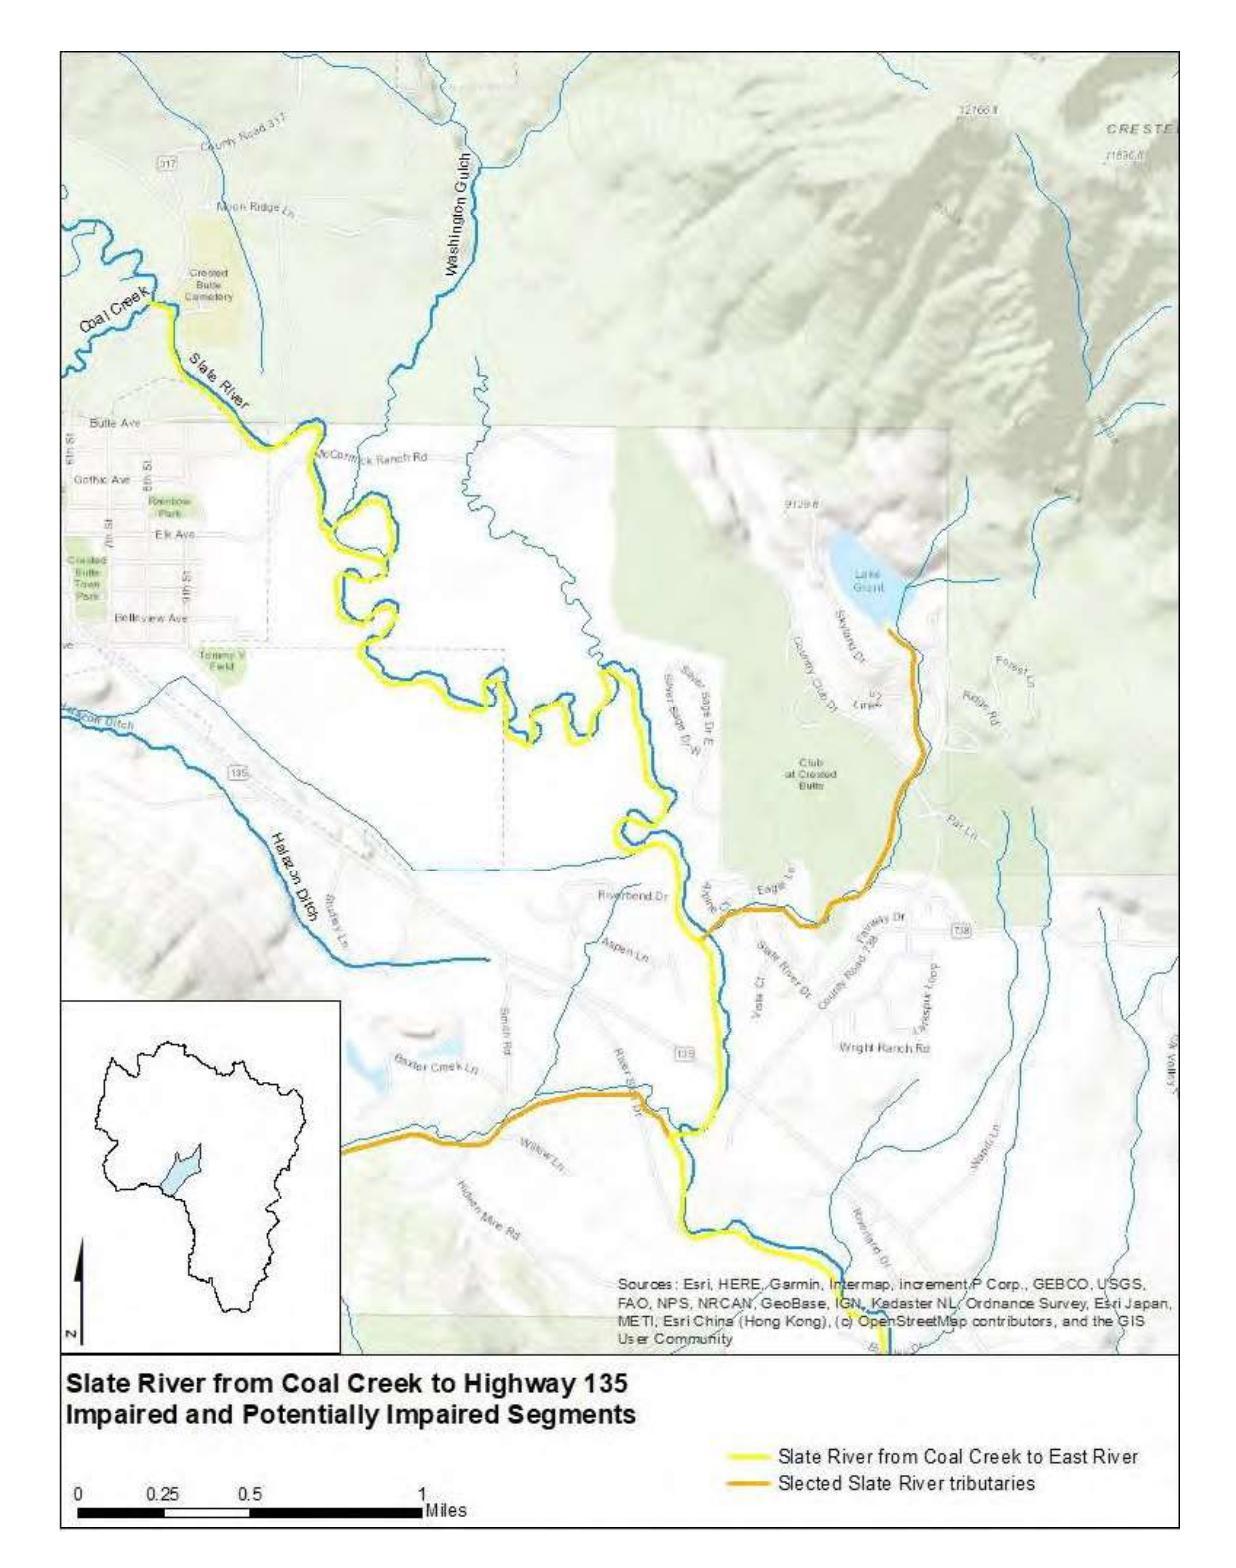
Figure 15-3: Impaired and potentially impaired stream segments in the Slate River from Coal Creek to the Highway 135 Bridge

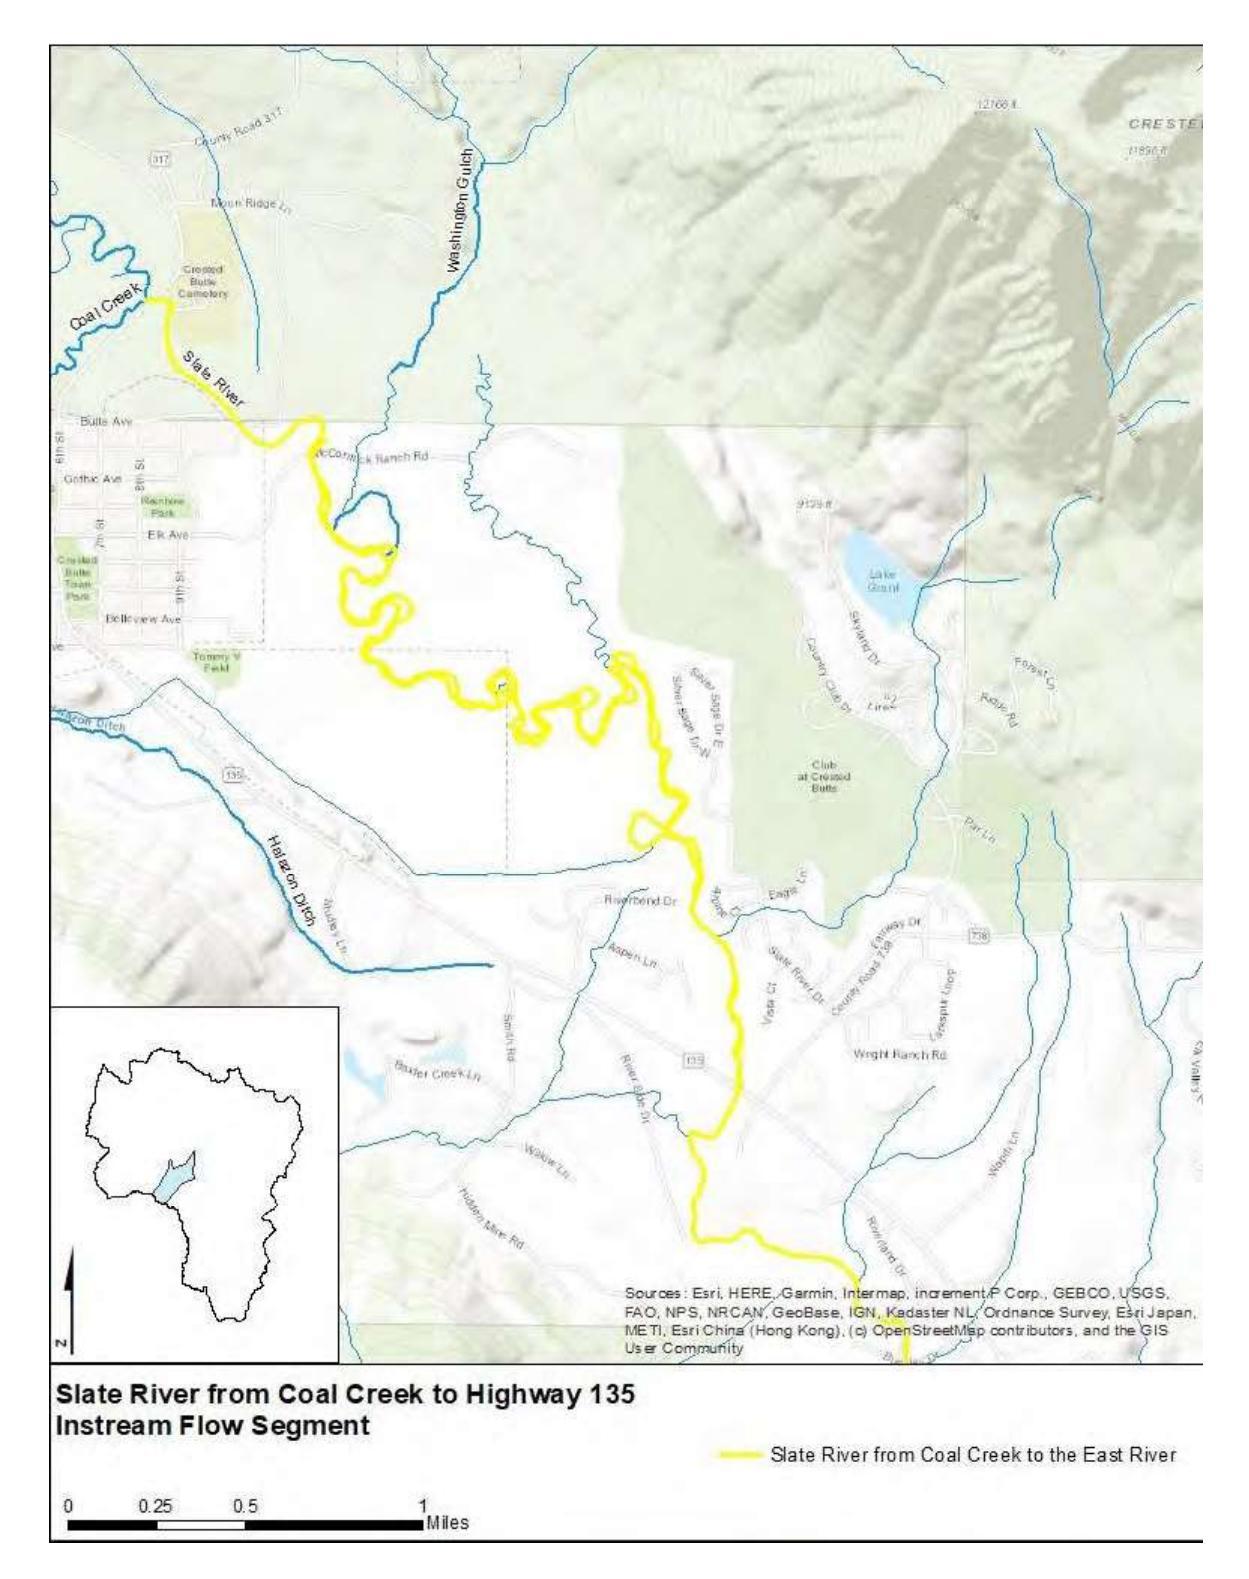
Figure 15-4: Slate River instream flow water right in the Slate River from Coal Creek and the Highway 135 Bridge

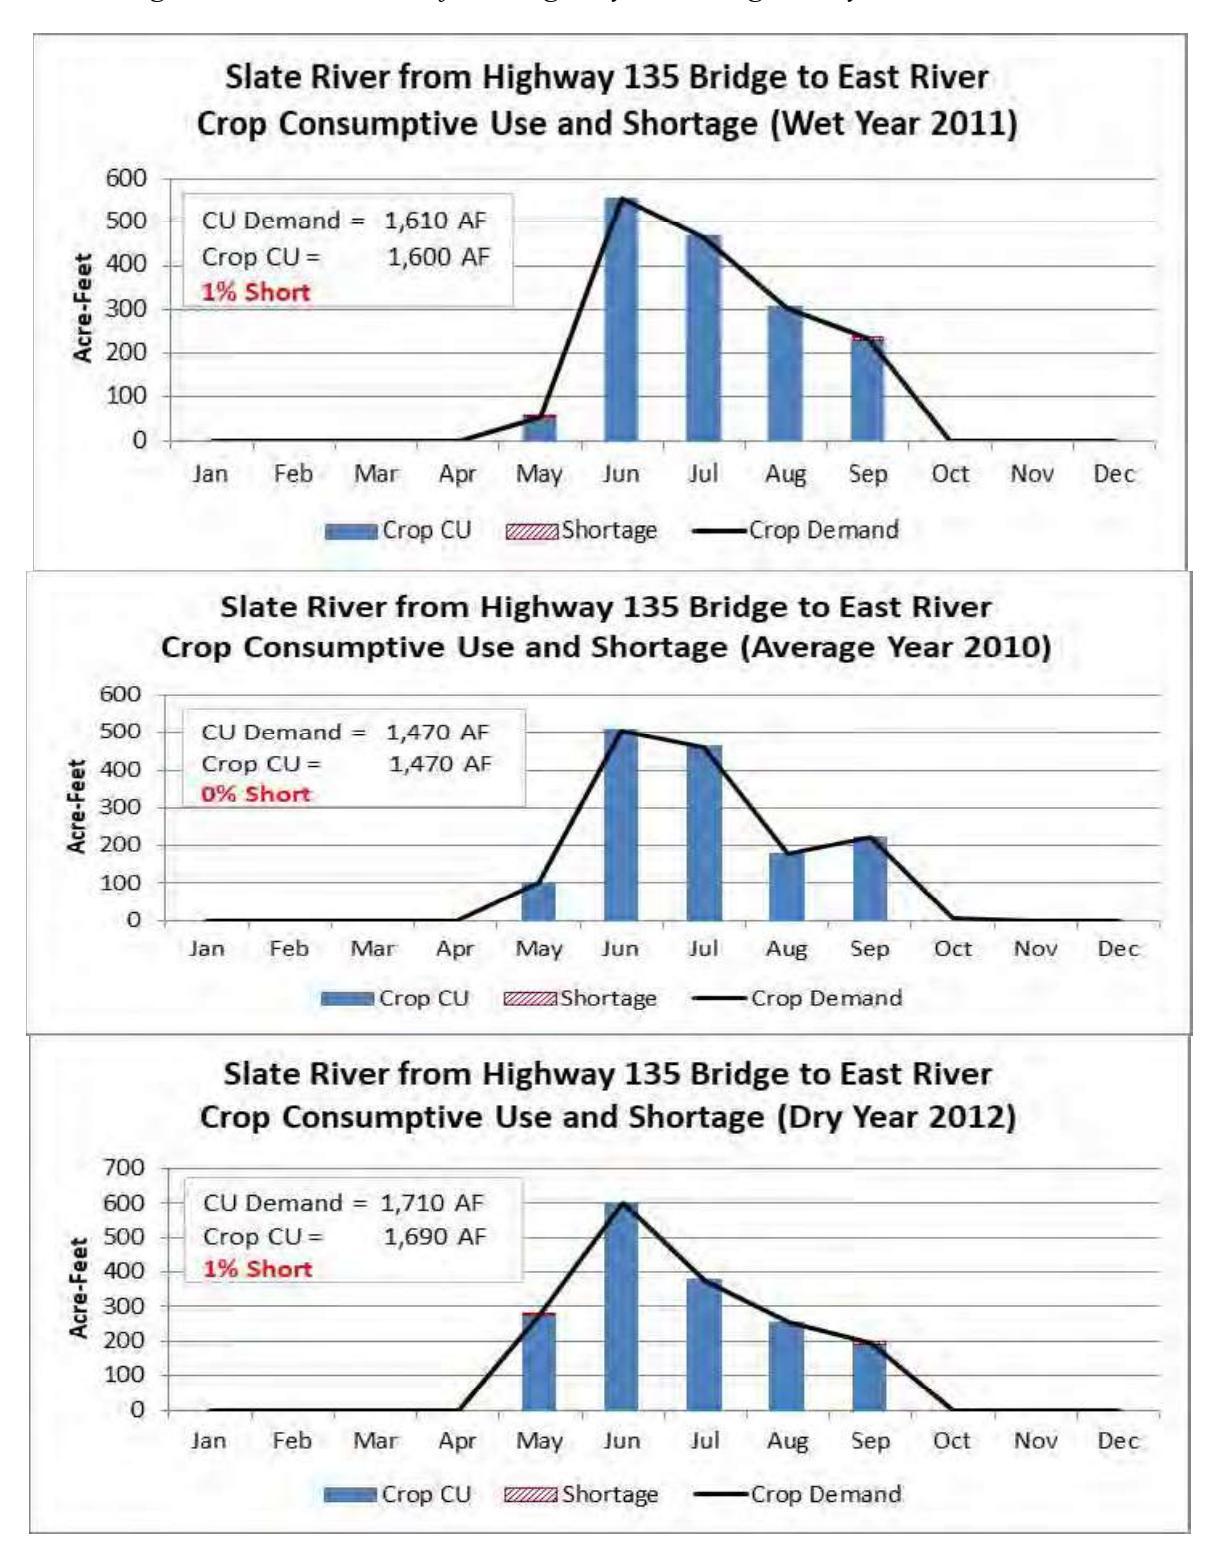
Figure 16-2: Slate River from Highway 135 Bridge at Skyland to East River

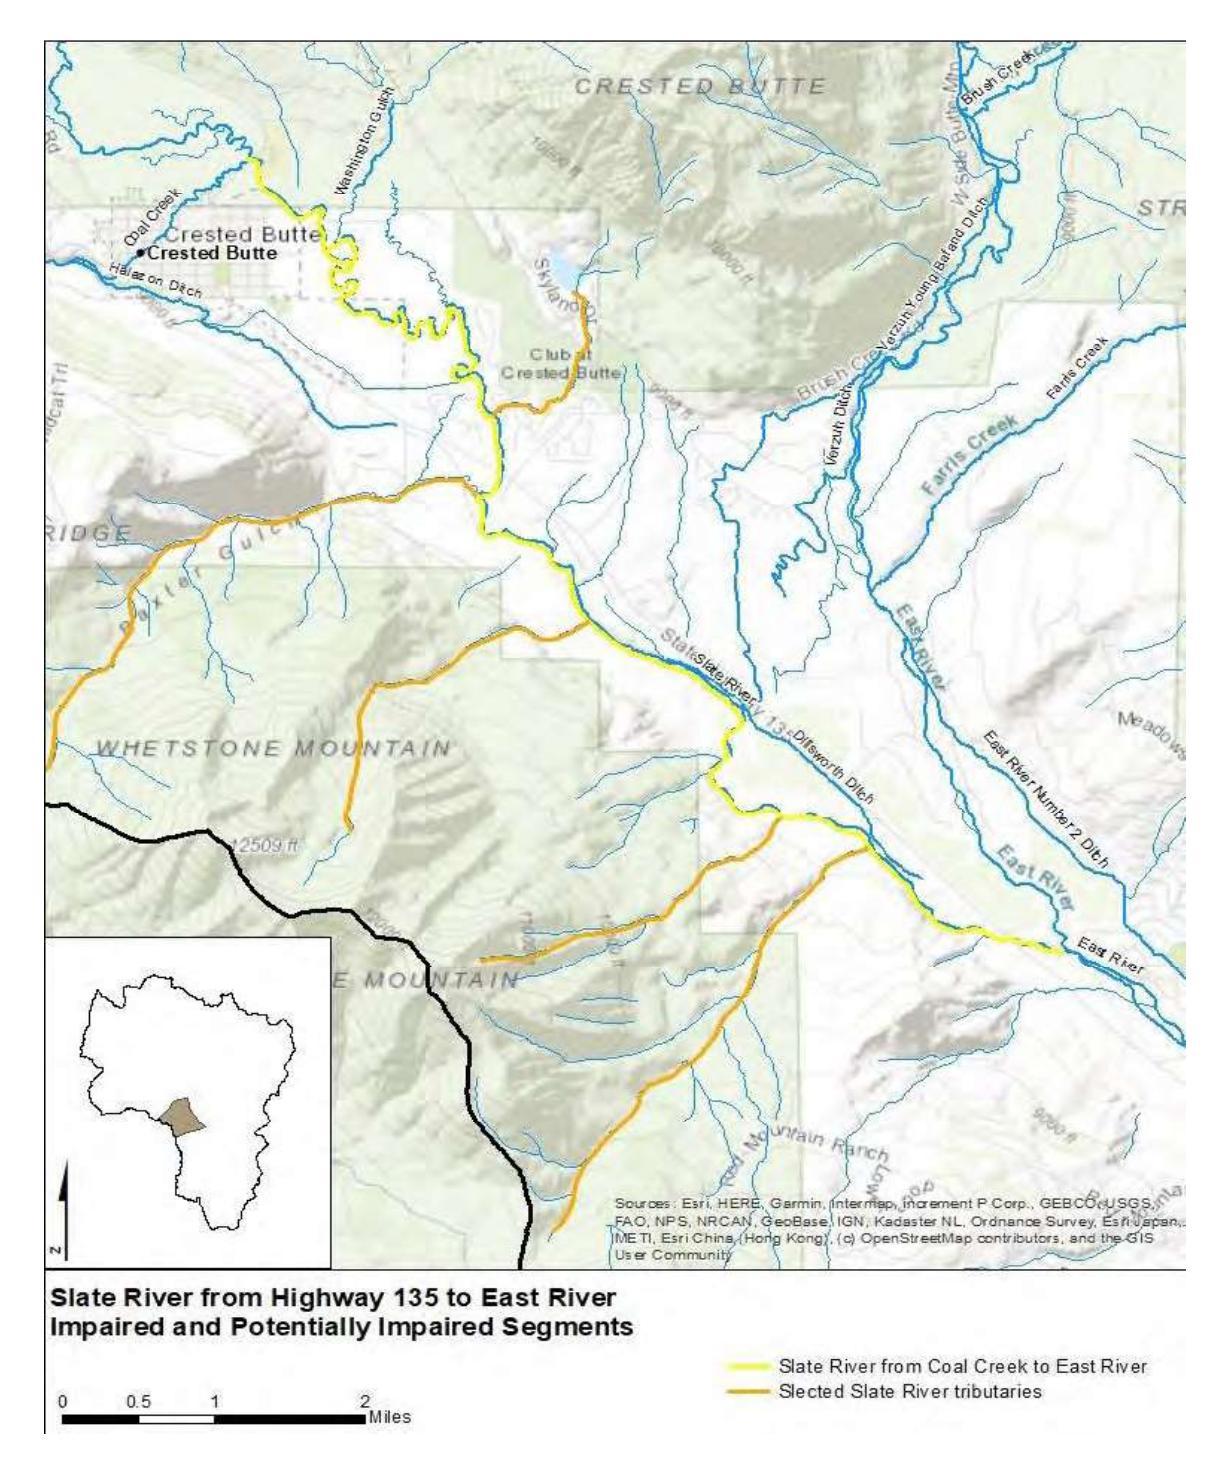
Figure 16-3: Impaired and potentially impaired stream segments in the Slate River from Highway 135 at Skyland to the East River

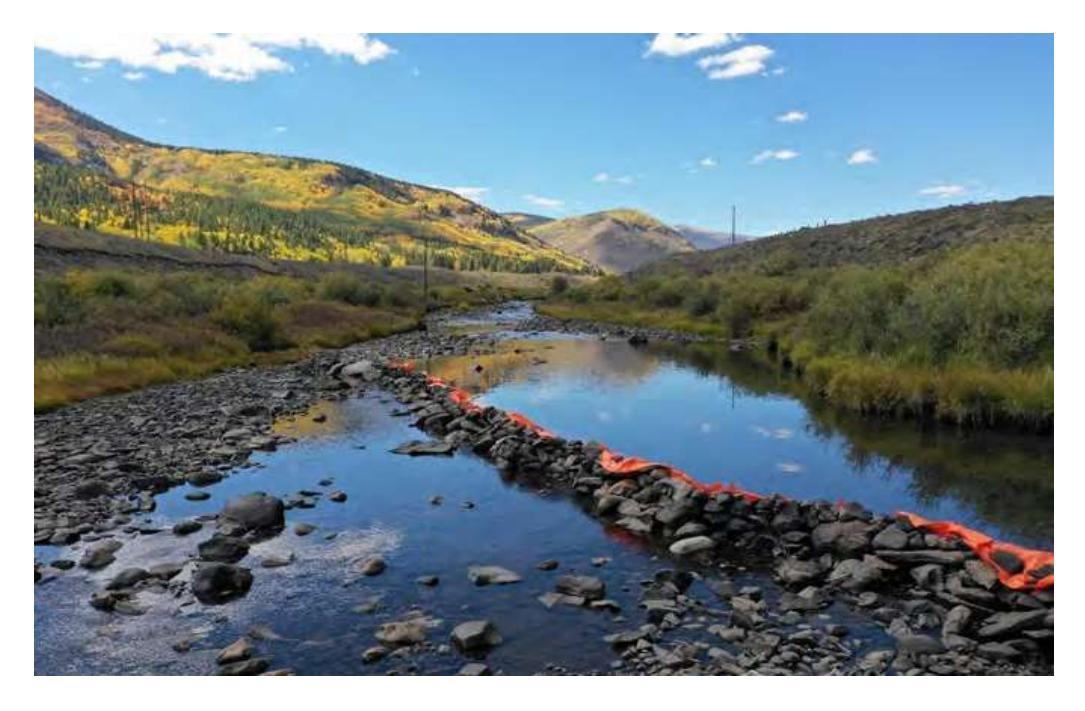
Photo 16-2: A large diversion in the Slate River caused substantial dry down during early fall 2018. The diversion structure dried a portion of the channel (see left side of photo) and the pushup dam prevented fish passage. The diversion structure also increases labor costs for the irrigator.

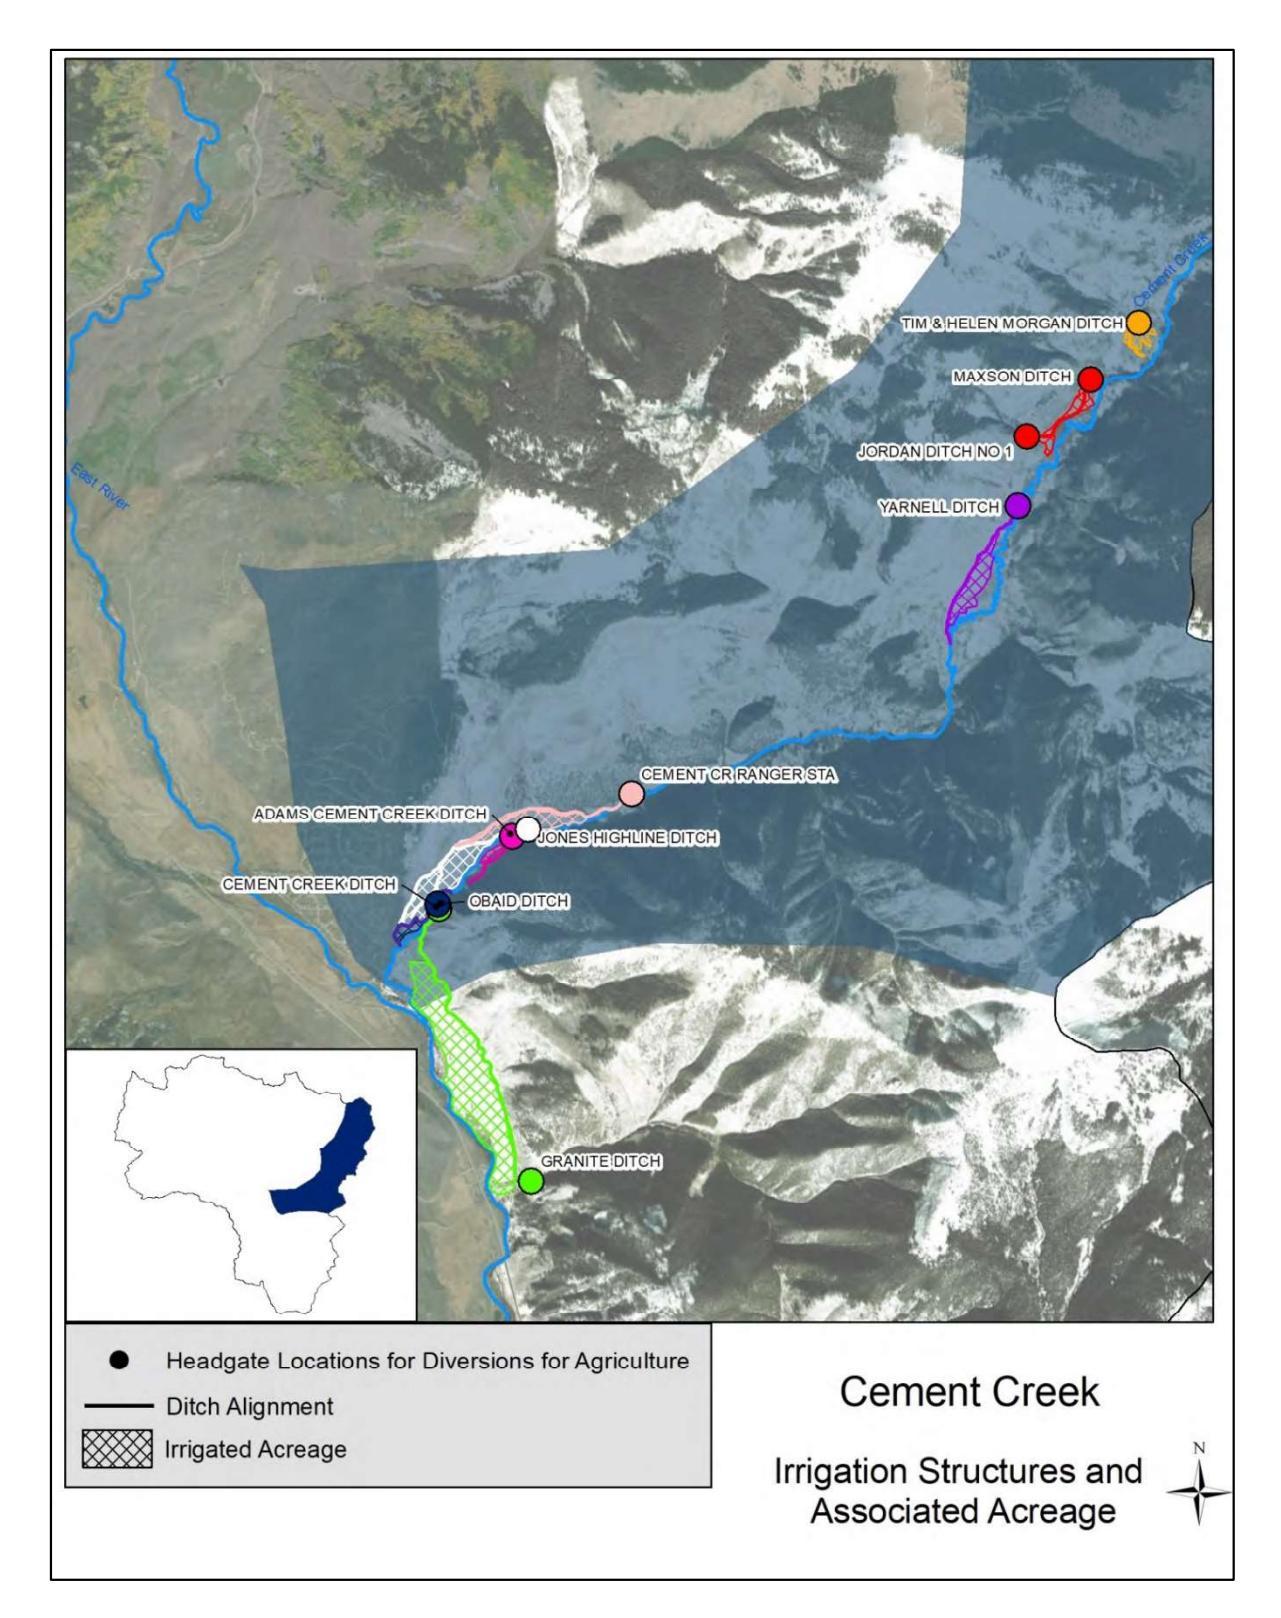
Figure 16-1: Diversion structures and irrigated acreage in the Cement Creek reach

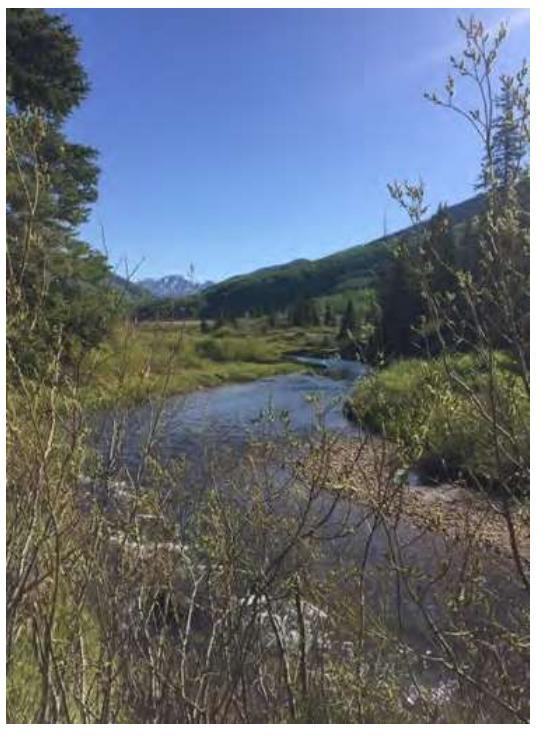
Photo 17-1: Cement Creek near Cement Creek Ranch. The creek supports ample riparian vegetation. Italian Mountain is visible in the background.

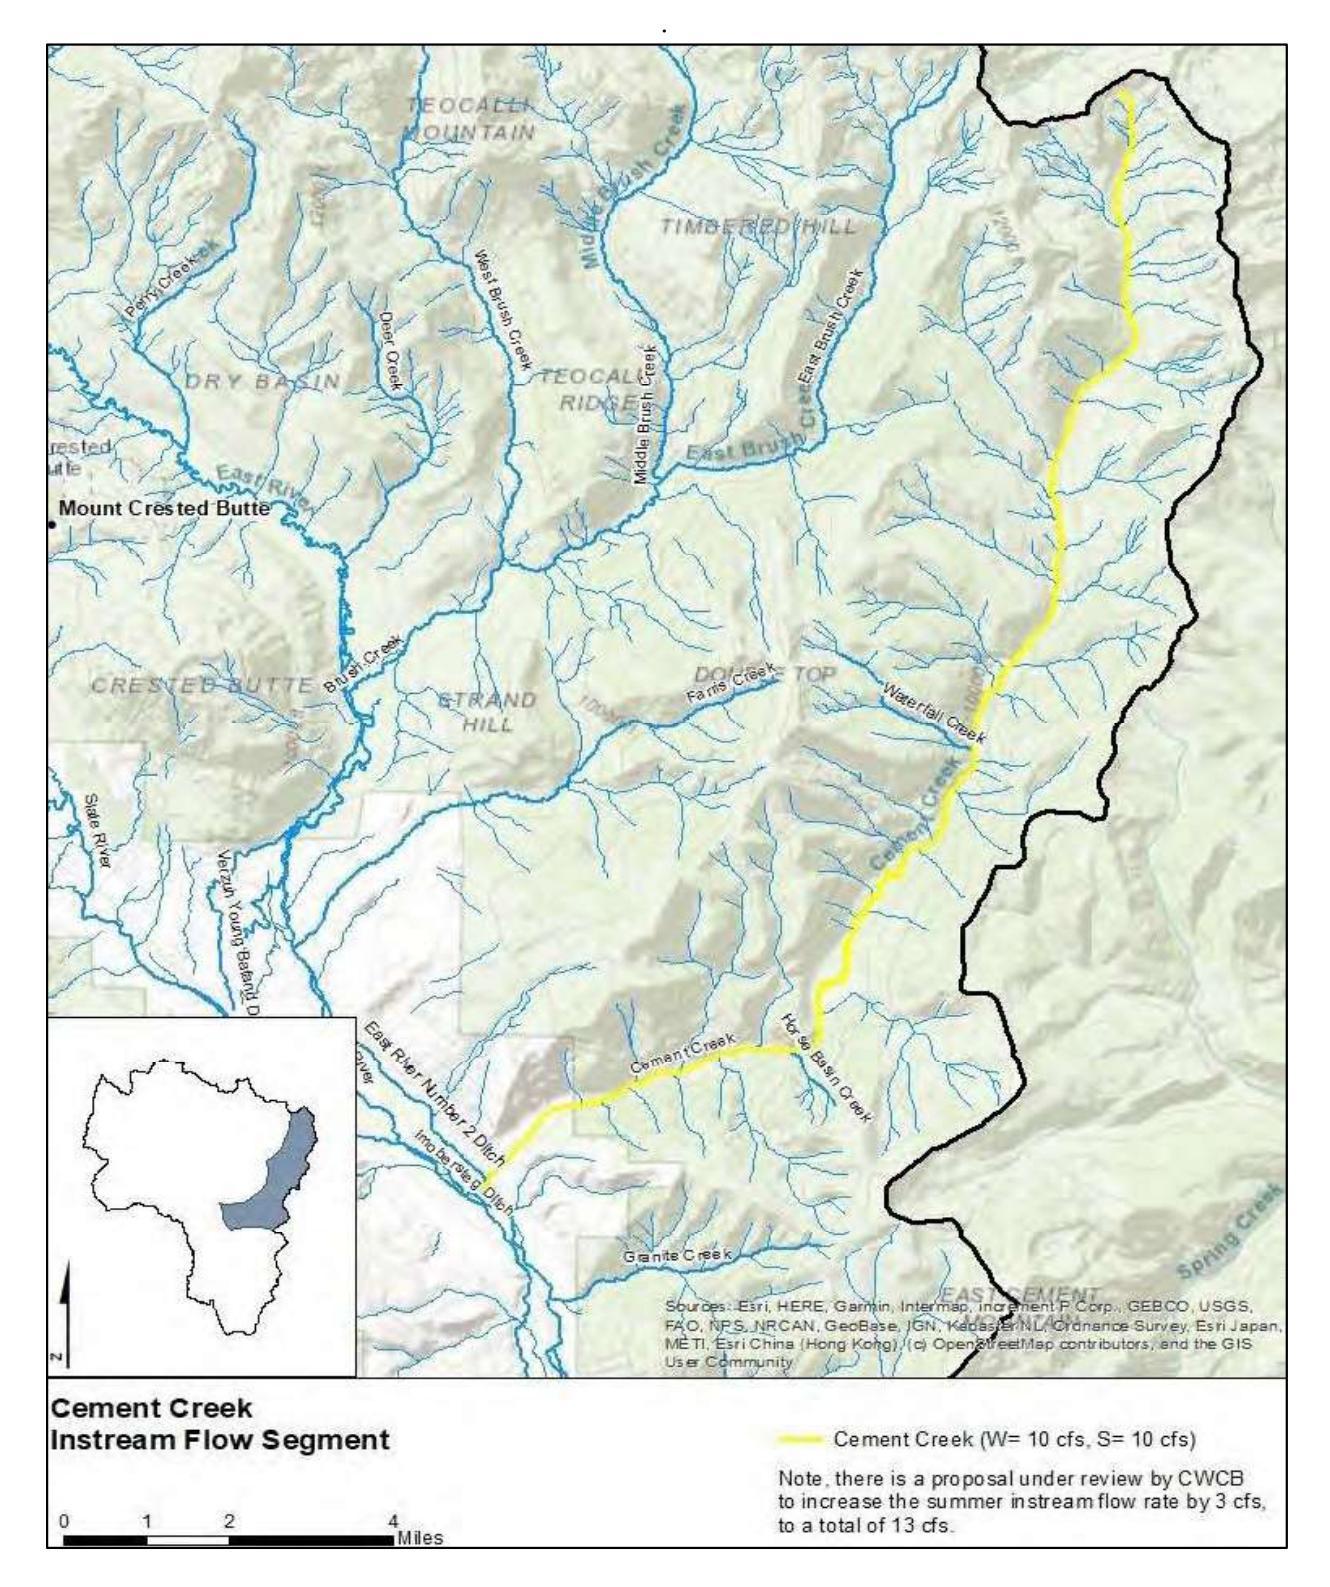
Figure 17-3: Cement Creek instream flow water right

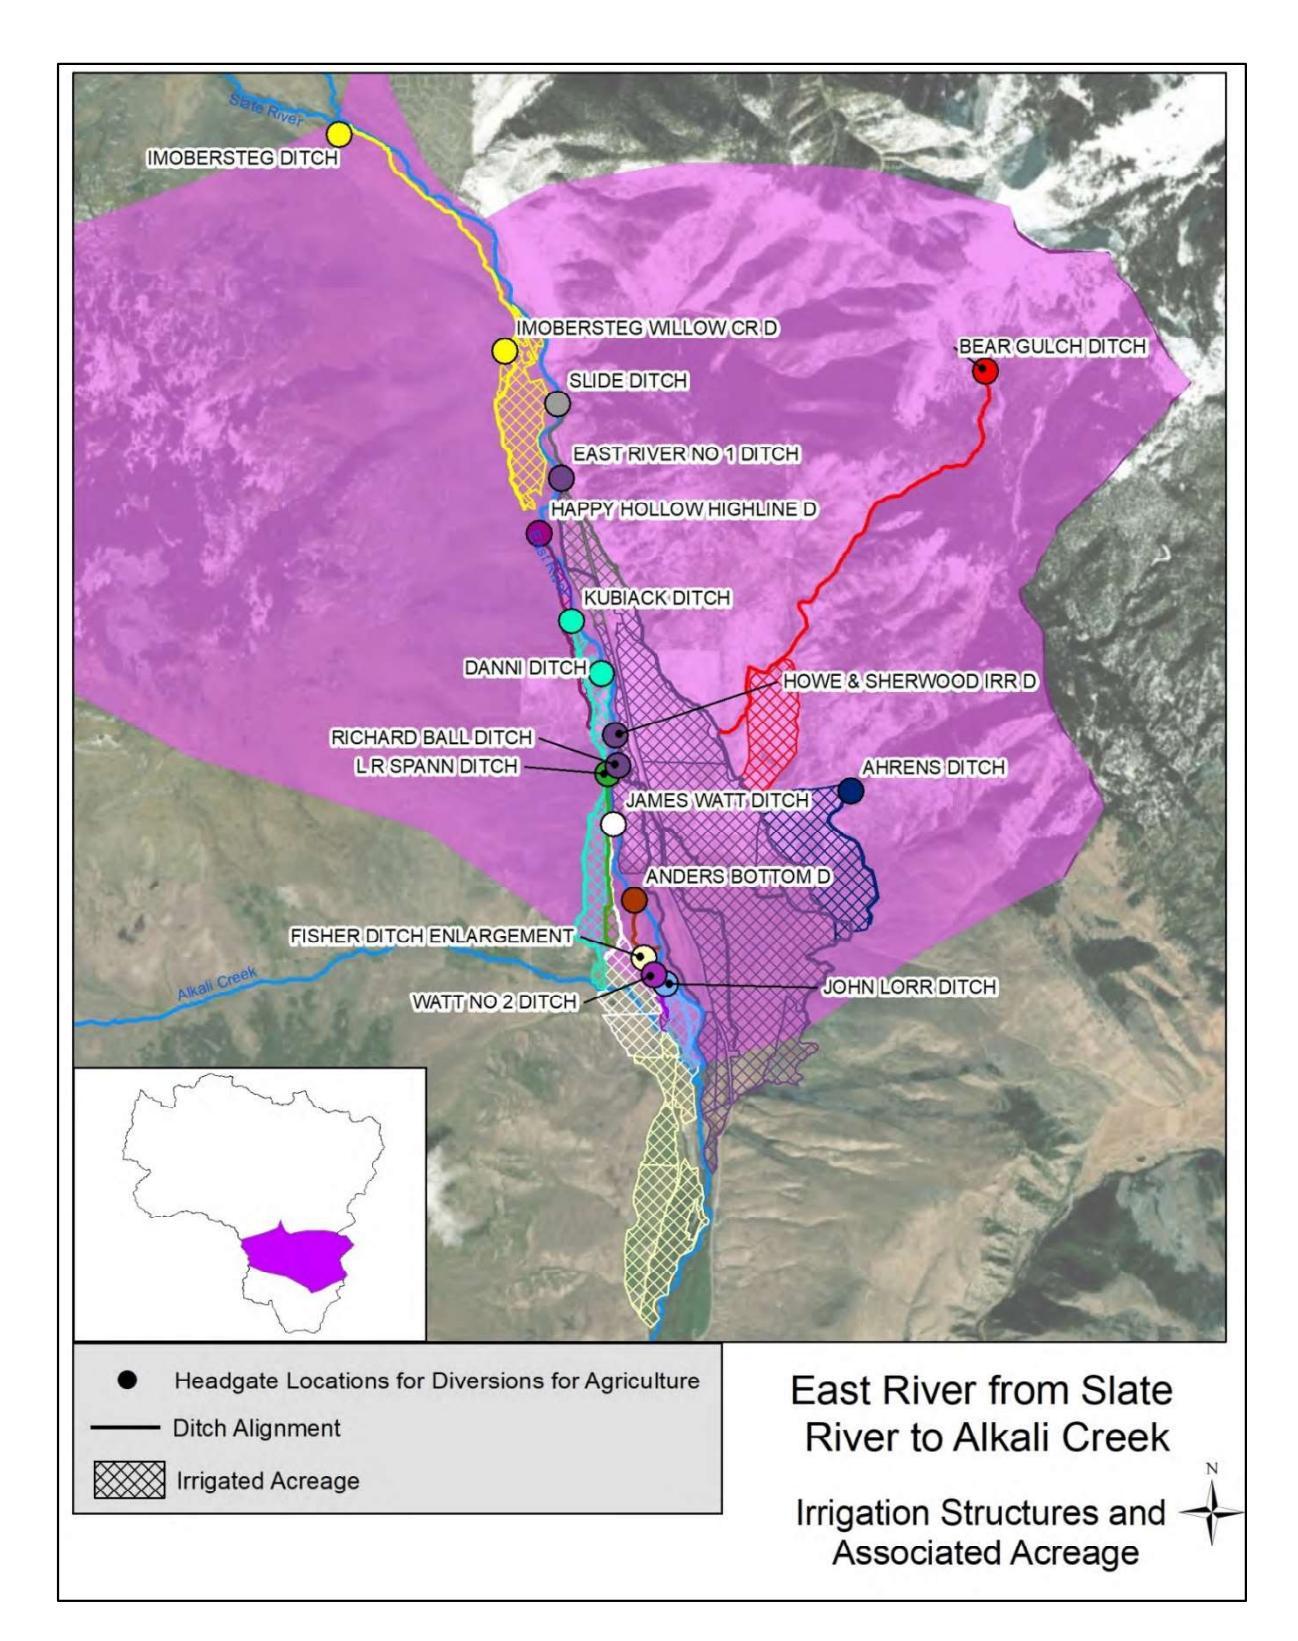
Figure 17-1: East River from Slate River to Alkali Creek diversion structures and acreage

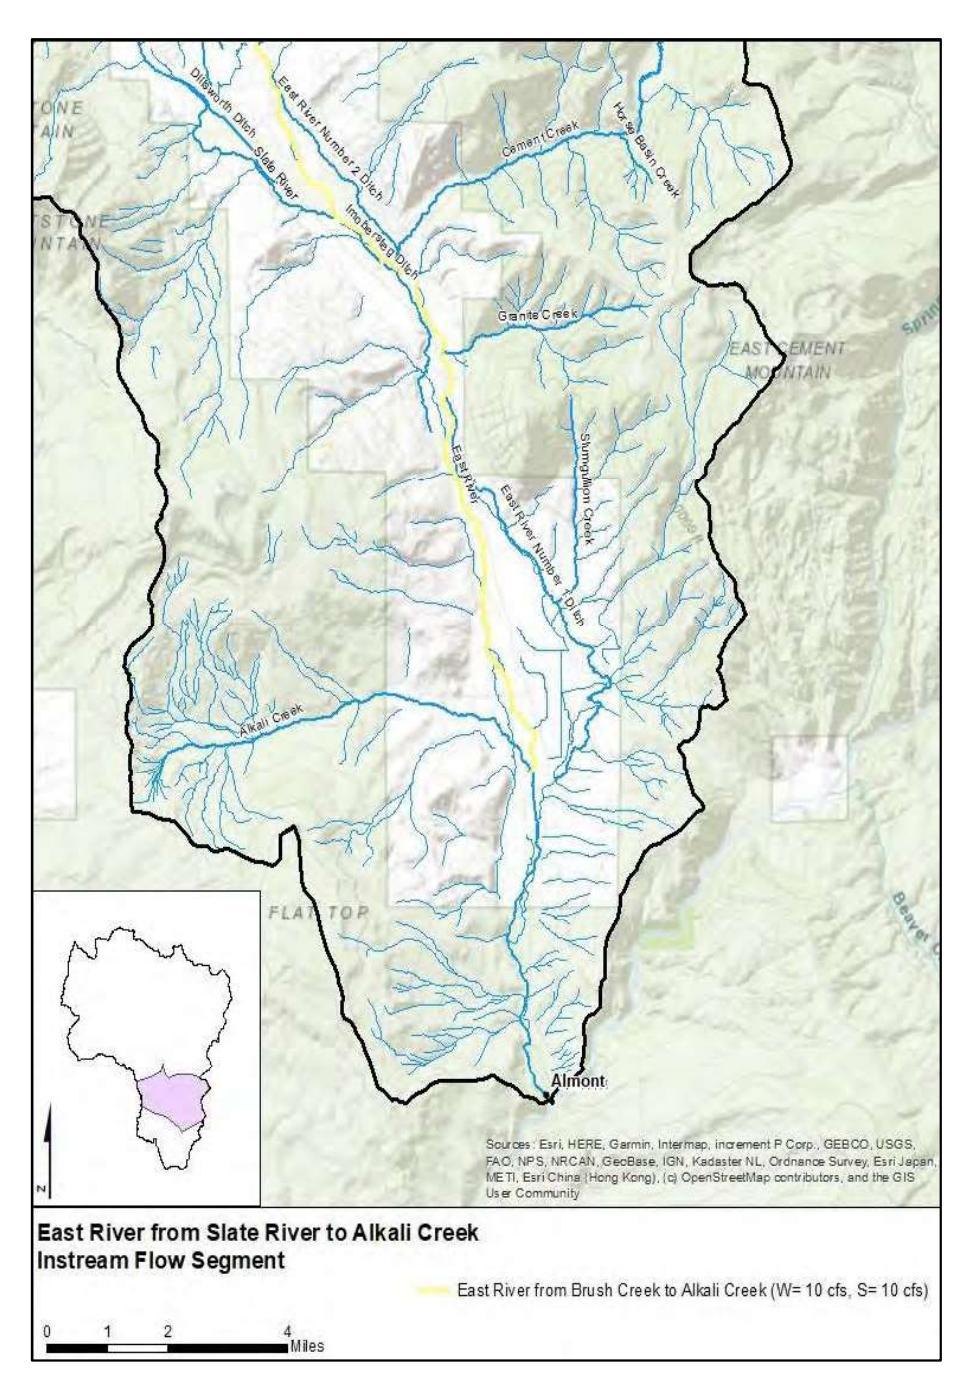
Figure 18-3: East River from Brush Creek to Alkali Creek instream flow water right

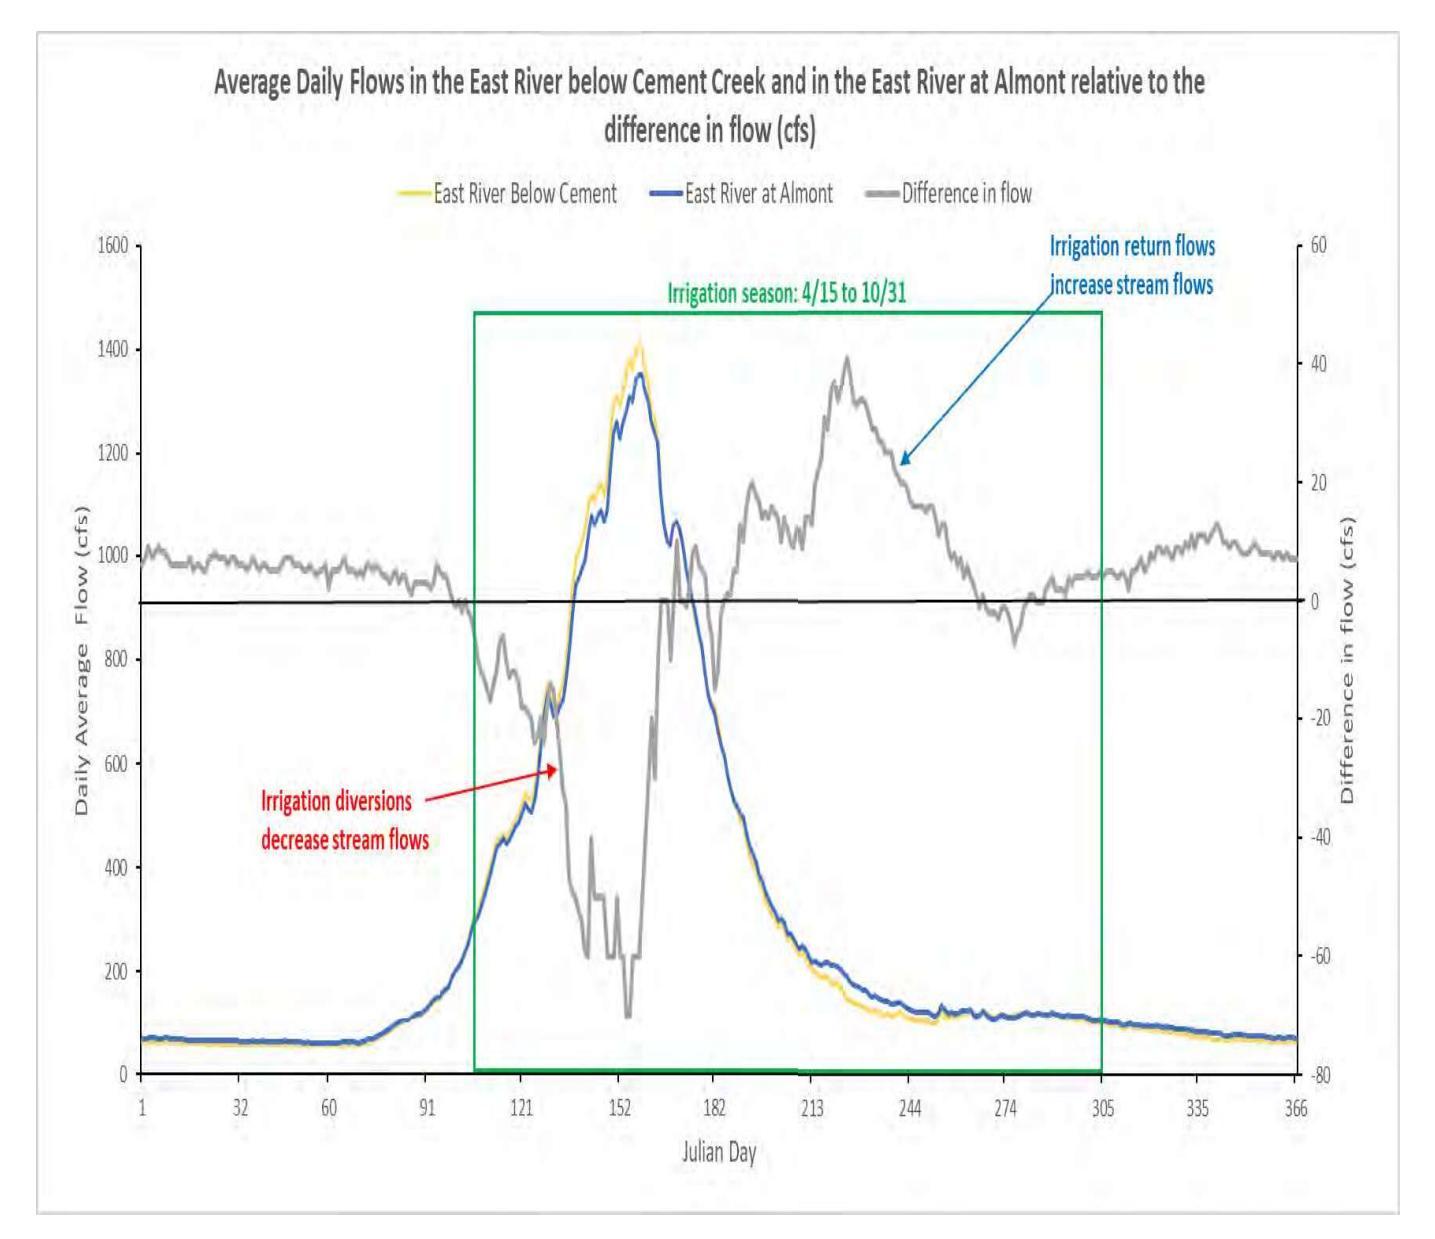
Figure 18-4: Average Daily Flows in the East River below Cement Creek and at Almont
