Chapter 6 The East River Basin

Section 1. Basin Characteristics

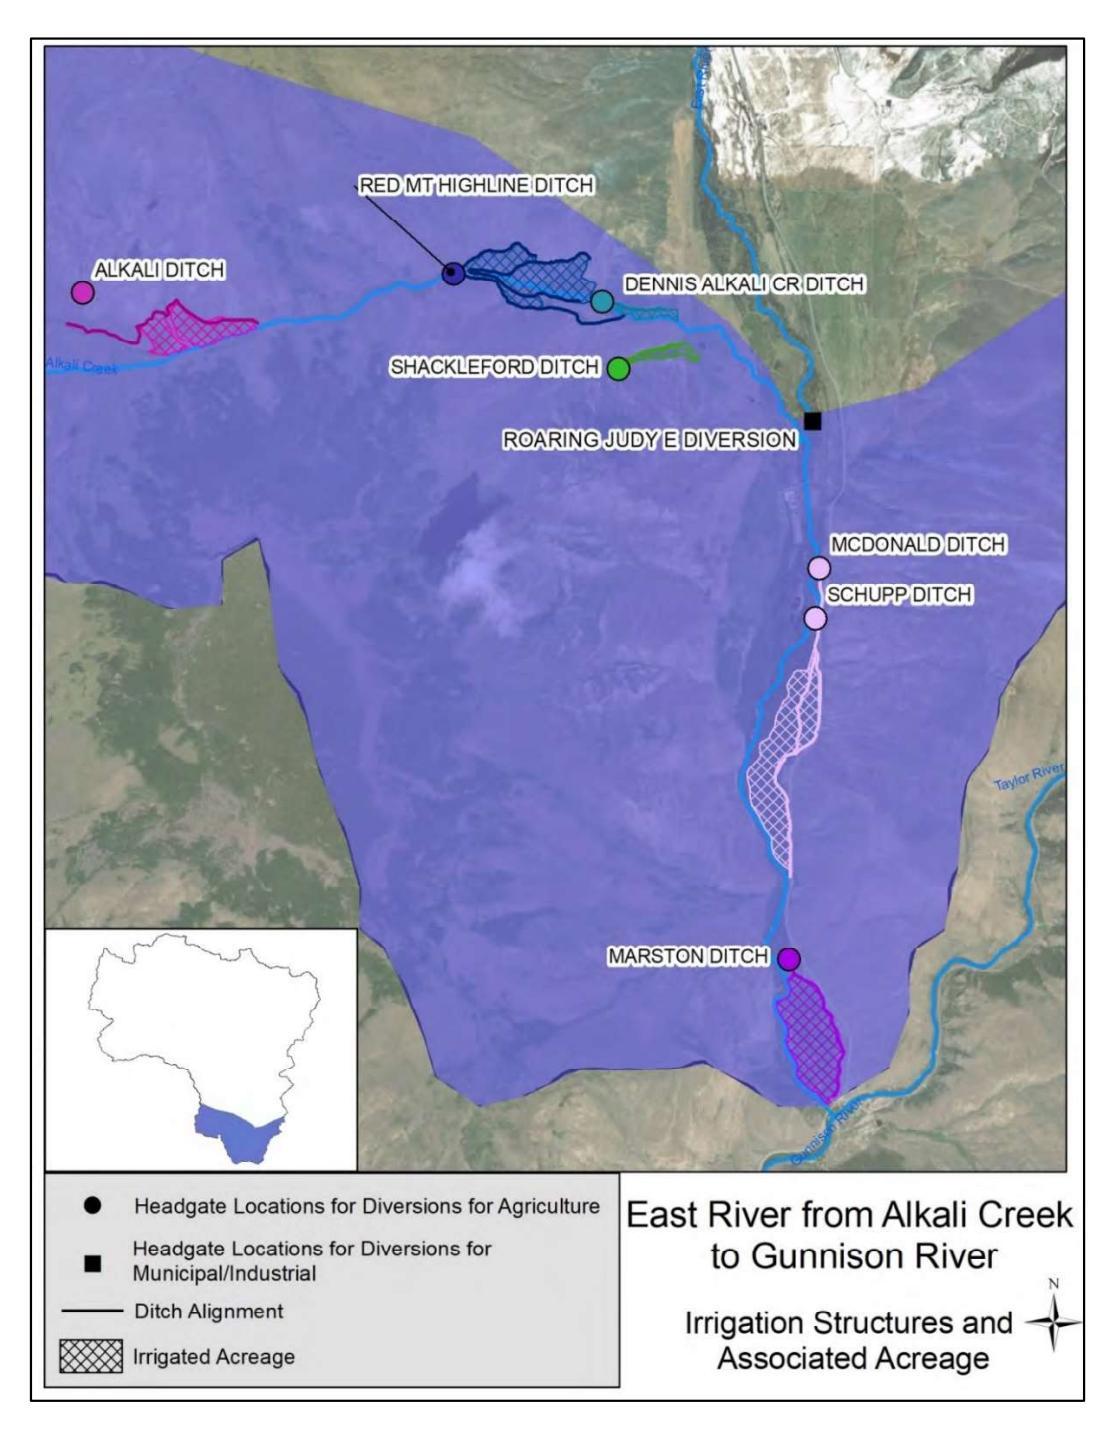
Figure 18-1: East River from Alkali Creek to Gunnison River diversion structures and acreage

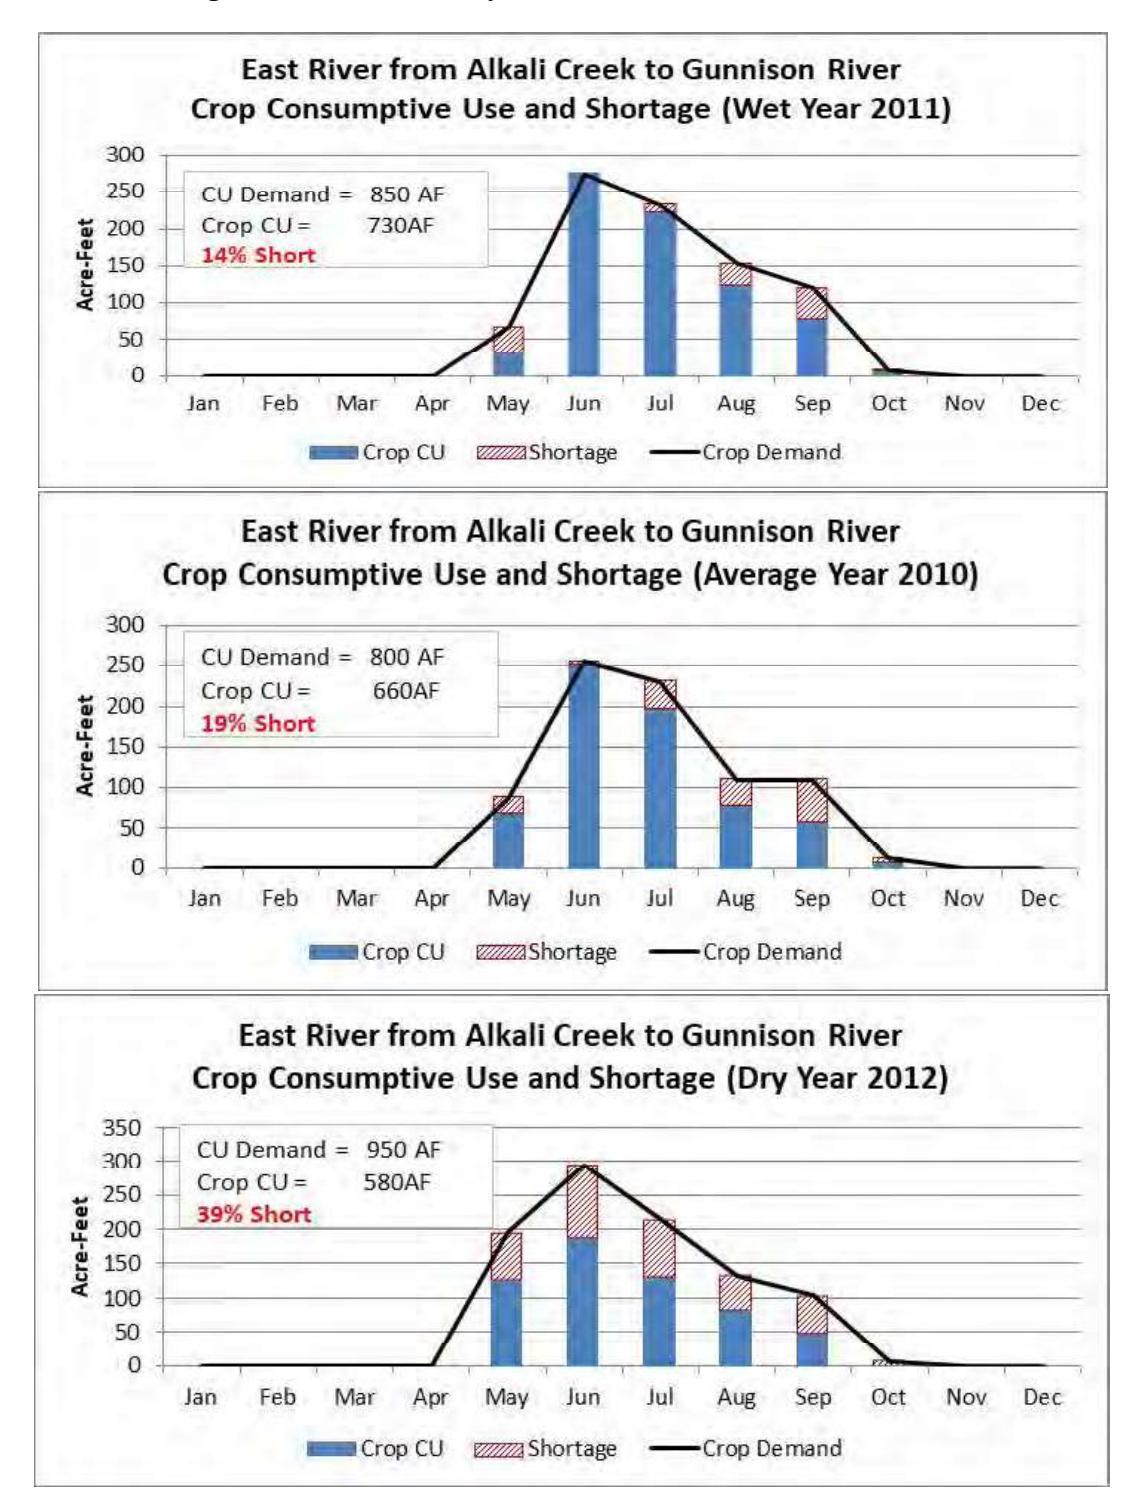
Figure 19-2: East River from Alkali Creek to Gunnison River

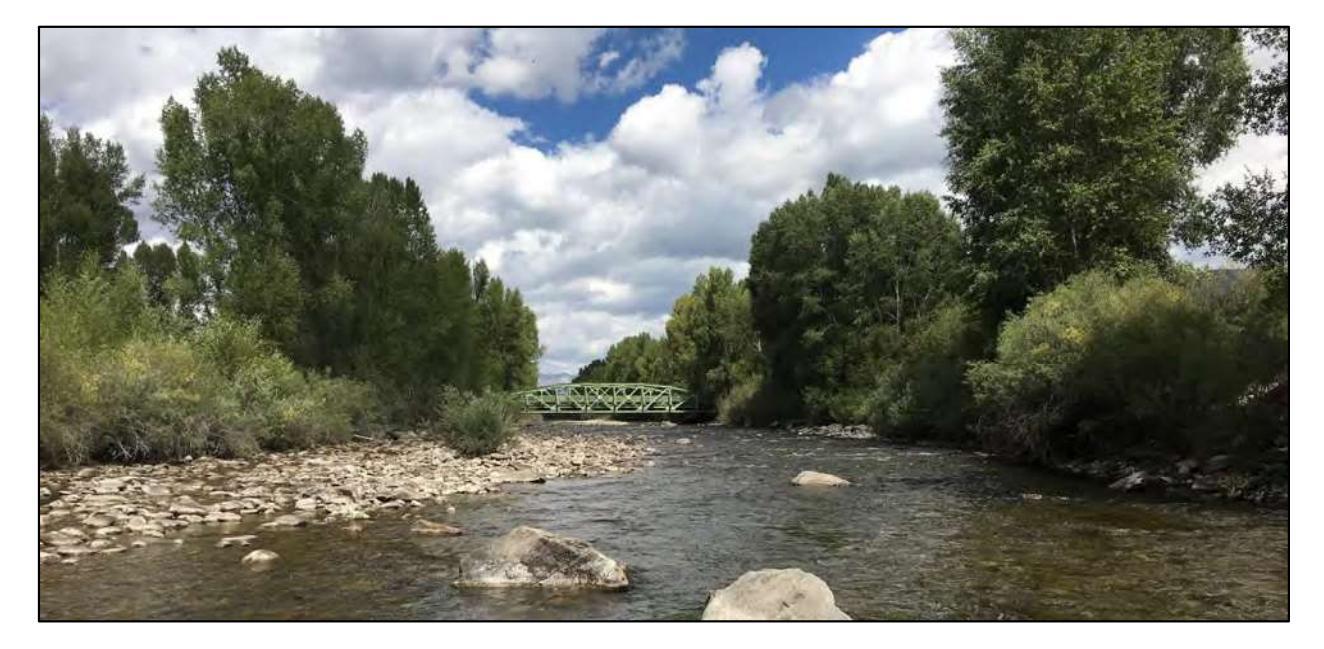
Photo 19-1. The East River downstream of Roaring Judy Road Bridge on August 27, 2018. The flow measured during the assessment was 65 cfs. The average daily flow for the East River at Almont is 158 cfs. The 2018 flow was just 41 percent of average.
